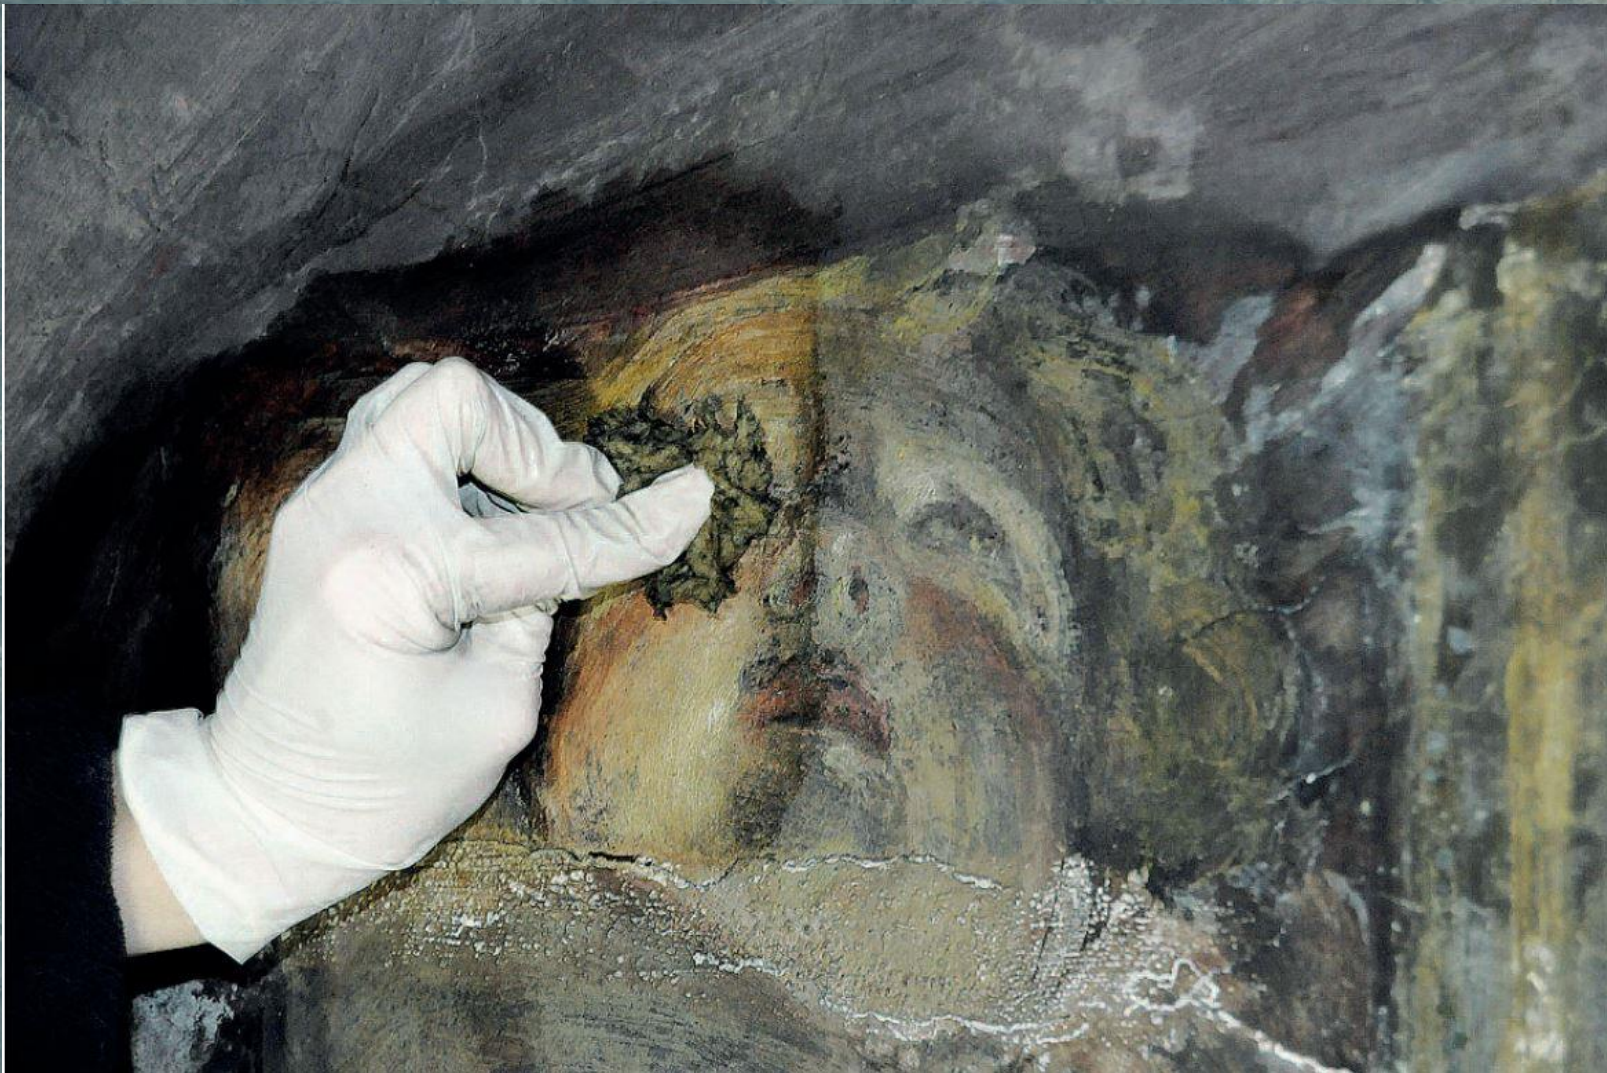
Example of cleaning, wall painting by Dionis Vidal, Church of San Nicolás Obispo y San Pedro Mártir, Valencia (Spain), 1694-1700; Photo: 2014, UPV; Weyer, E. (ed.), (2015), *EwaGlos:European Illustrated Glossary Of Conservation Terms For Wall Paintings And Architectural Surfaces*, Petersberg: Hornemann Institute; 304.

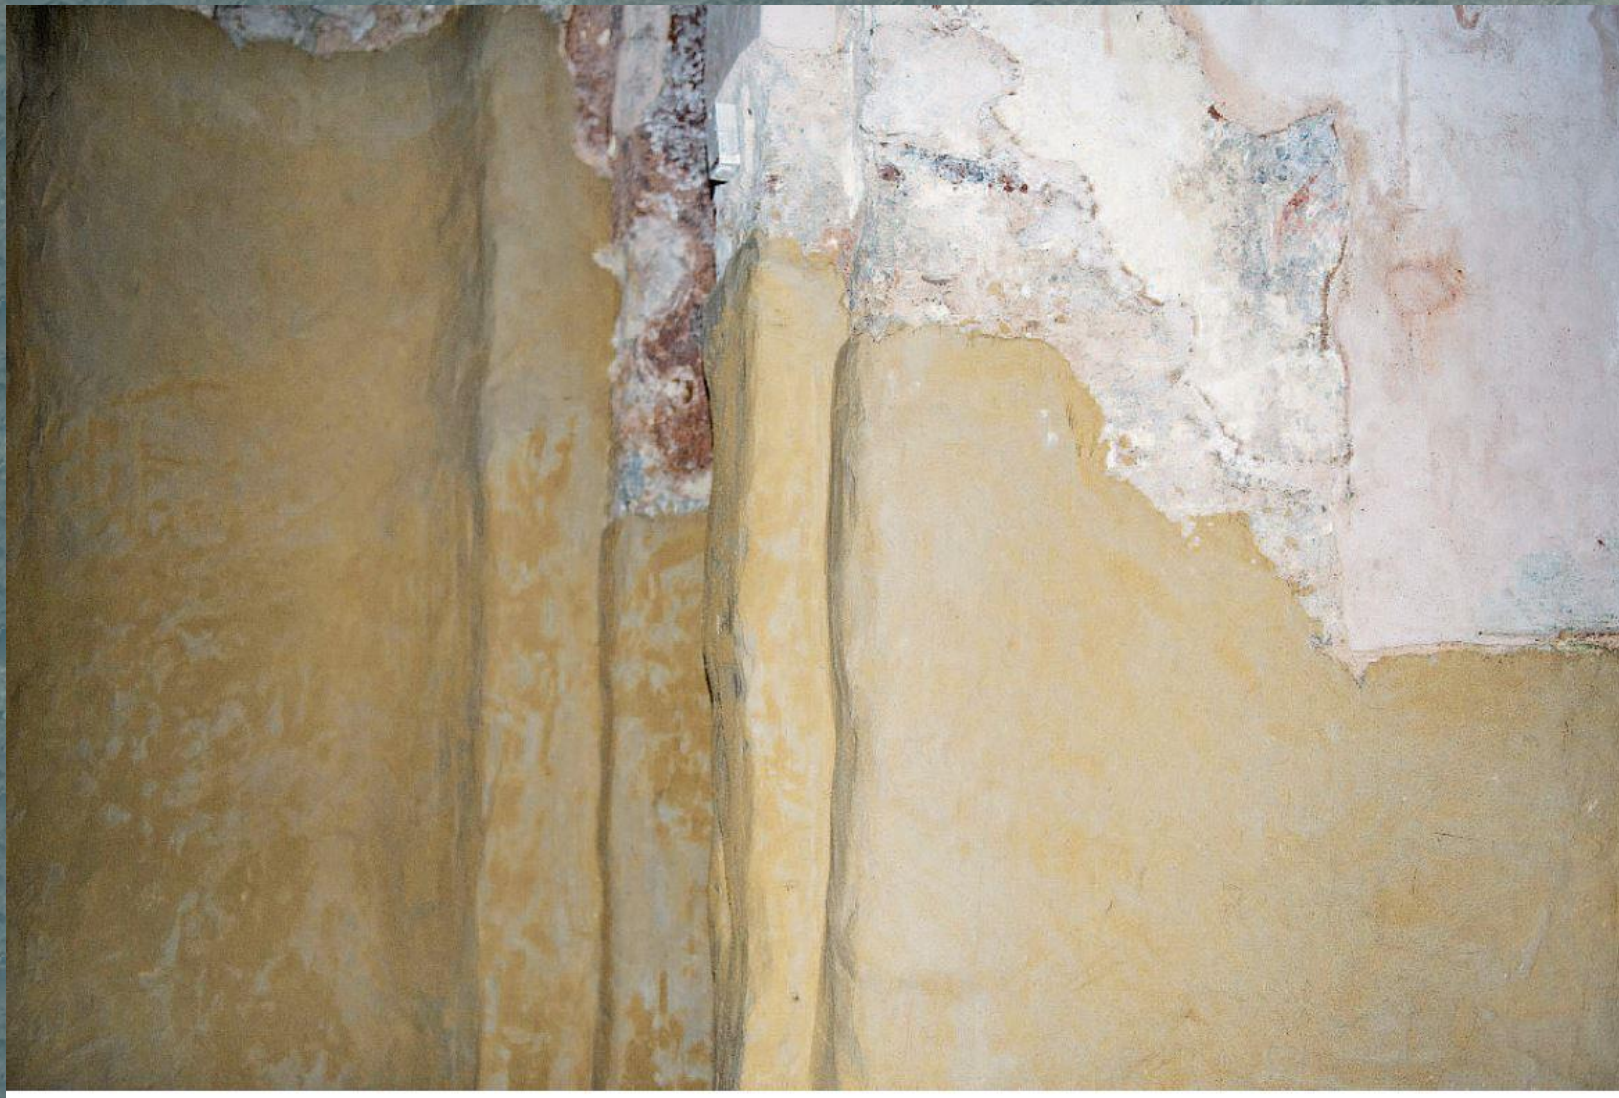
Sacrificial render applied to a wall within the church of St. Michael, Ston (Croatia), 11th century; Photo: 2011, HRZ (Veronika Šulić); Weyer, E. (ed.), (2015), *EwaGlos: European Illustrated Glossary Of Conservation Terms For Wall Paintings And Architectural Surfaces*, Petersberg: Hornemann Institute; 308.

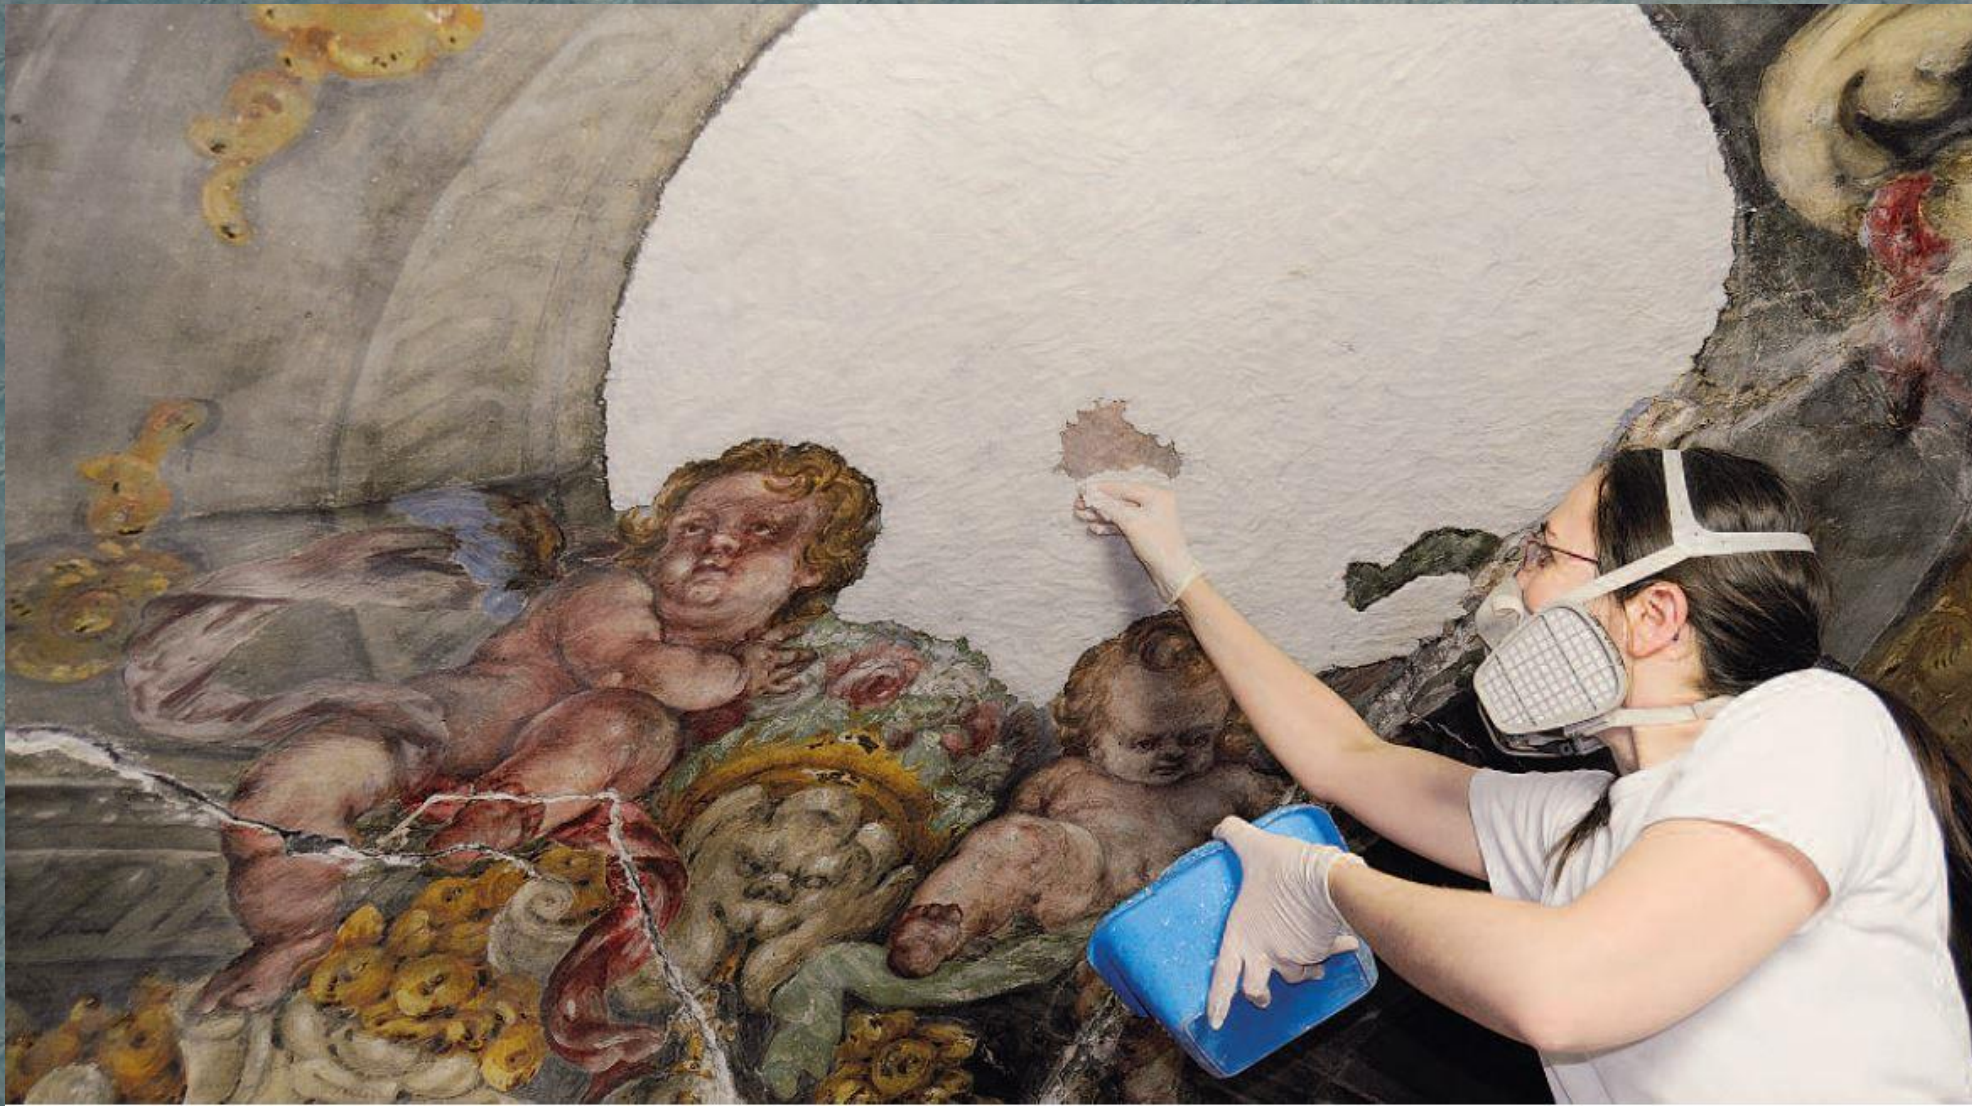
Application of a poultice, wall painting by Dionis Vidal, Church of San Nicolas Obispo y San Pedro Martir, Valencia (Spain), 1694-1700; Photo: 2014, UPV; Weyer, E. (ed.), (2015), EwaGlos:European Illustrated Glossary Of Conservation Terms For Wall Paintings And Architectural Surfaces, Petersberg: Hornemann Institute; 310.

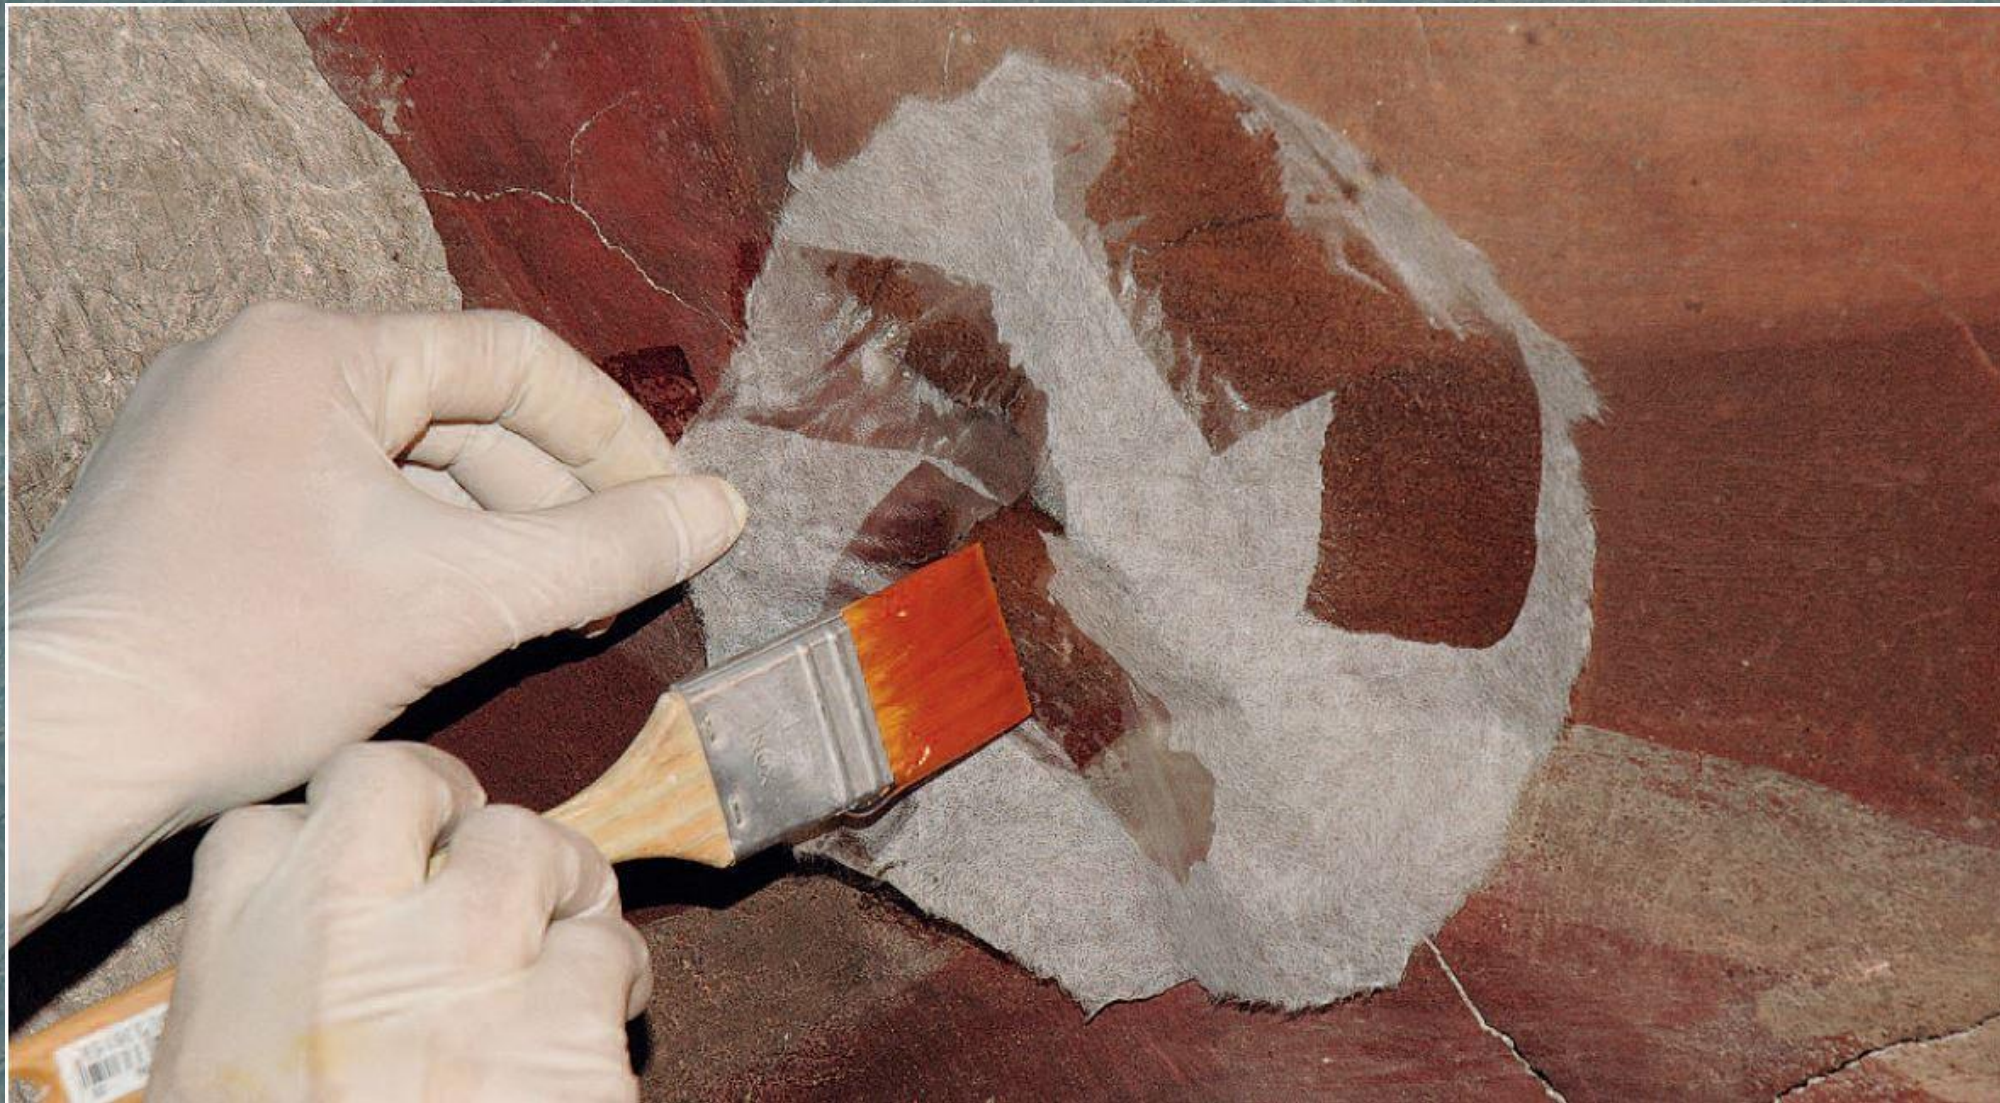
Application of a consolidant, wall painting by Antonio A. Palomino/ Guilló, Church of Santos Juanes, Valencia (Spain), 1698-1700; Photo: 2009, UPV; Weyer, E. (ed.), (2015), *EwaGlos:European Illustrated Glossary Of Conservation Terms For Wall Paintings And Architectural Surfaces*, Petersberg: Hornemann Institute; 312.

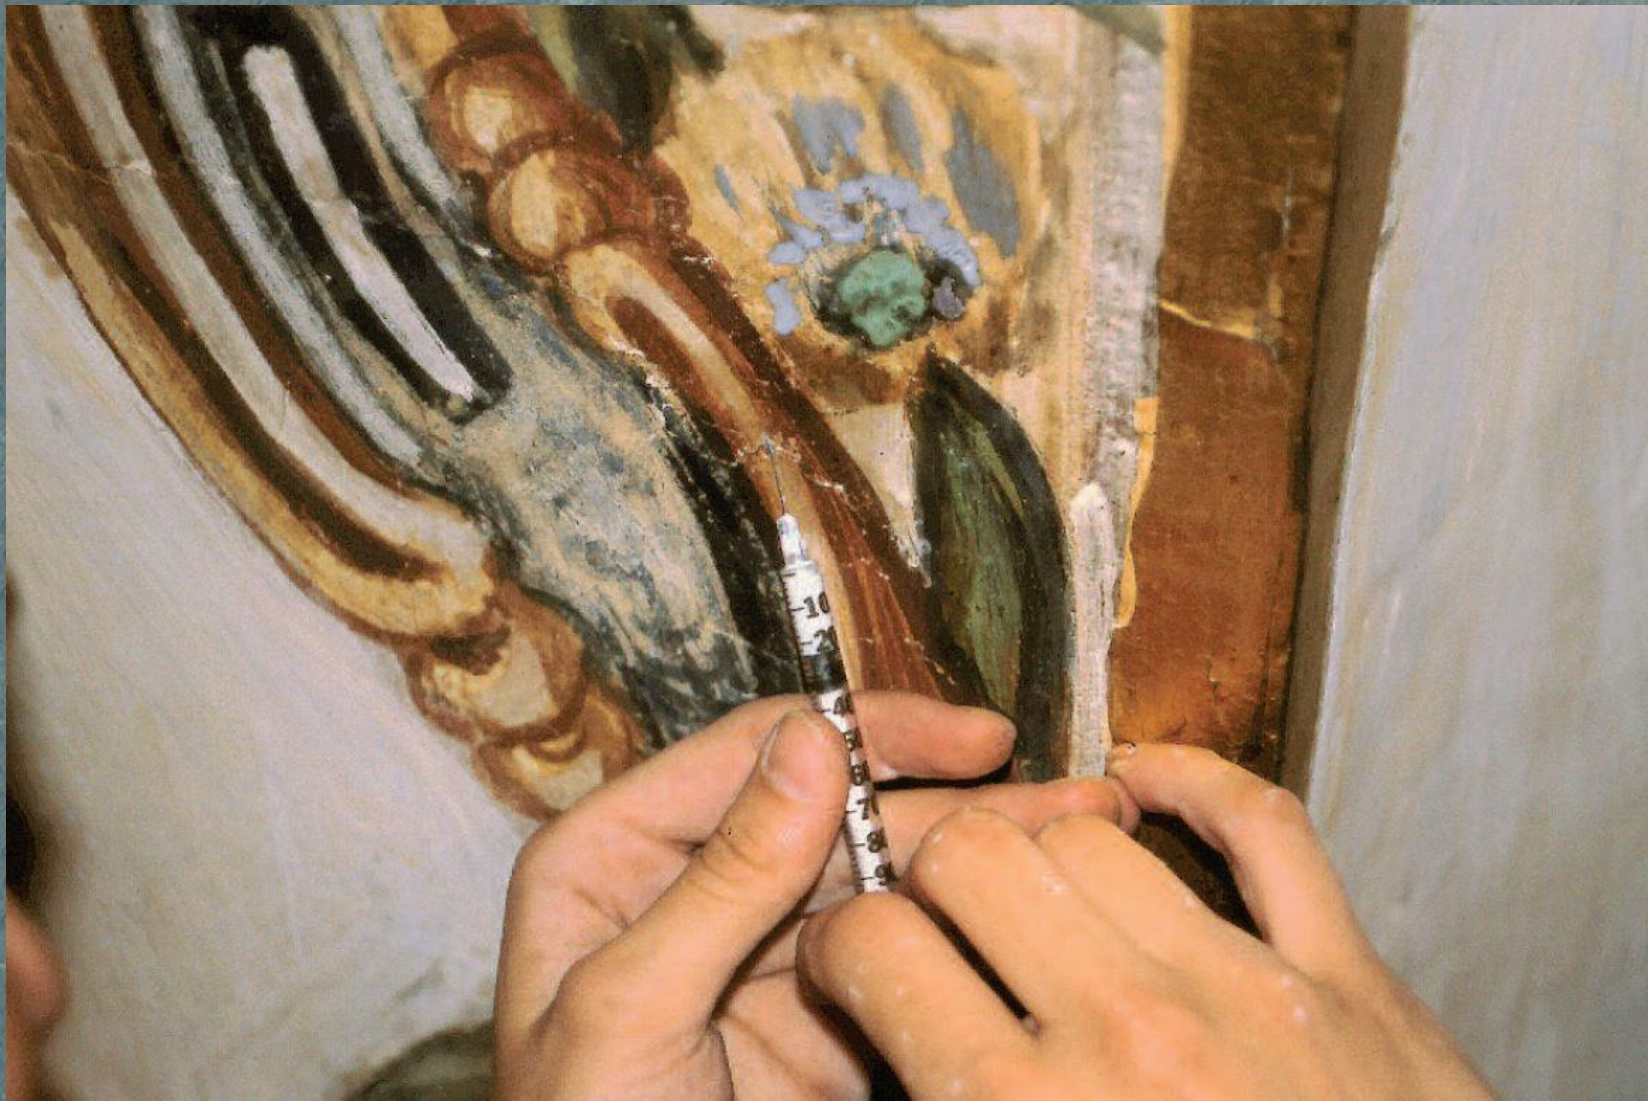
Injection of an adhesive into a wall painting, Church of San Roque, Oliva (Spain), 20th century; Photo: 2009, UPV; Weyer, E. (ed.), (2015), *EwaGlos:European Illustrated Glossary Of Conservation Terms For Wall Paintings And Architectural Surfaces*, Petersberg: Hornemann Institute; 314.

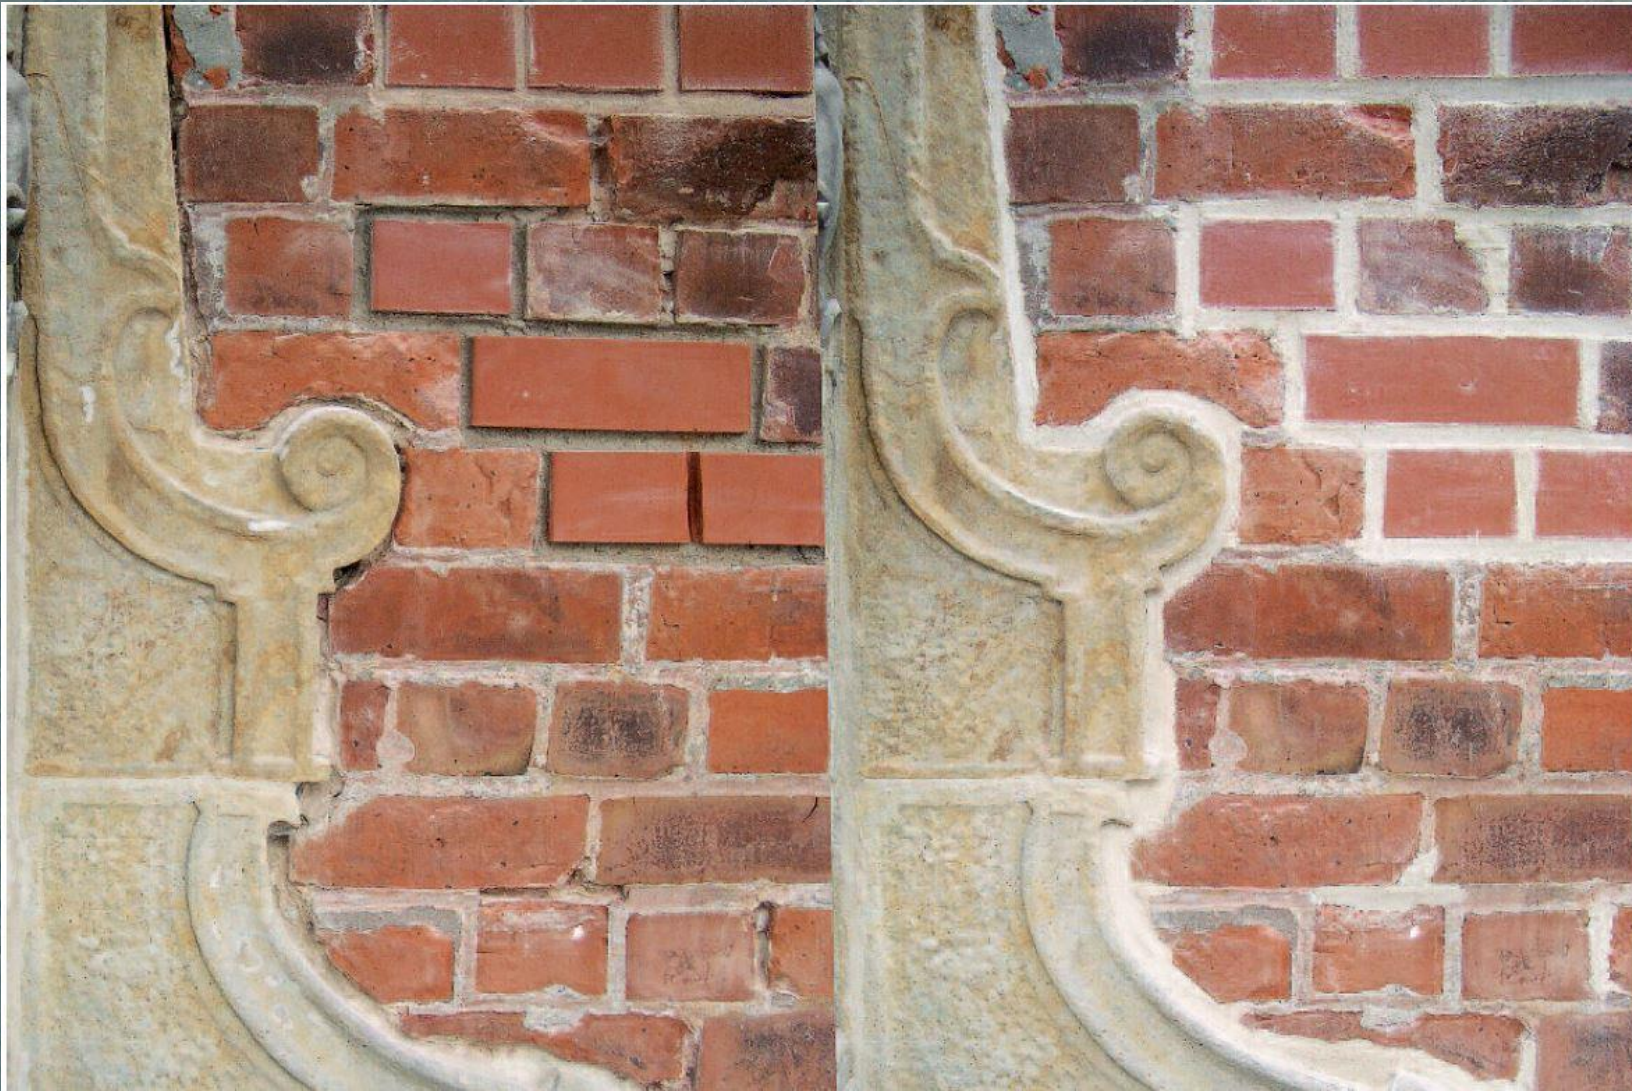
Raked (left) and repointed joints (right) of brick masonry and parts of a sandstone epitaph, Church of St. Gabriel, Haseldorf (Germany), end of 16th century; Photo: 2007 (Sophie Haake); Weyer, E. (ed.), (2015), EwaGlos:European Illustrated Glossary Of Conservation Terms For Wall Paintings And Architectural Surfaces, Petersberg: Hornemann Institute; 320.

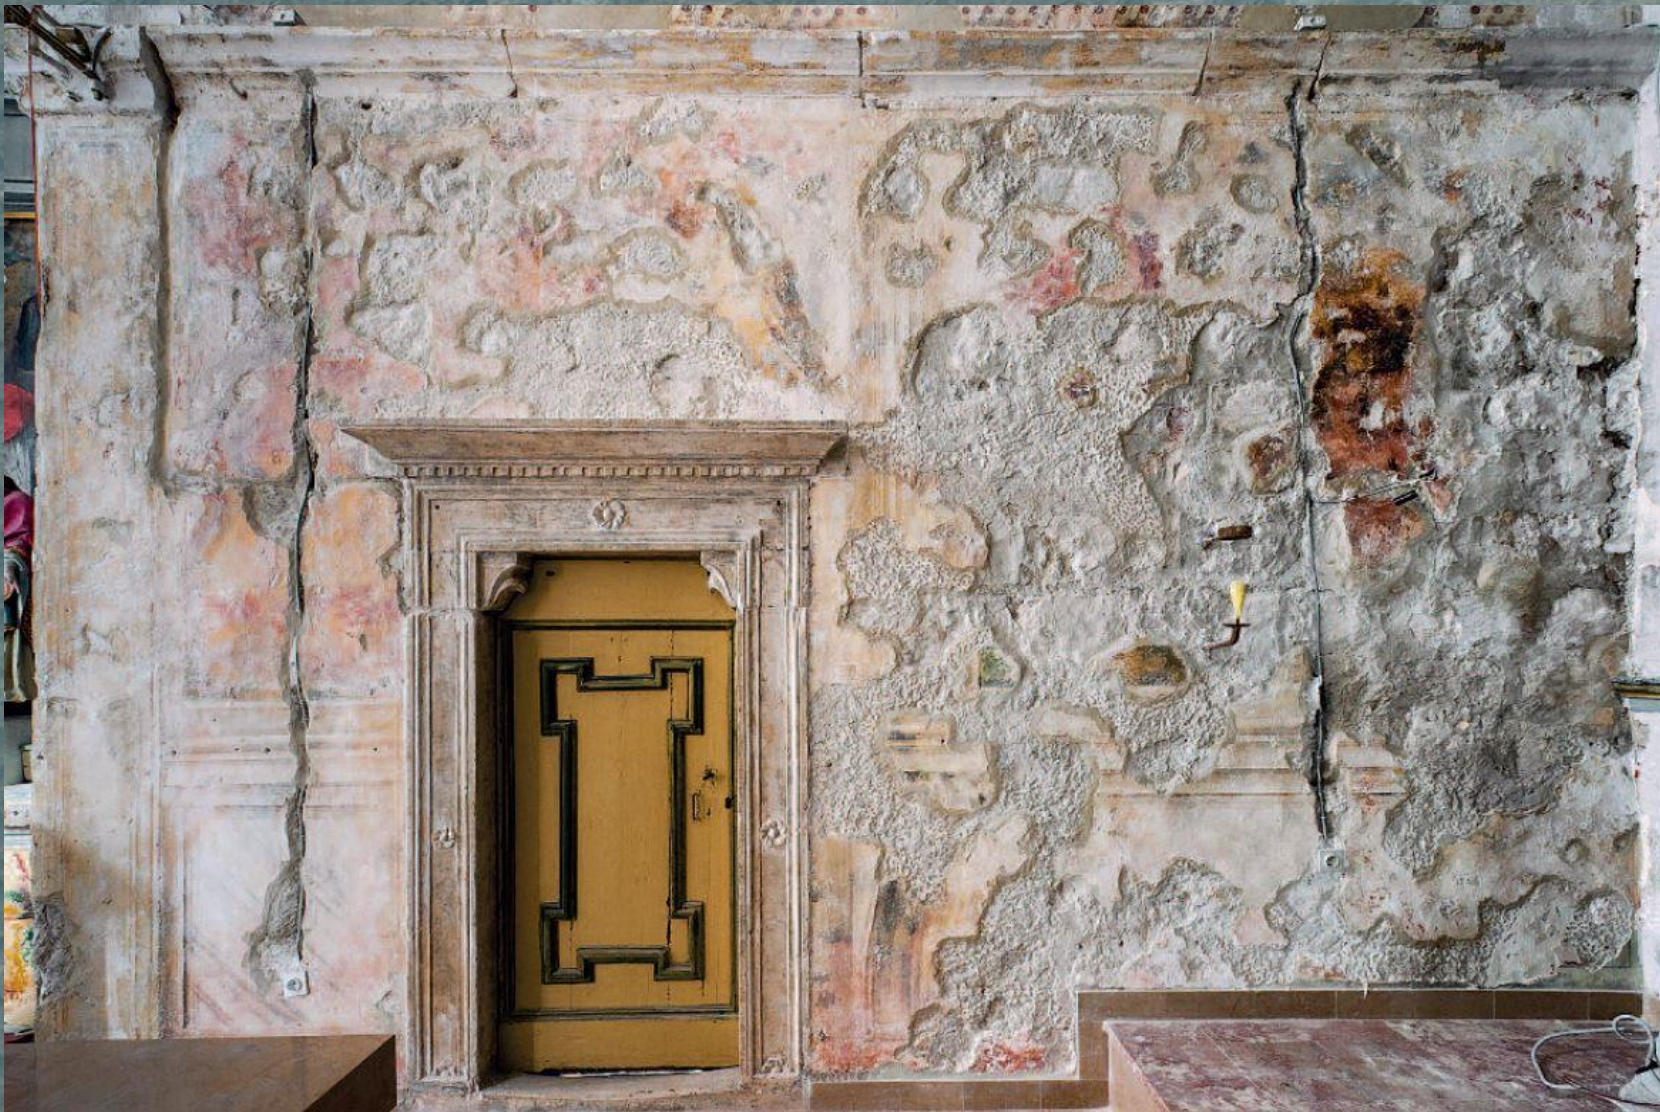
Mortar additions along the borders of historic plaster, Church of St. Vitus, Modestus and Crescentia, Trsteno (Croatia), 16/17th century; Photo: 2010, HRZ (Katarina Gavrilica); Weyer, E. (ed.), (2015), EwaGlos:European Illustrated Glossary Of Conservation Terms For Wall Paintings And Architectural Surfaces, Petersberg: Hornemann Institute; 322.

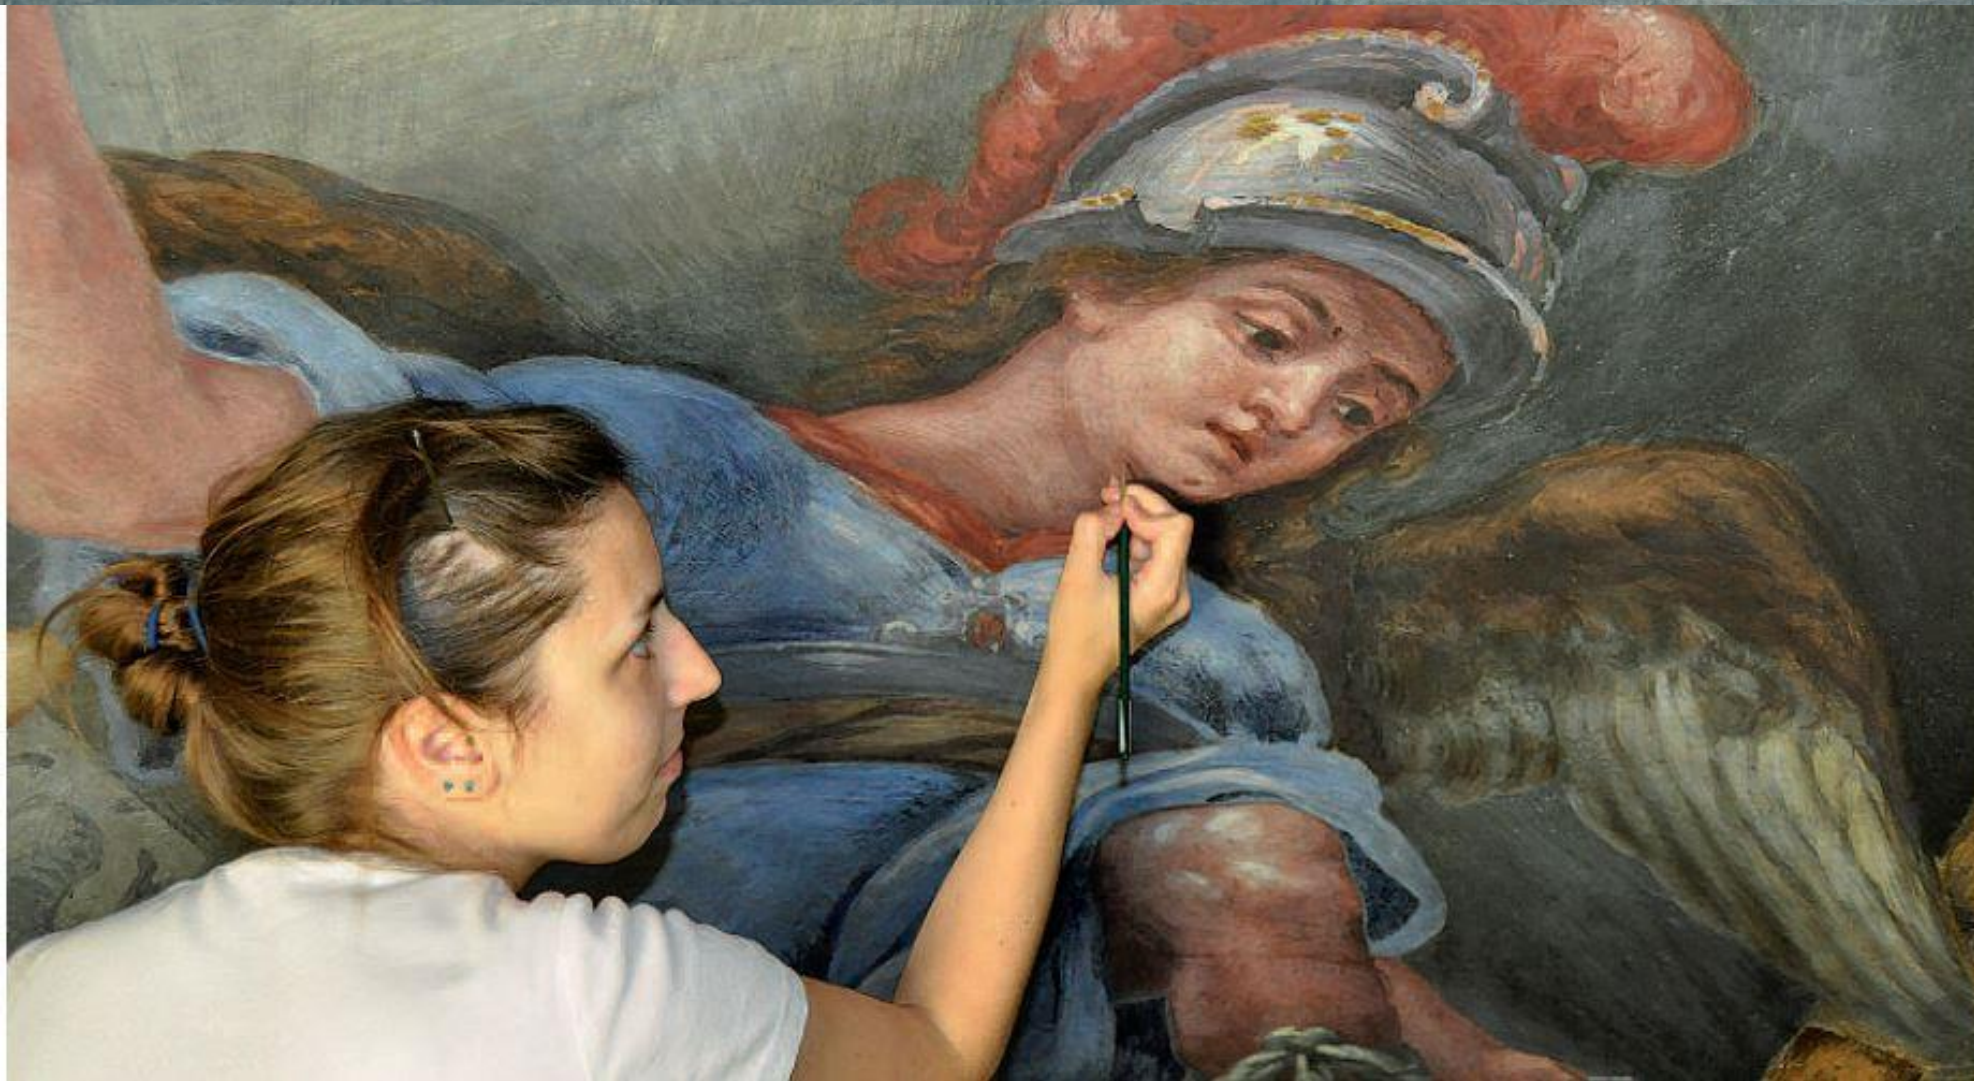
Carrying out reintegration, wall painting by Dionis Vidal, Church of San Nicolás Obispo y San Pedro Mártir, Valencia (Spain), 1694-1700; Photo: 2014, UPV; Weyer, E. (ed.), (2015), EwaGlos:European Illustrated Glossary Of Conservation Terms For Wall Paintings And Architectural Surfaces, Petersberg: Hornemann Institute; 328.

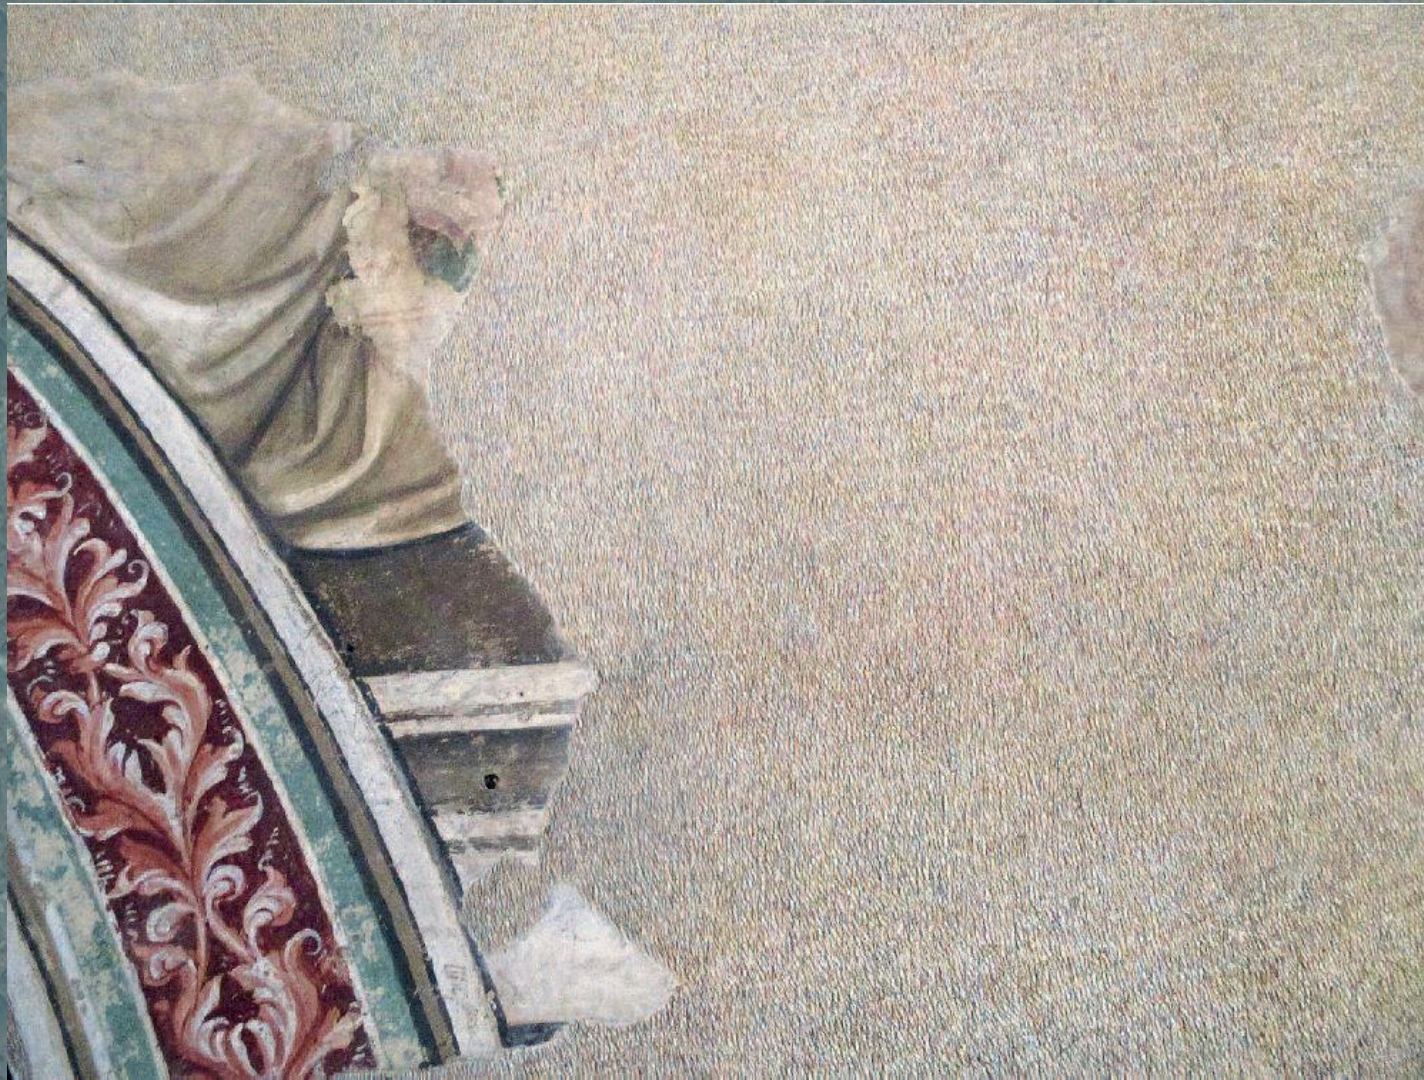
Reintegration of a large infill on a wall painting, Church of Santa Maria Novella, Florence (Italy), ca. 2nd half of 14th century; Photo: 2015, HAWK (Ursula Schädler-Saub); Weyer, E. (ed.), (2015), EwaGlos:European Illustrated Glossary Of Conservation Terms For Wall Paintings And Architectural Surfaces, Petersberg: Hornemann Institute; 340.

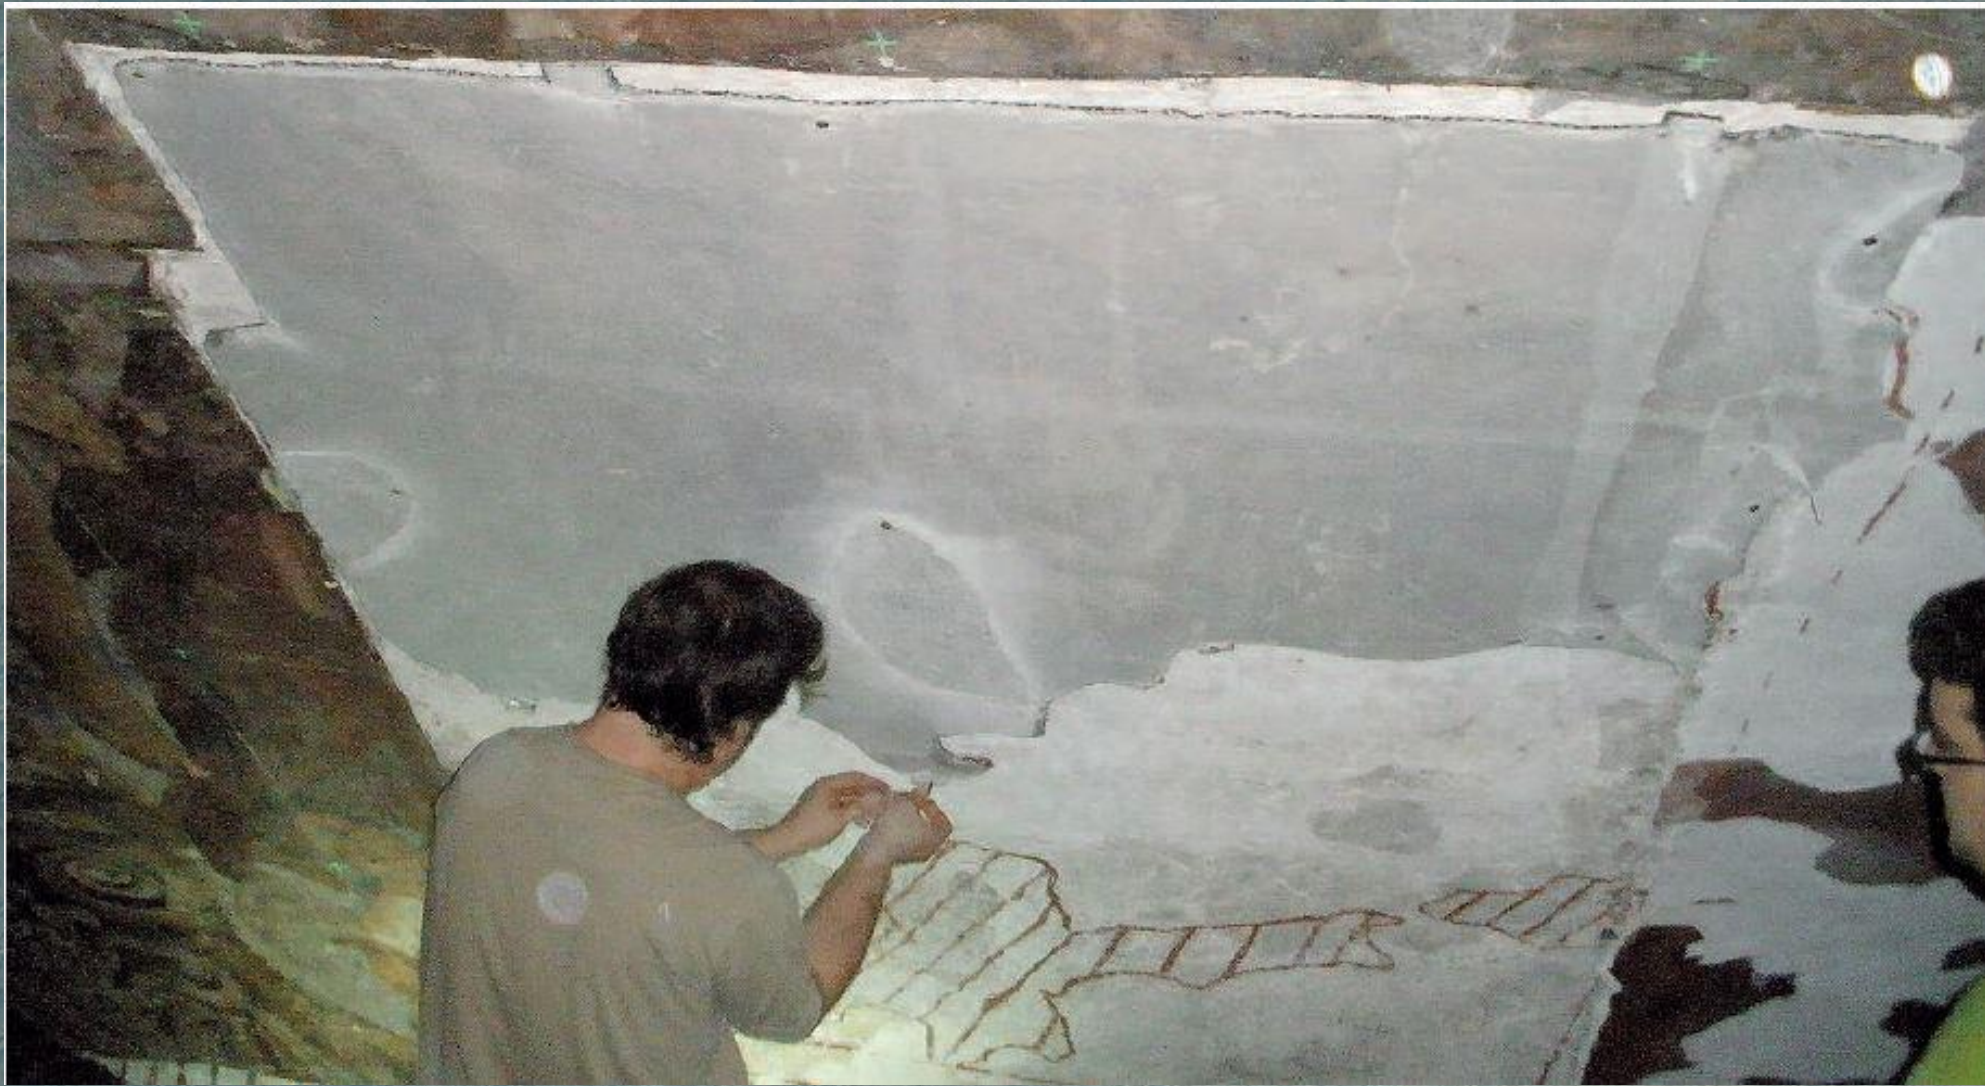
Transfer of a wall painting by Antonio A. Palomino/ Guilló, after its restoration, to its original place: Church of Santos Juanes, Valencia (Spain), 1698-1700; Photo: 2009, UPV (Pilar Soriano Sancho); Weyer, E. (ed.), (2015), EwaGlos:European Illustrated Glossary Of Conservation Terms For Wall Paintings And Architectural Surfaces, Petersberg: Hornemann Institute; 346.
