Bioremediation of Oil Contaminated Soil in Kuwait

Obayashi Corporation

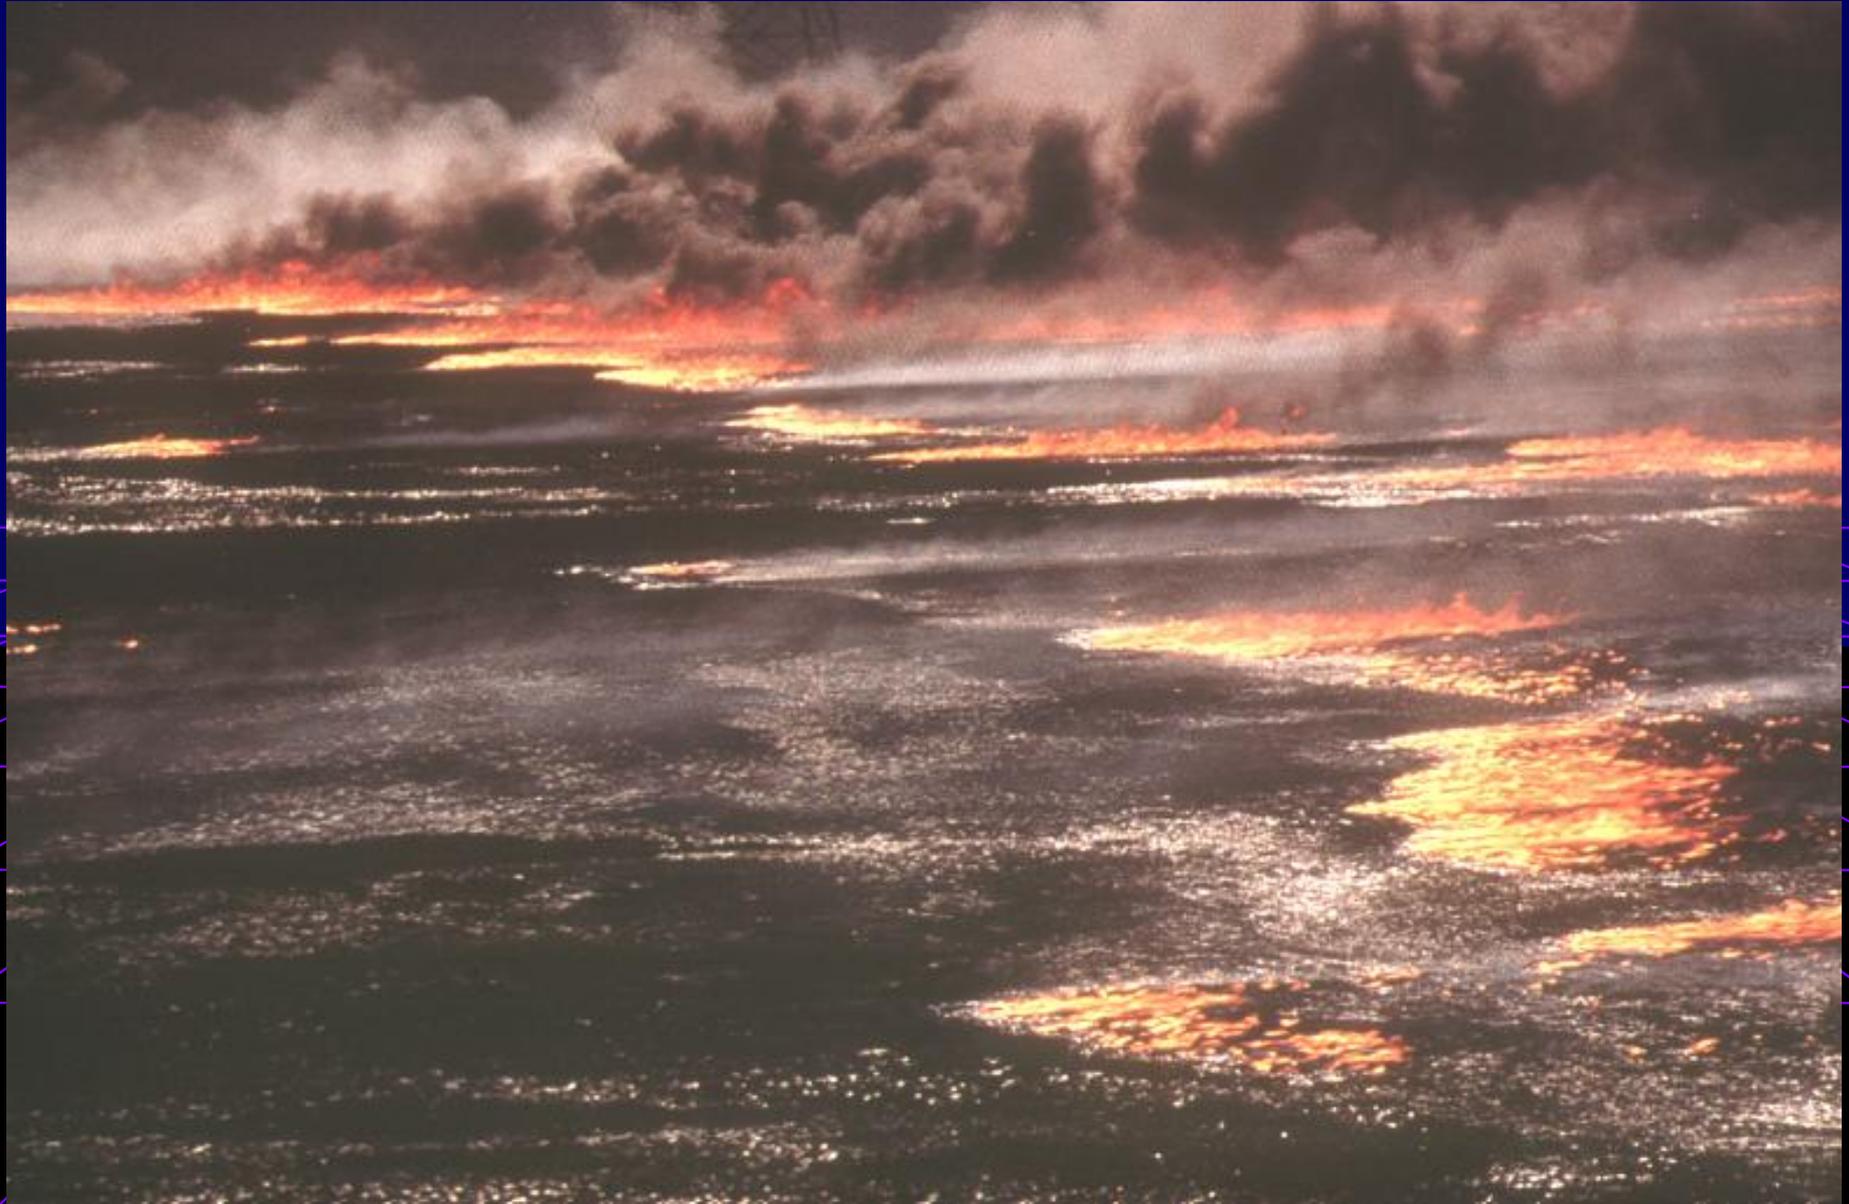
Oil Lake

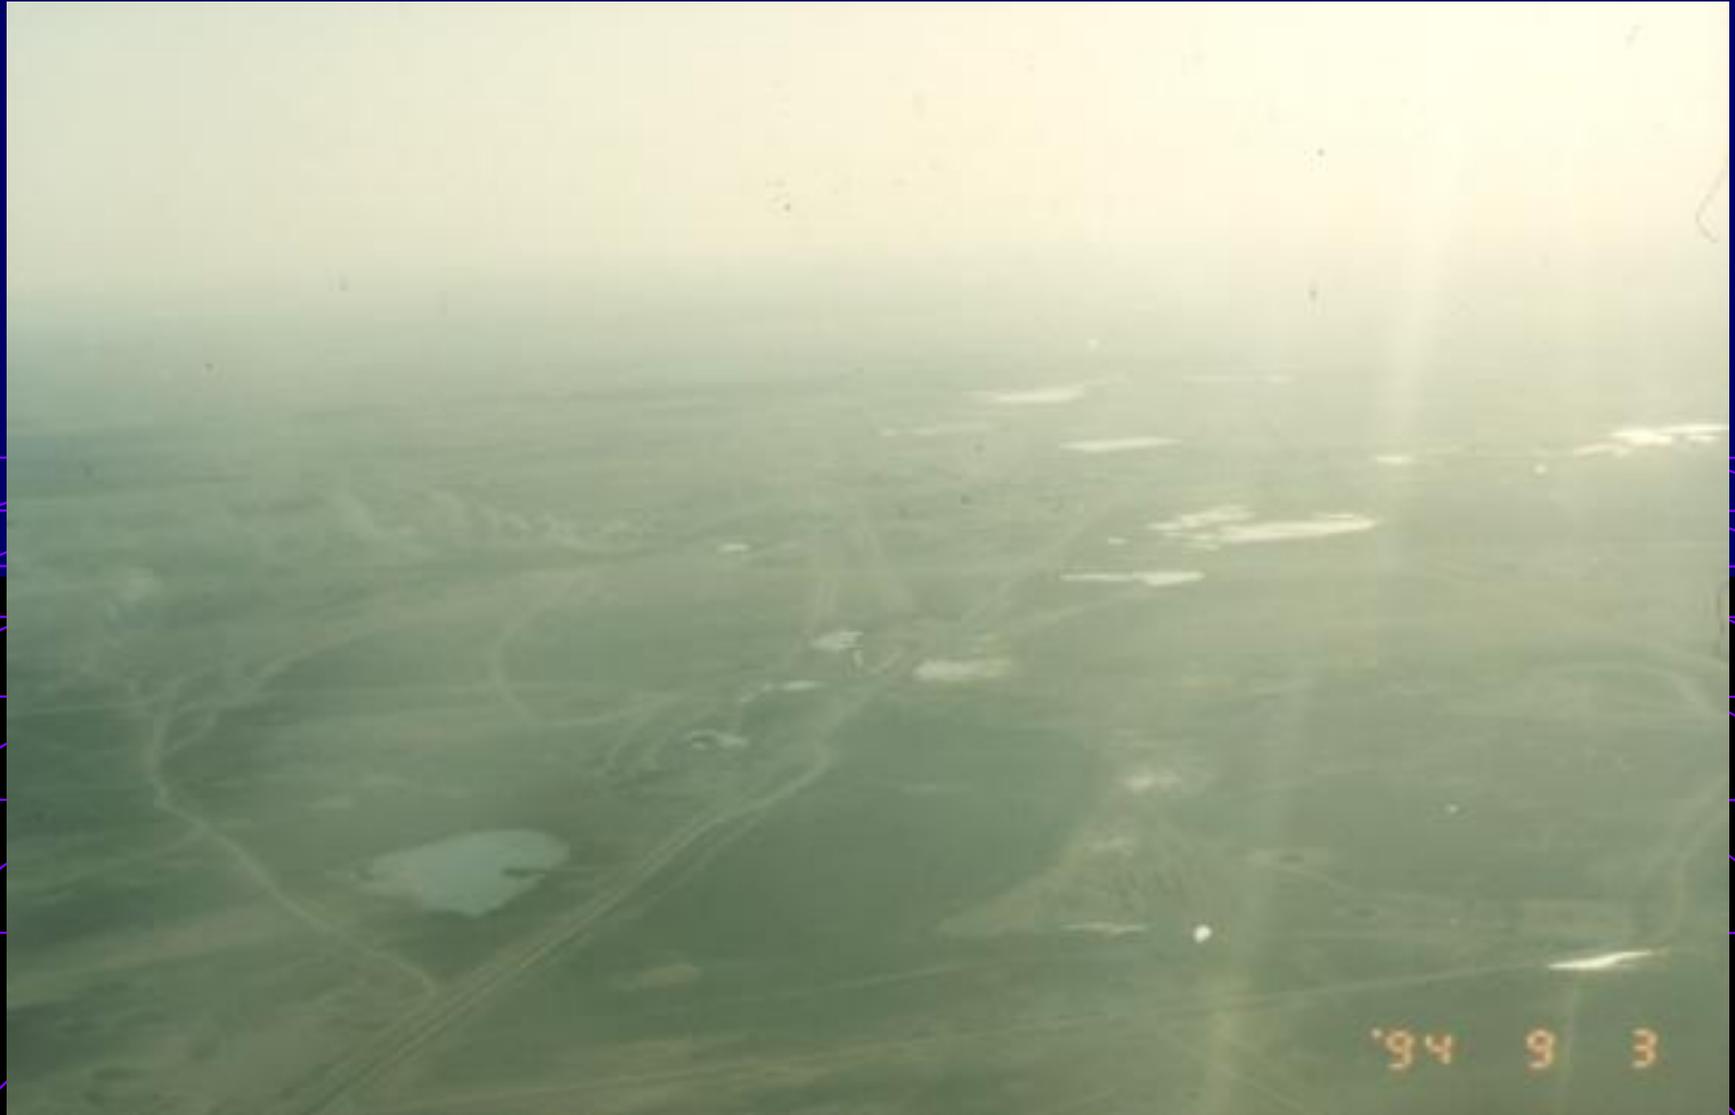
Oil Lake (an Aerial Photo)

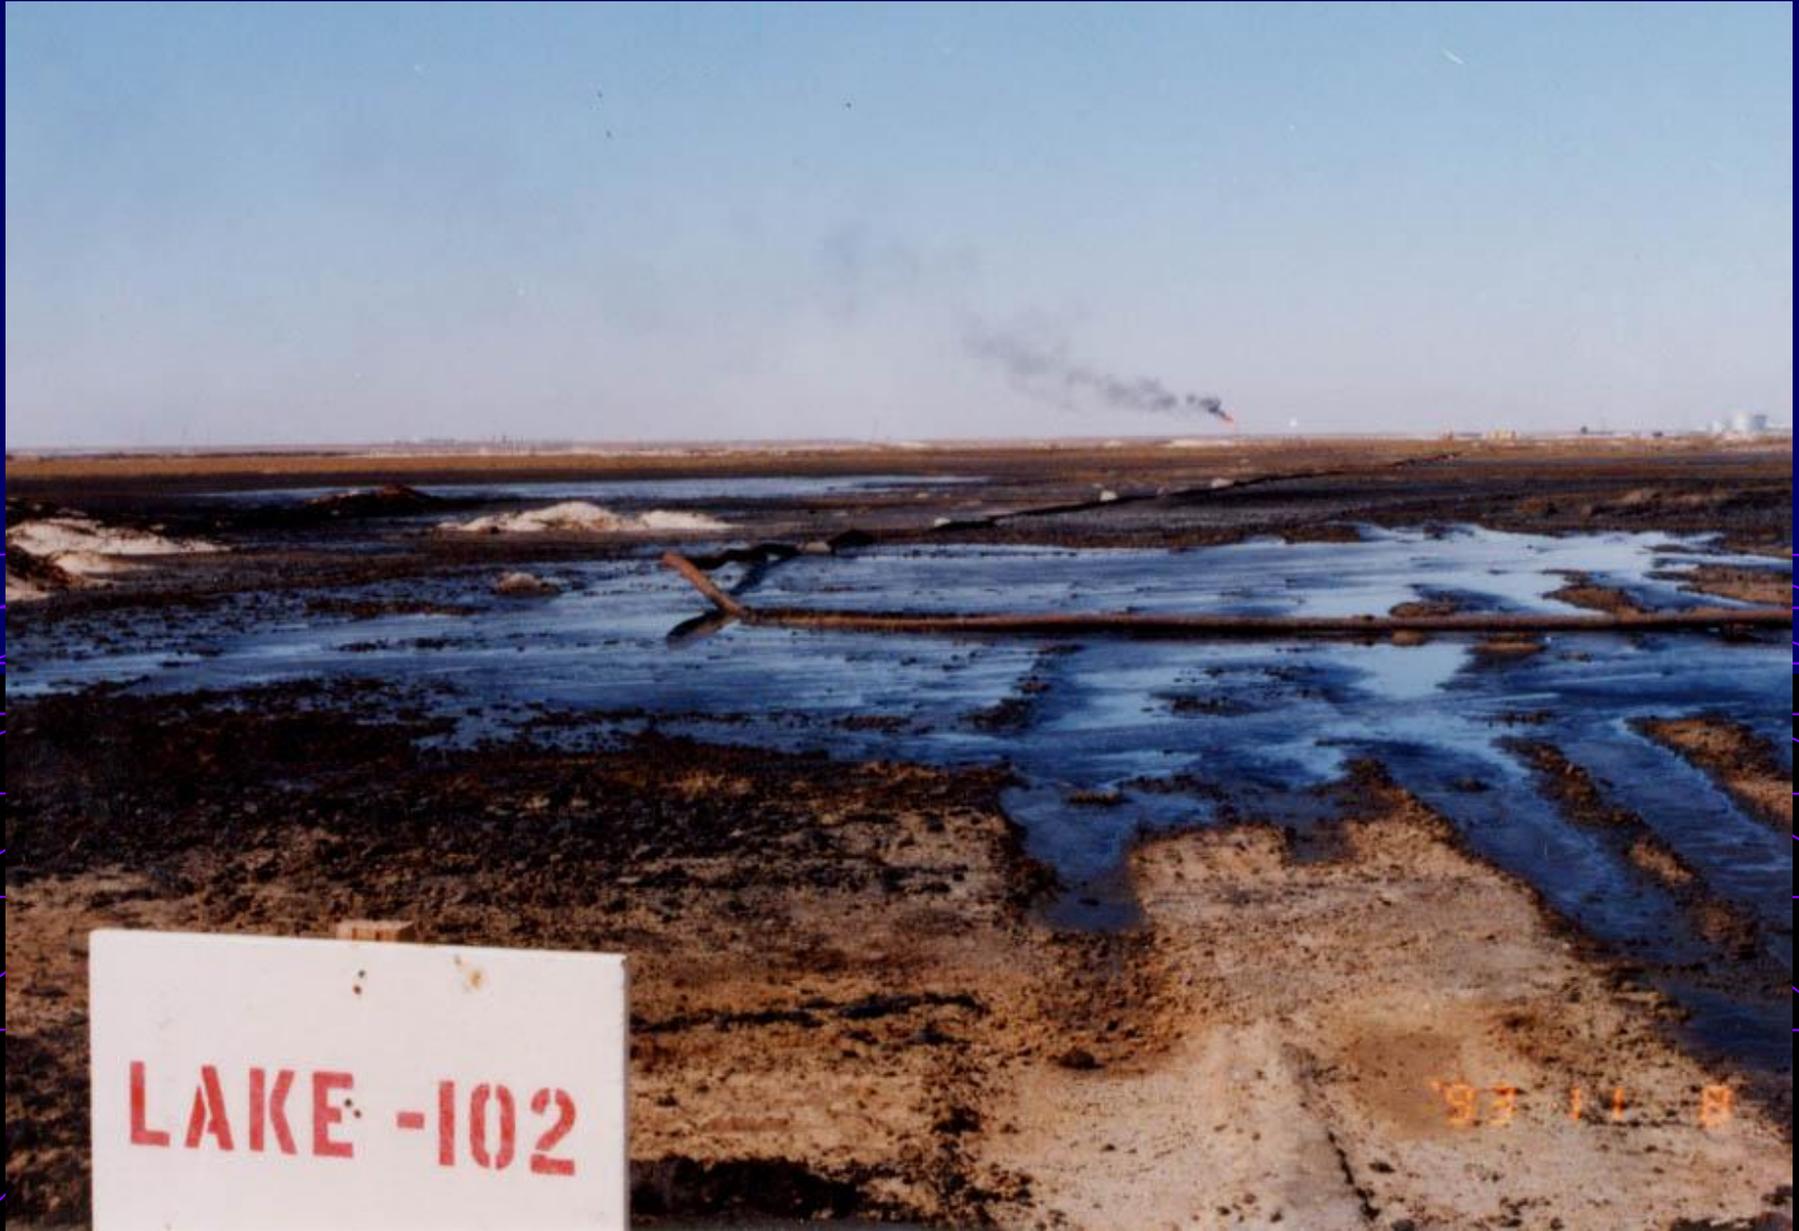
Oil Lake No.102

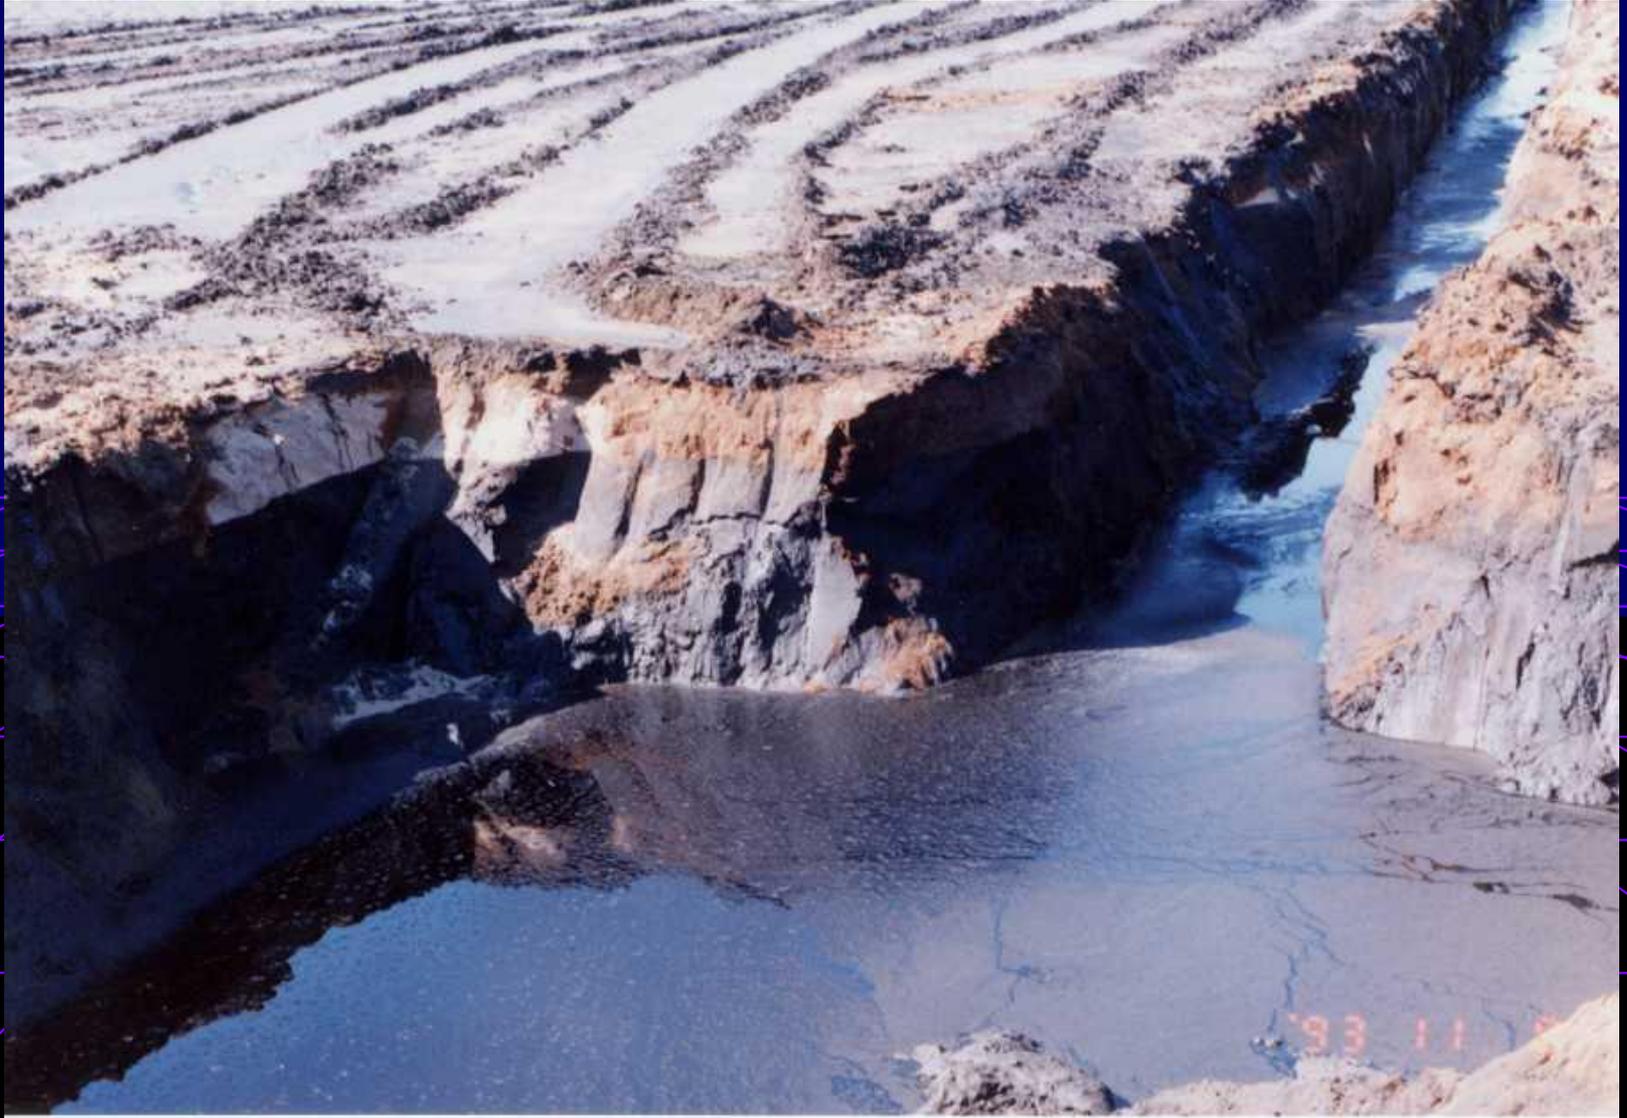
Removal of Oil Sludge

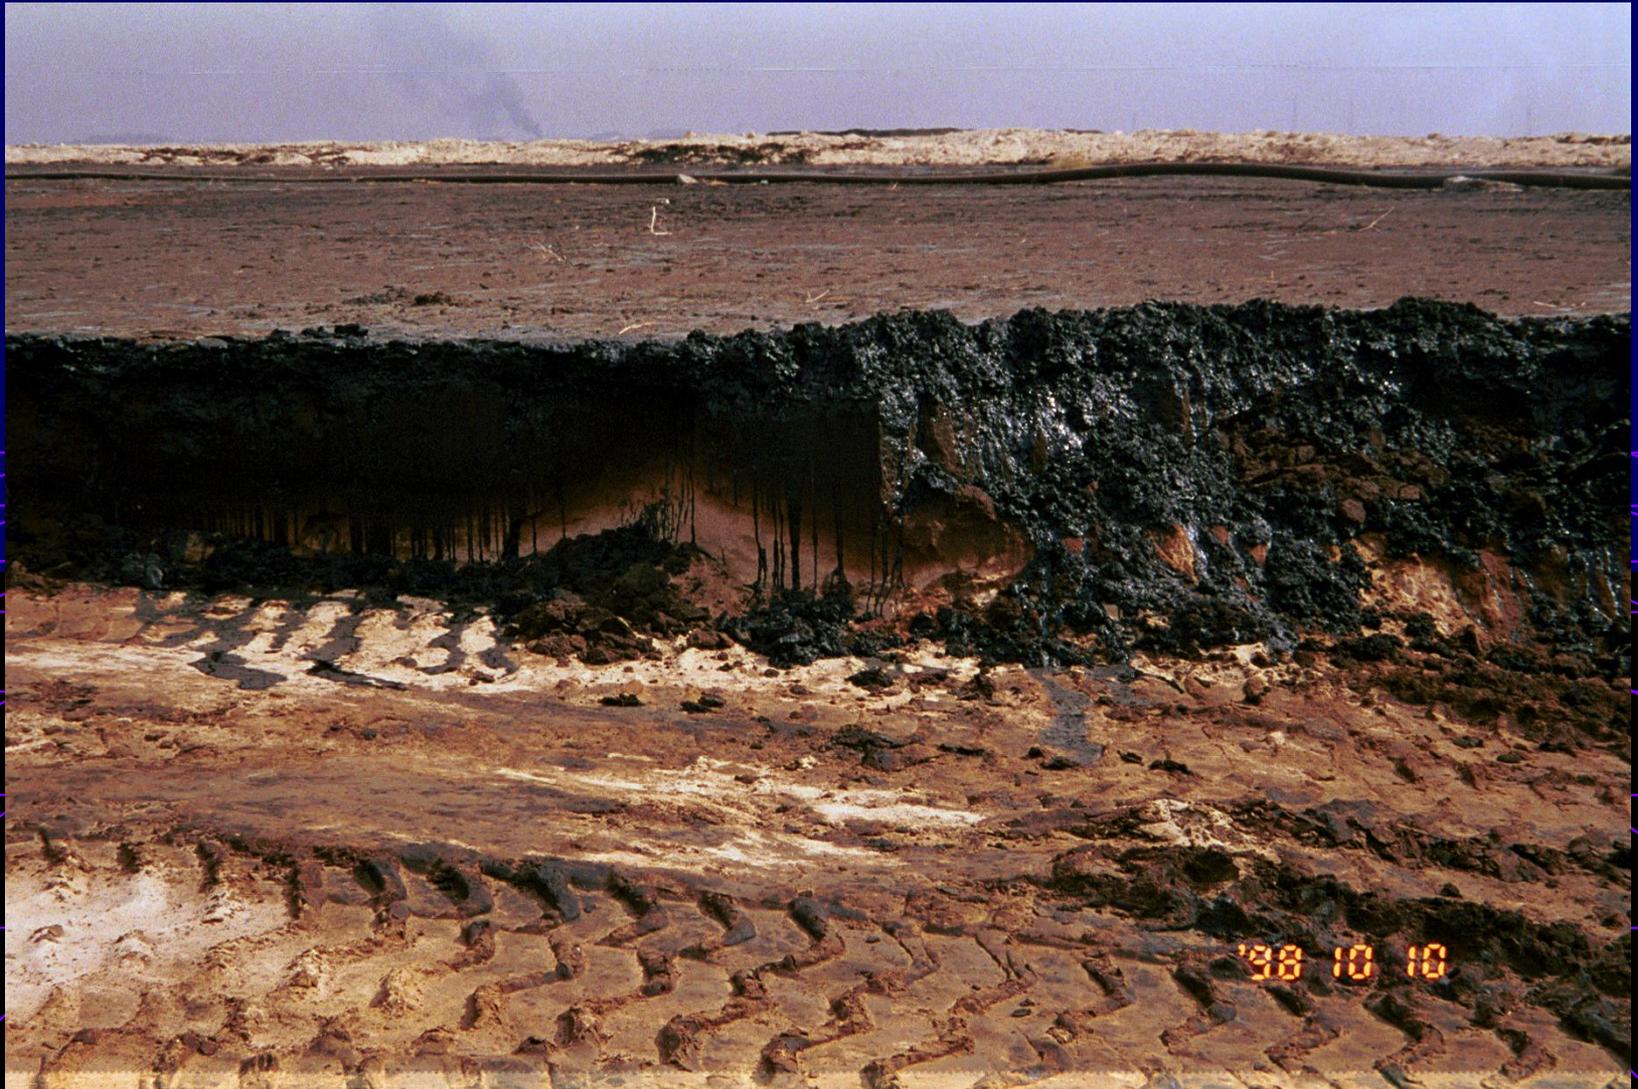
Example of Oil Contaminated Soil

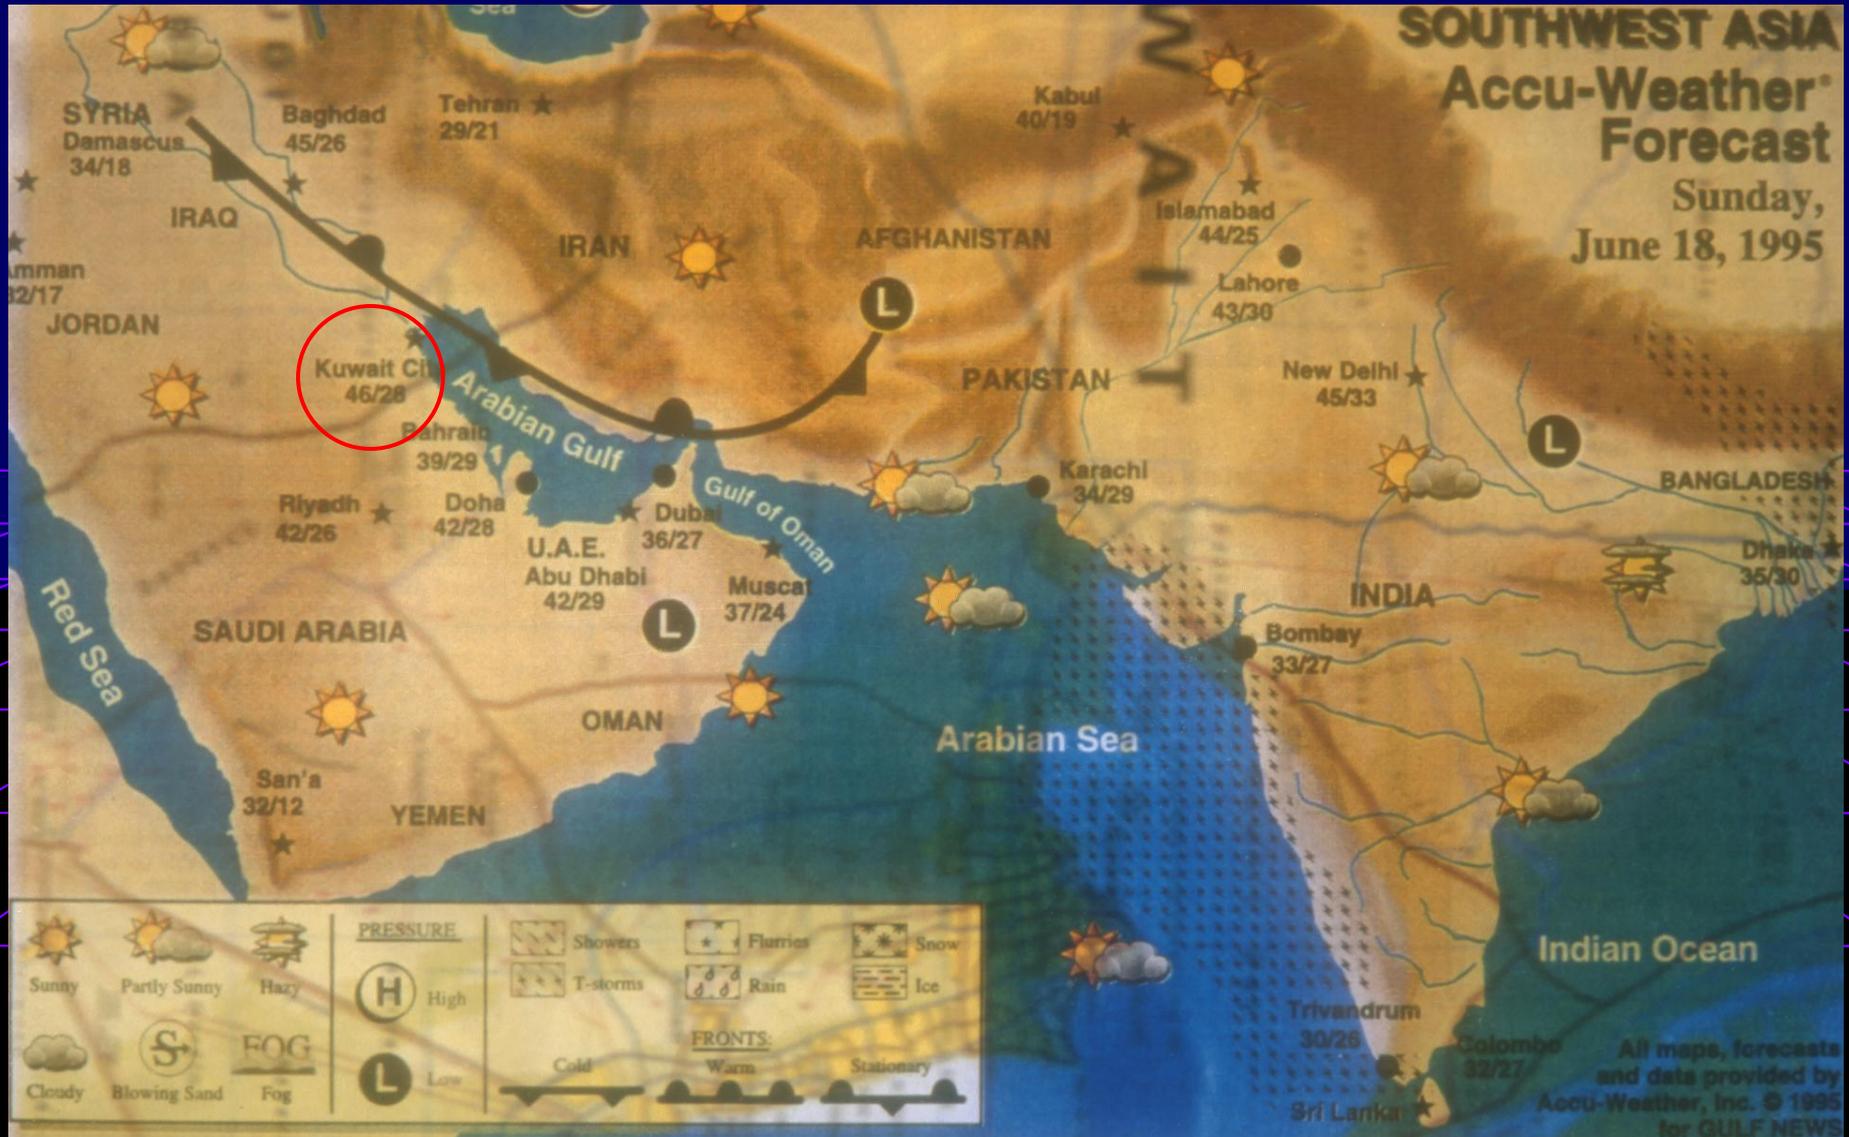
Weather of Kuwait

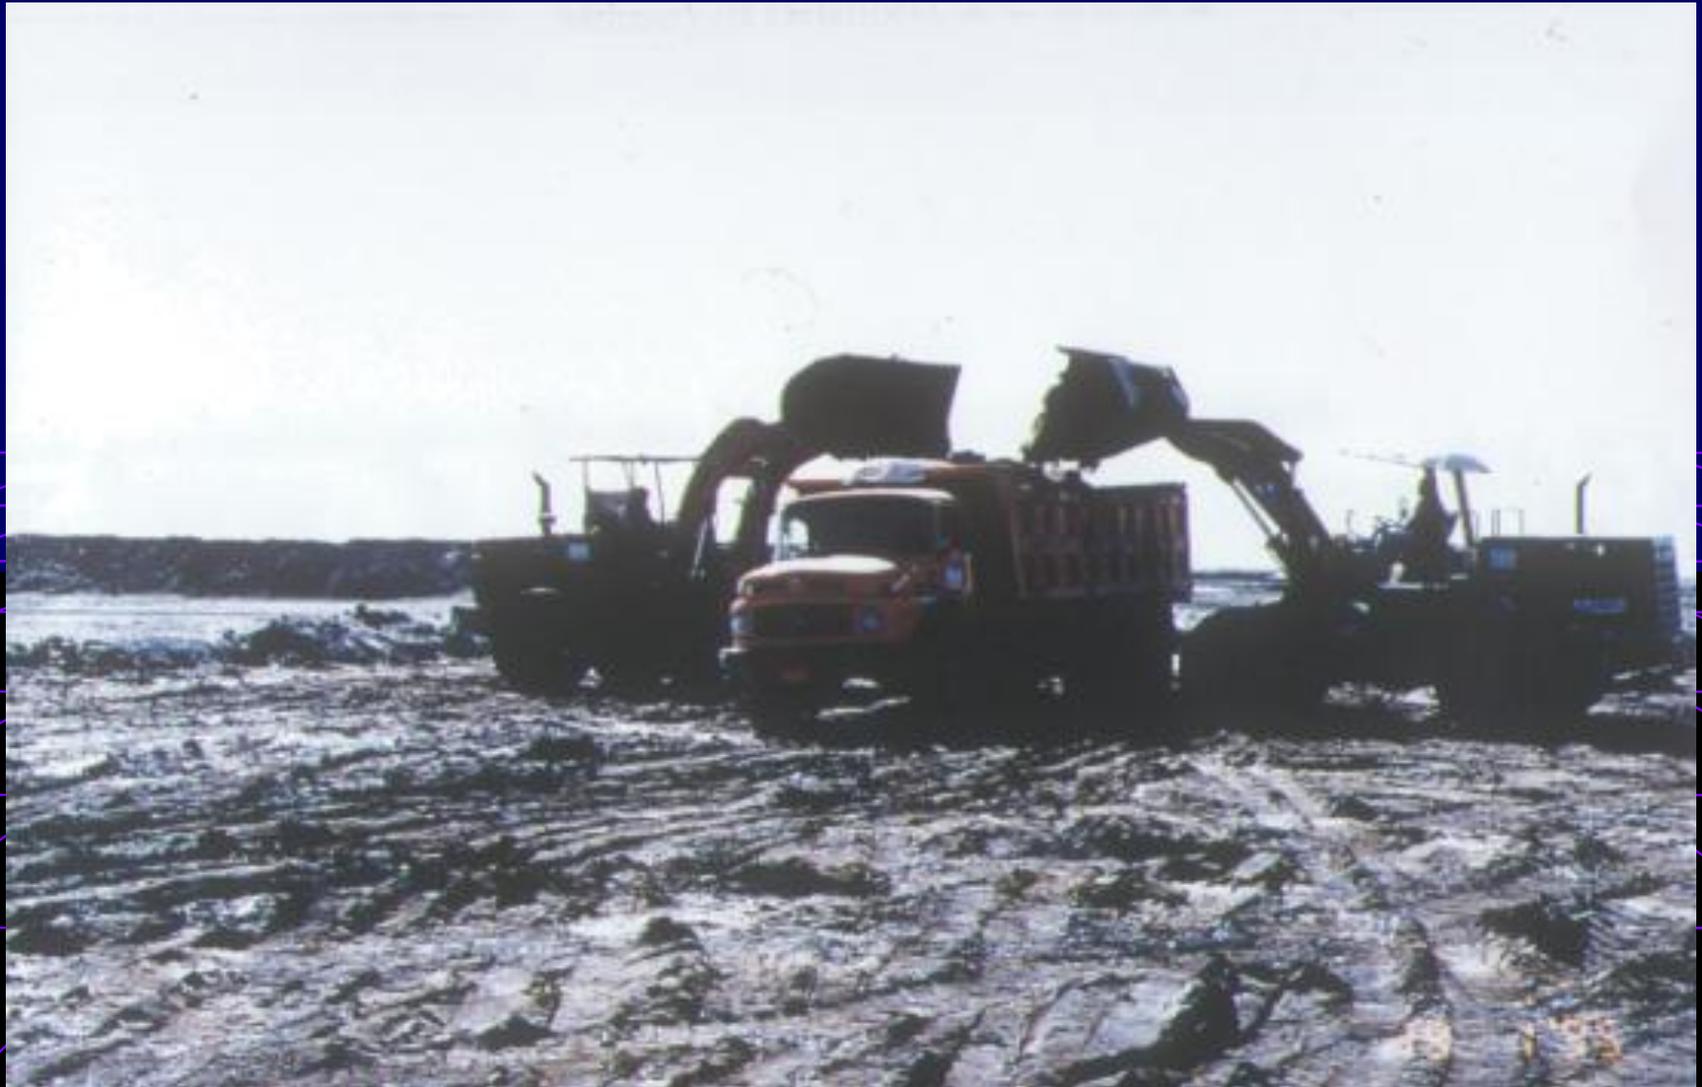
Excavation of the Oil Contaminated Soil

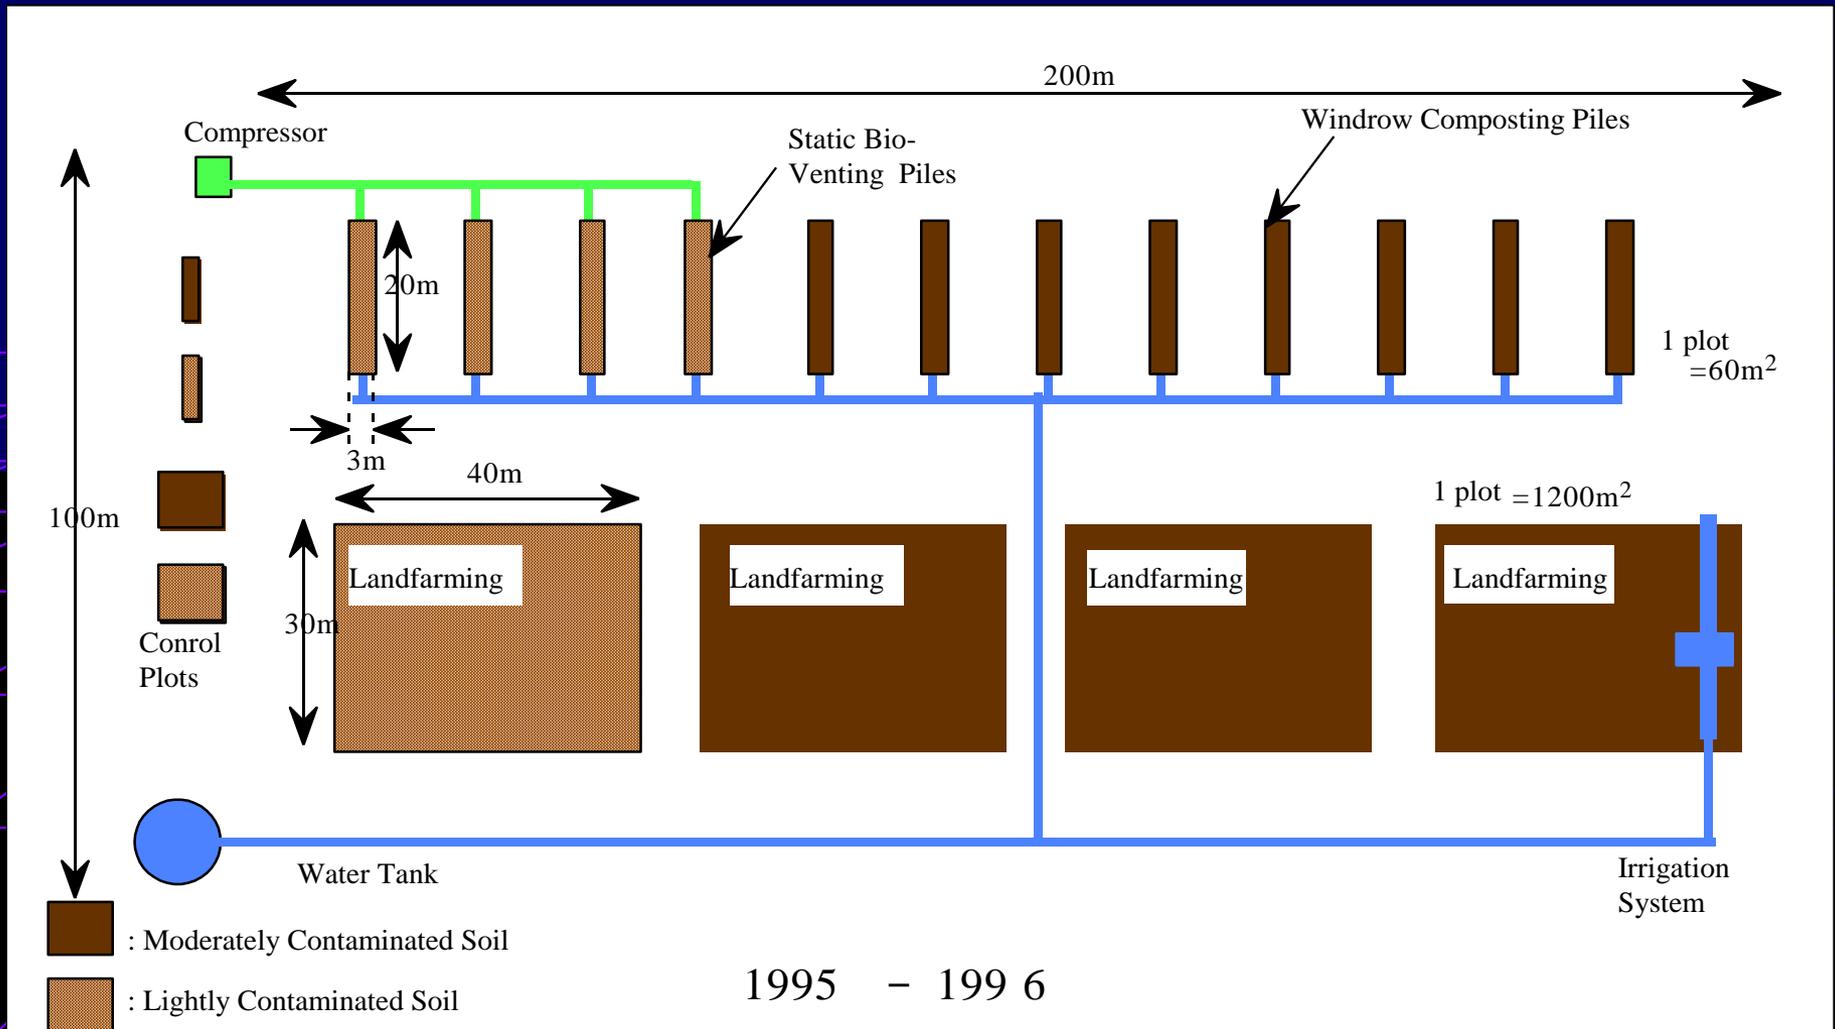
Landfarming Plots, Windrow Composting Piles, Static Bio-venting Piles and Static Bio-venting Piles

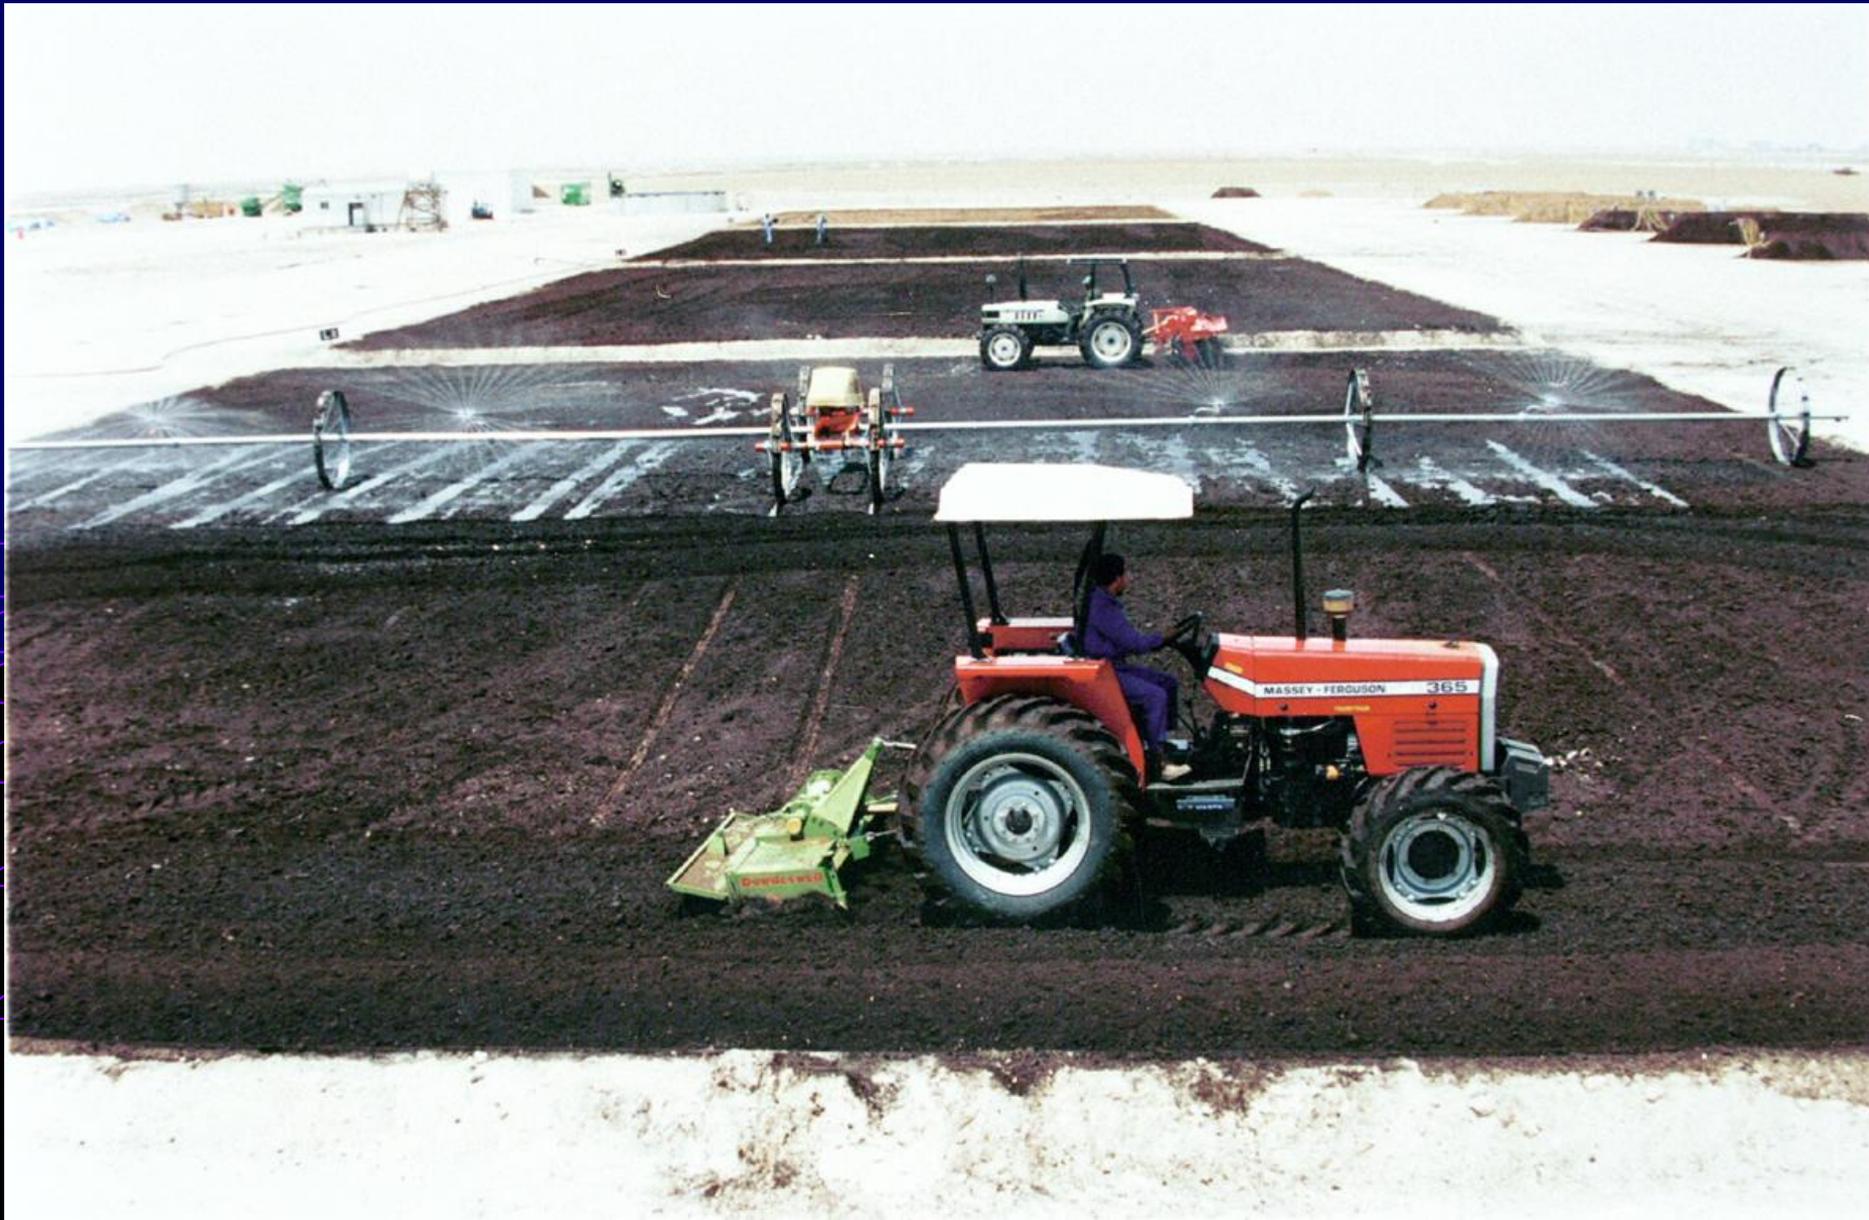
Maintenance of Landfarming

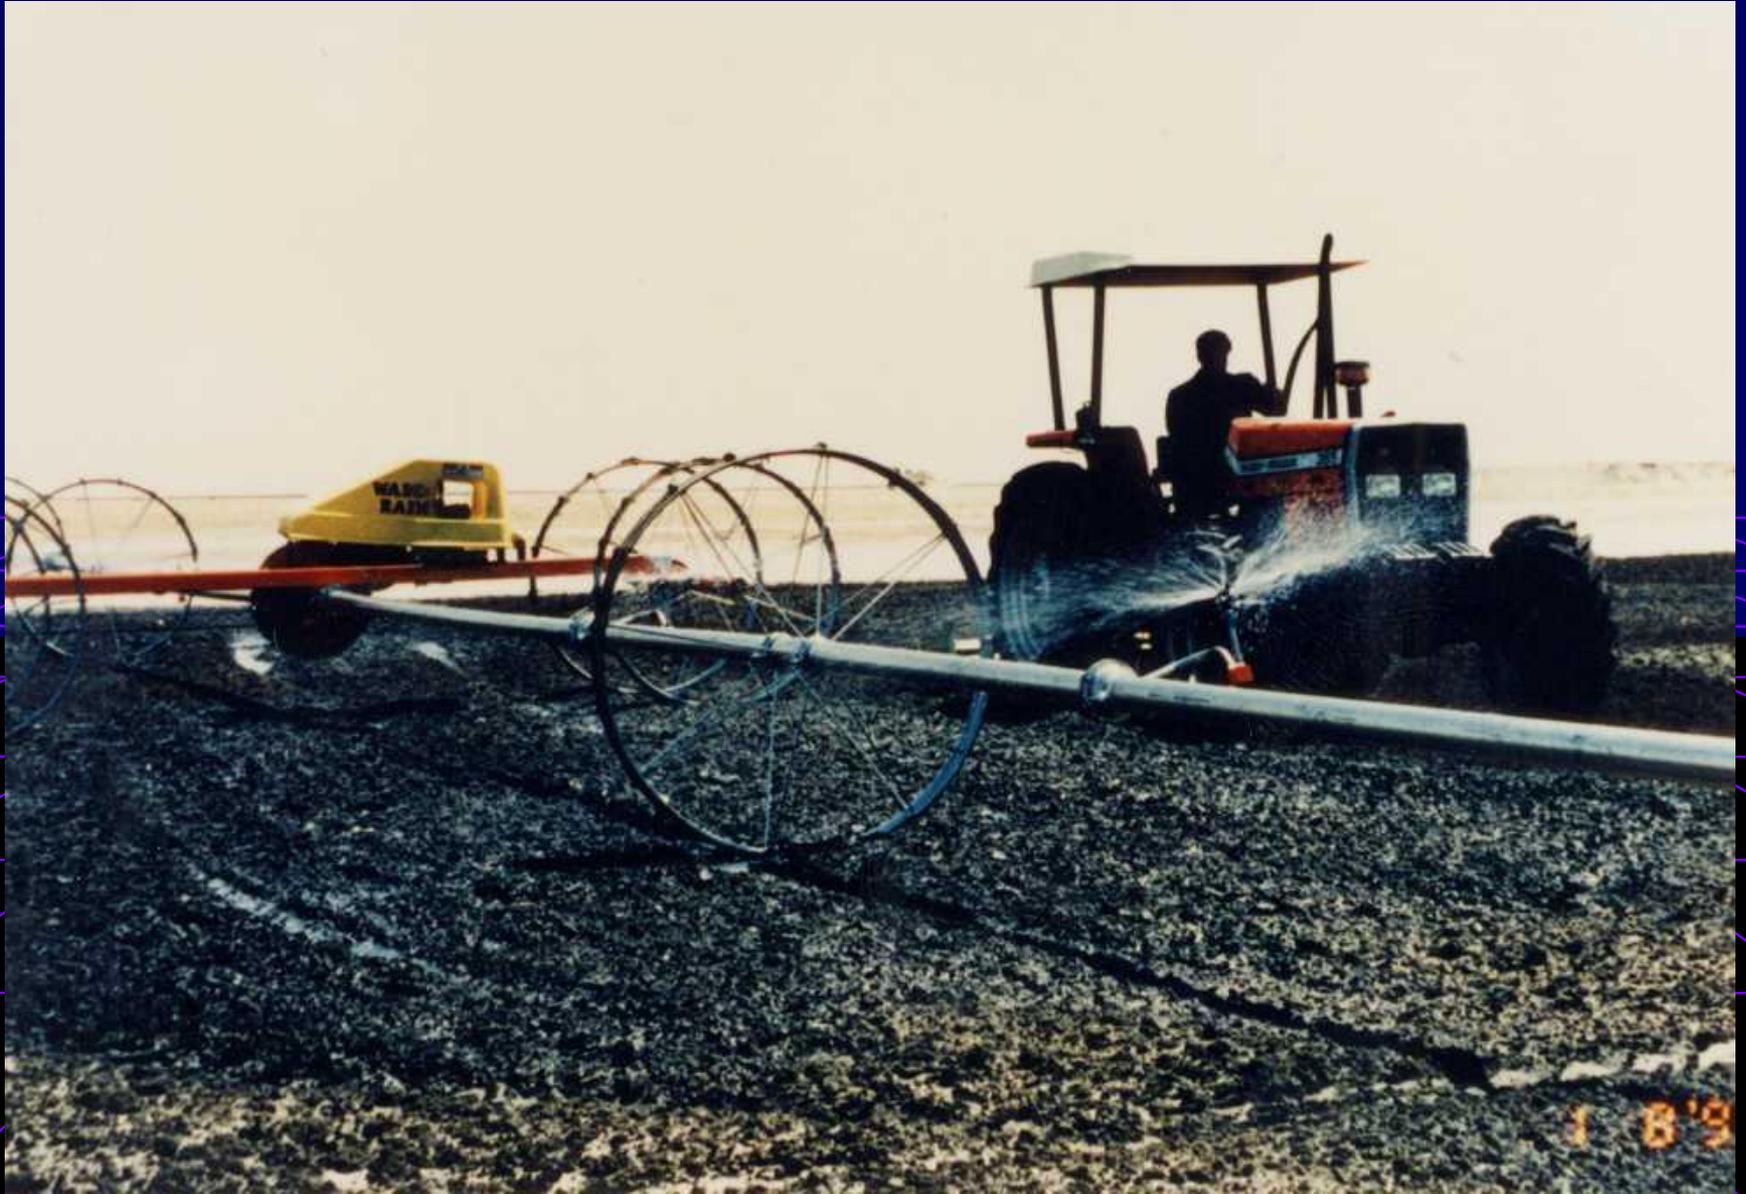
Maintenance of Landfarming

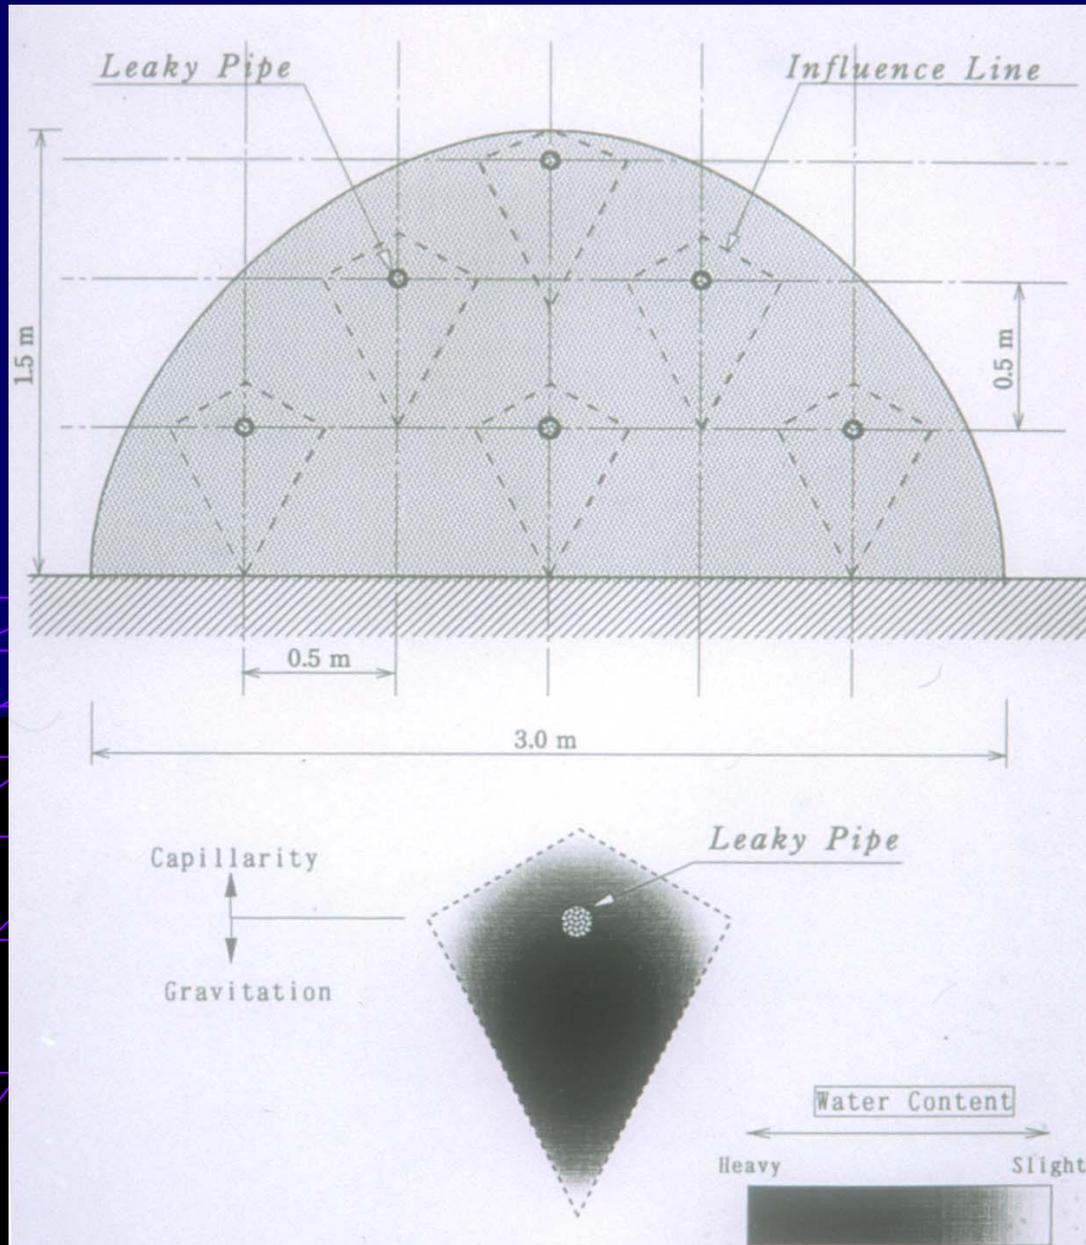
Cross Section in the Window Soil Pile
