Bioremediation of Oil Contaminated Soil in Kuwait

Obayashi Corporation

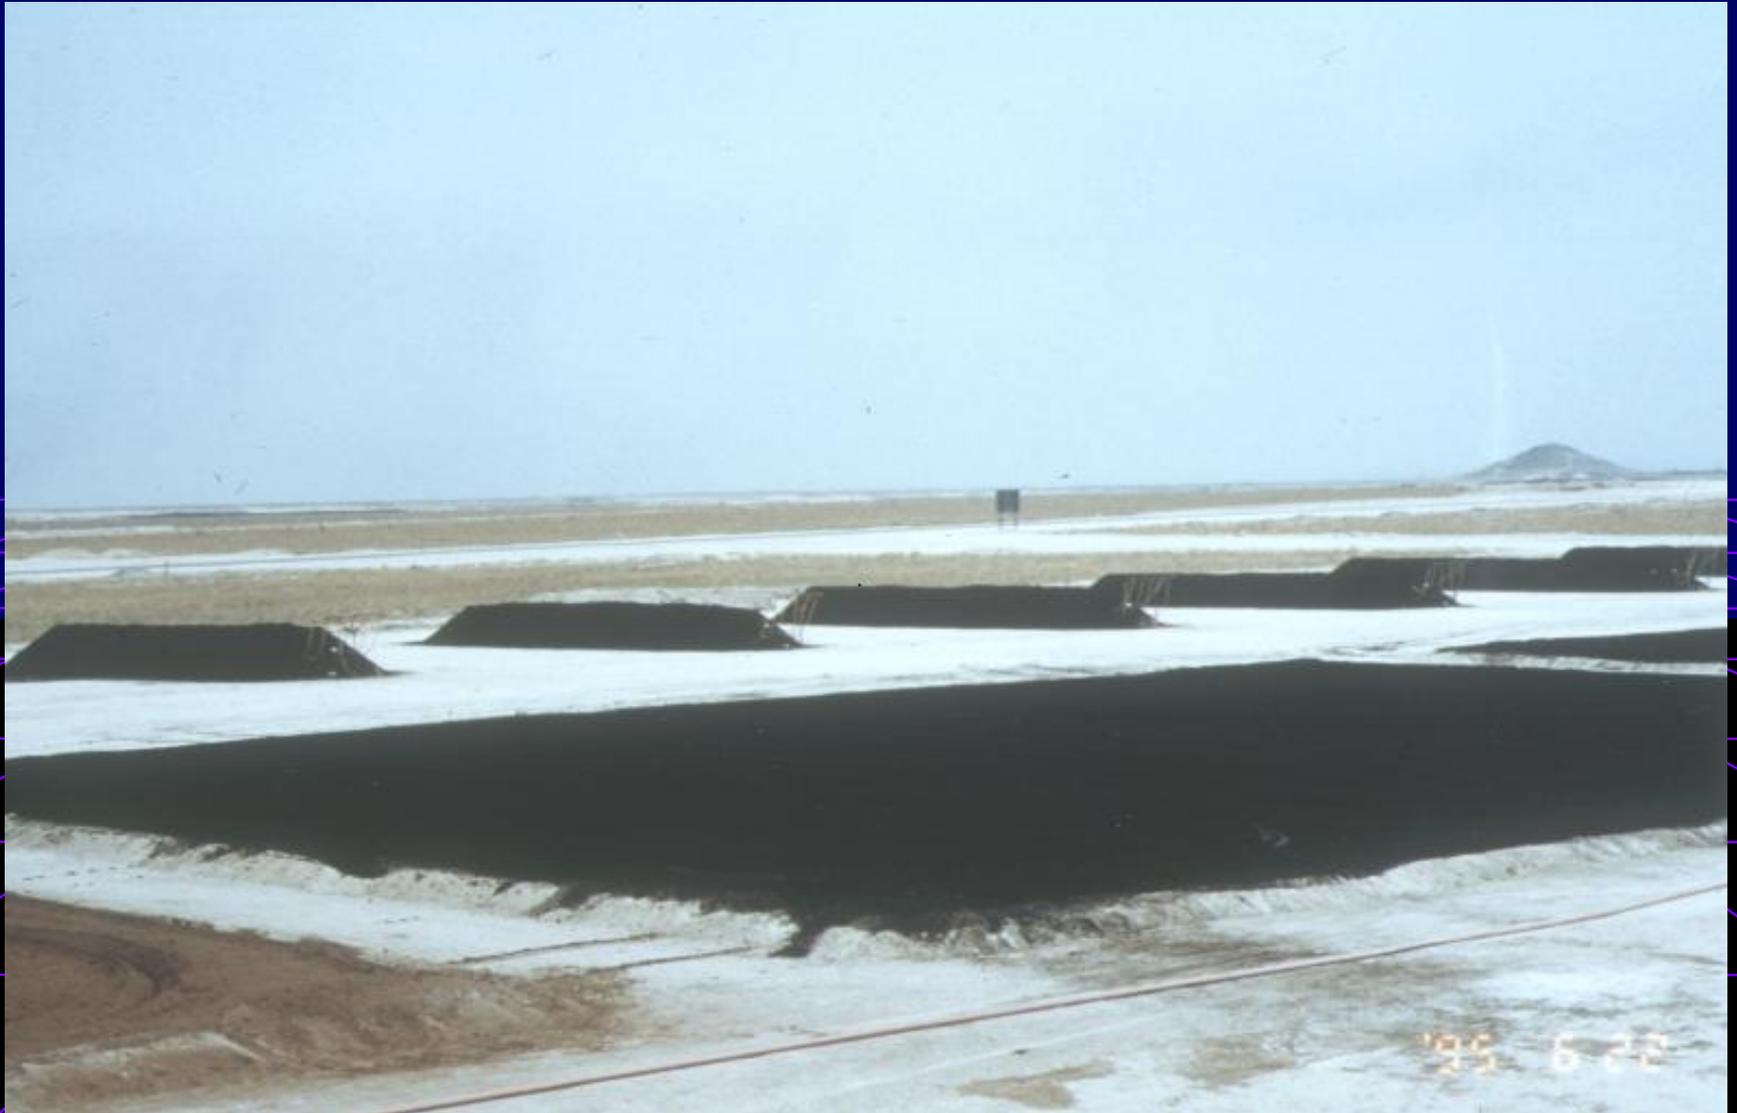
Soil Piles and Landfarming Plots

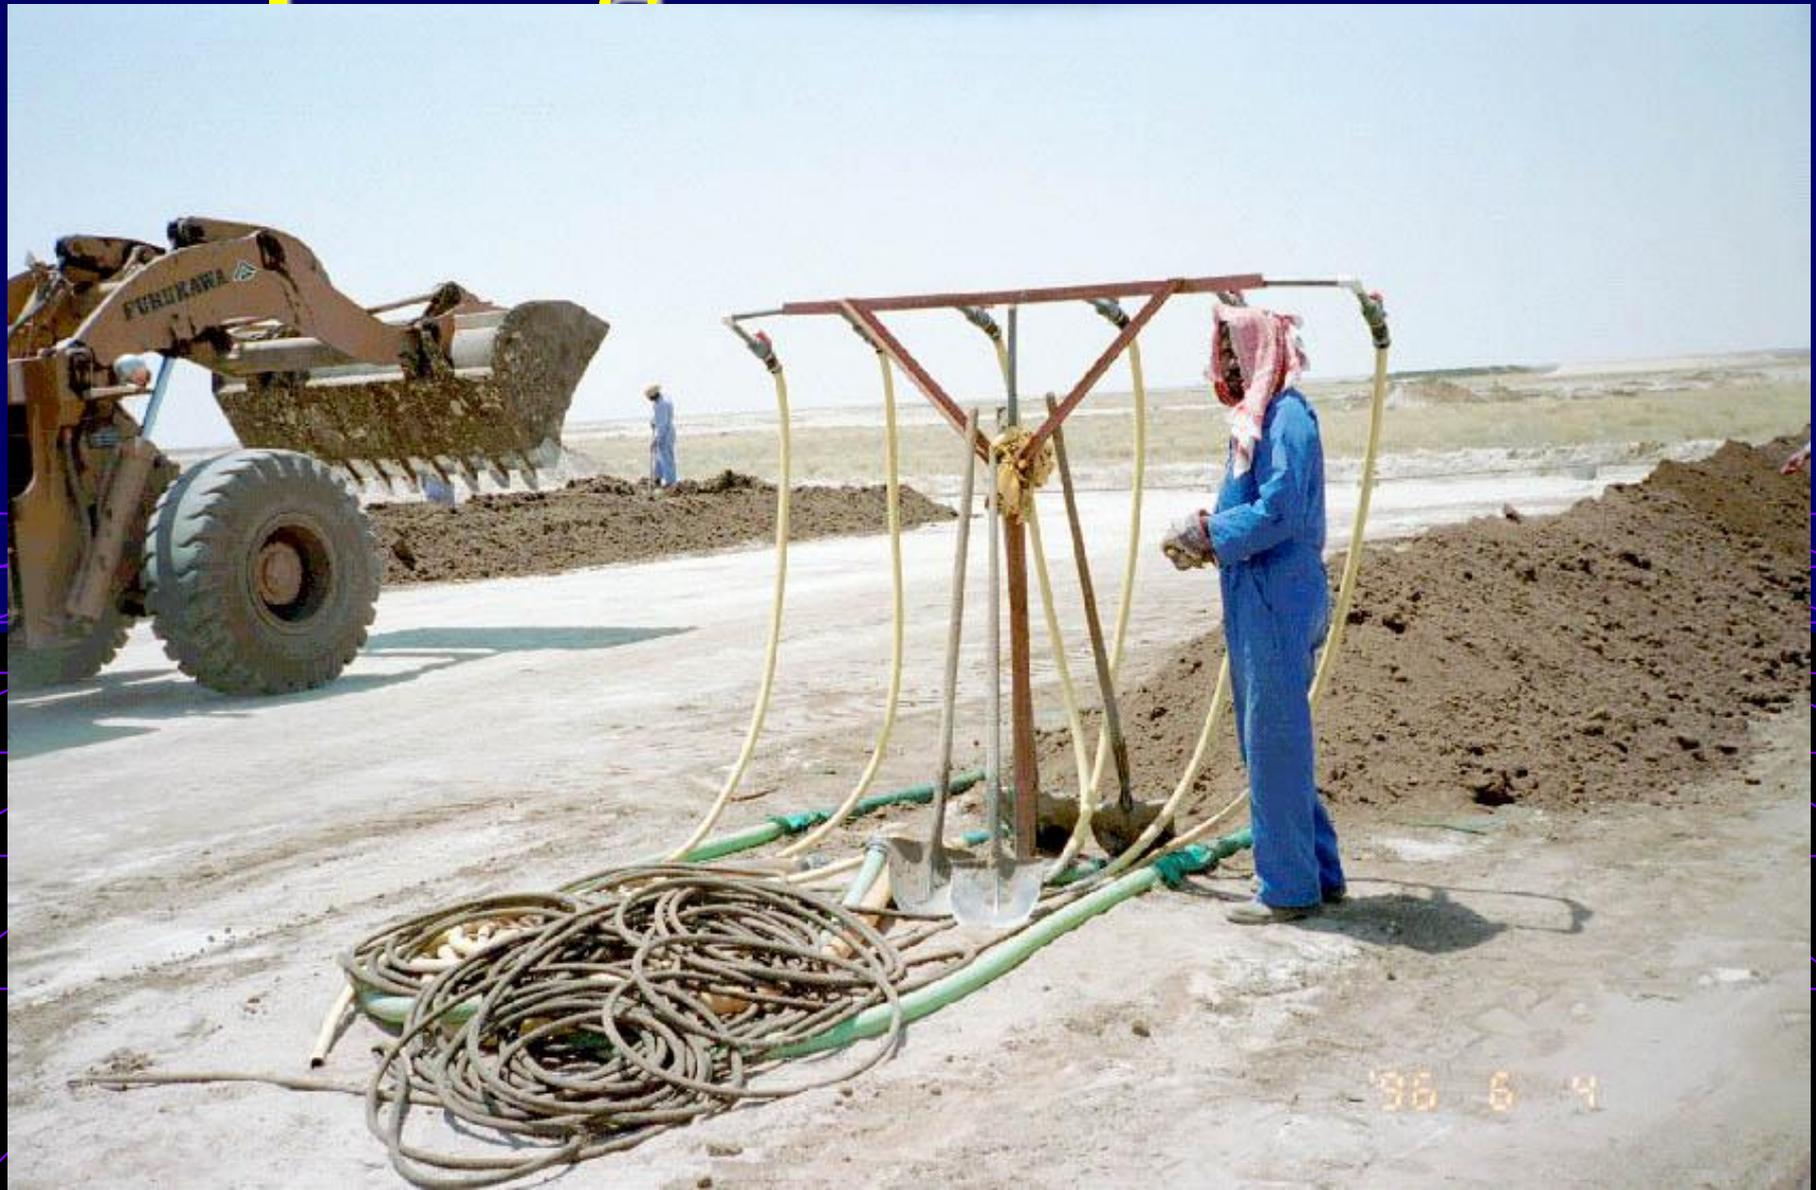
Maintenance of Windrow Composting Piles

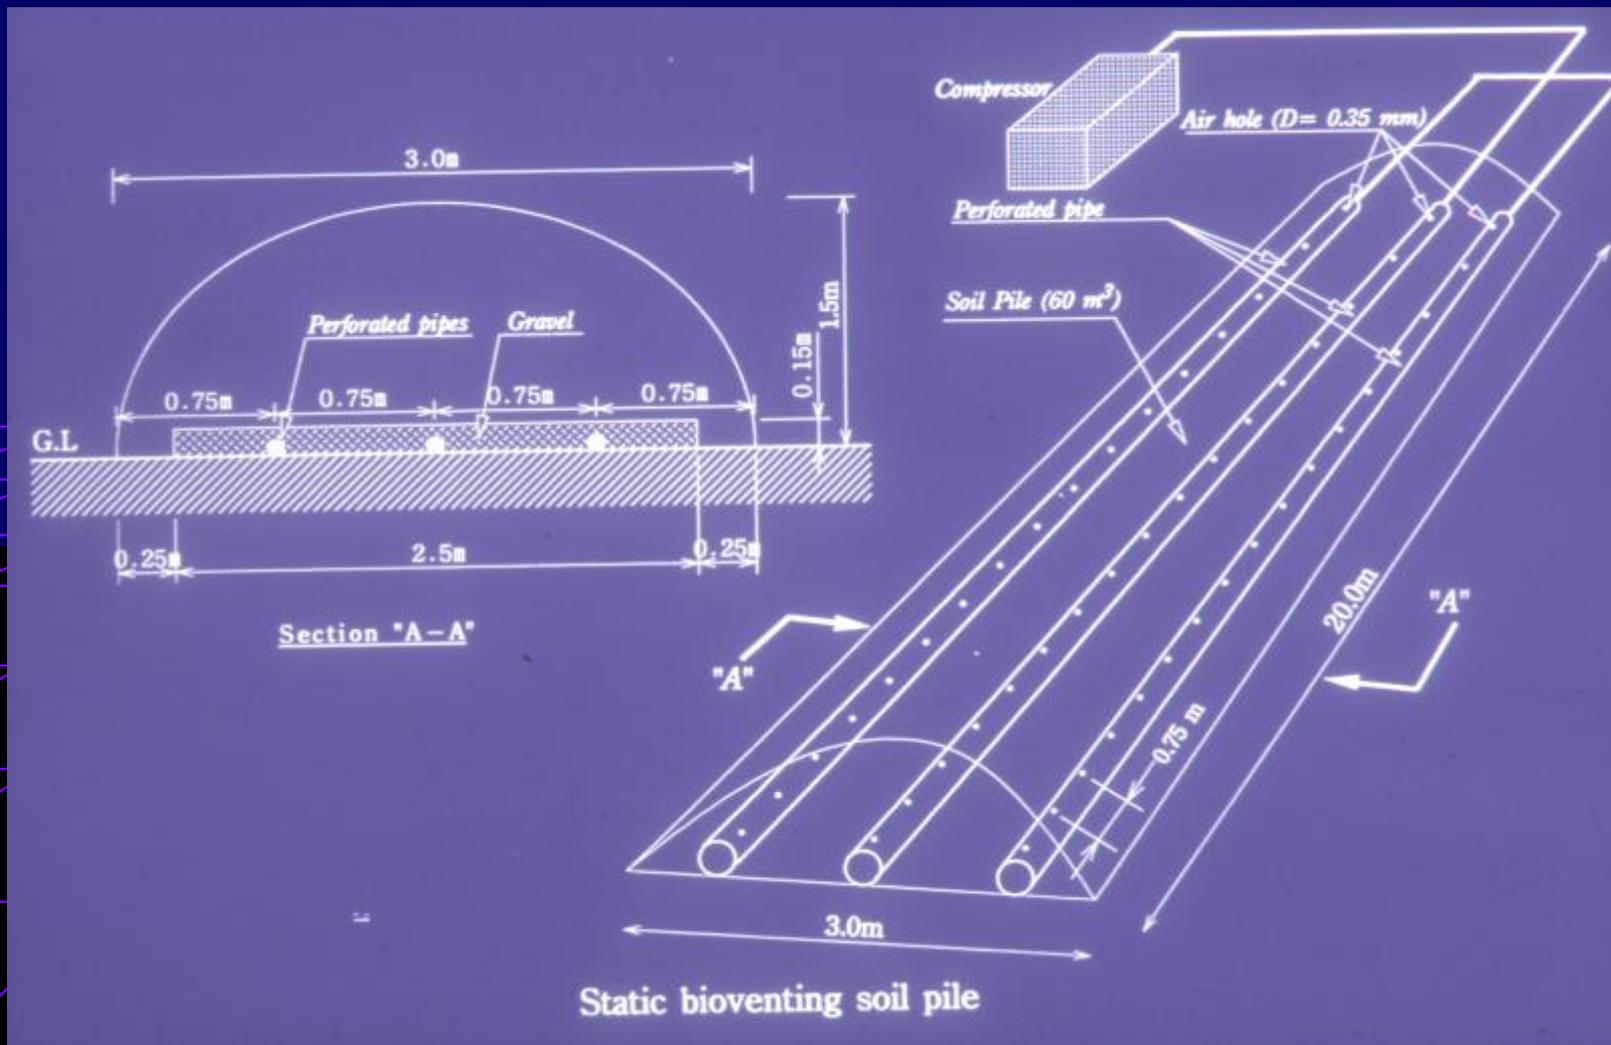
Concept of Static Bio-venting Soil Pile

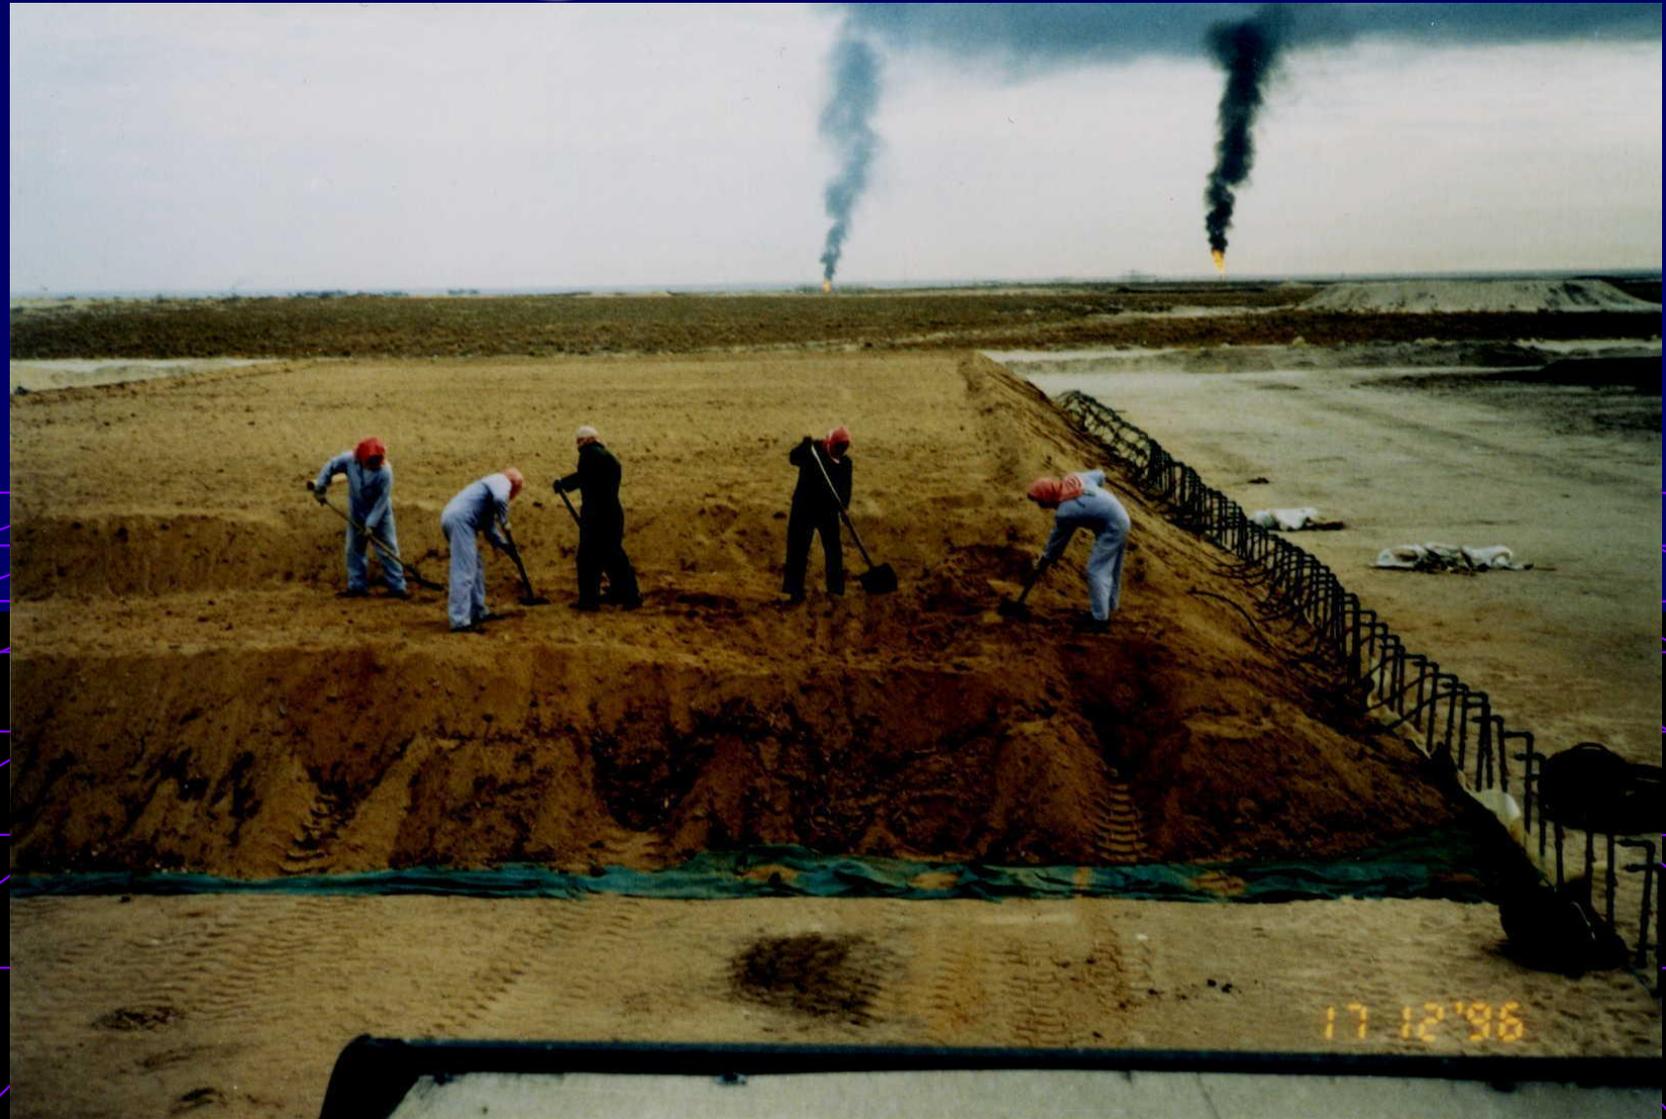
Construction of a Big Static Bio-venting Pile

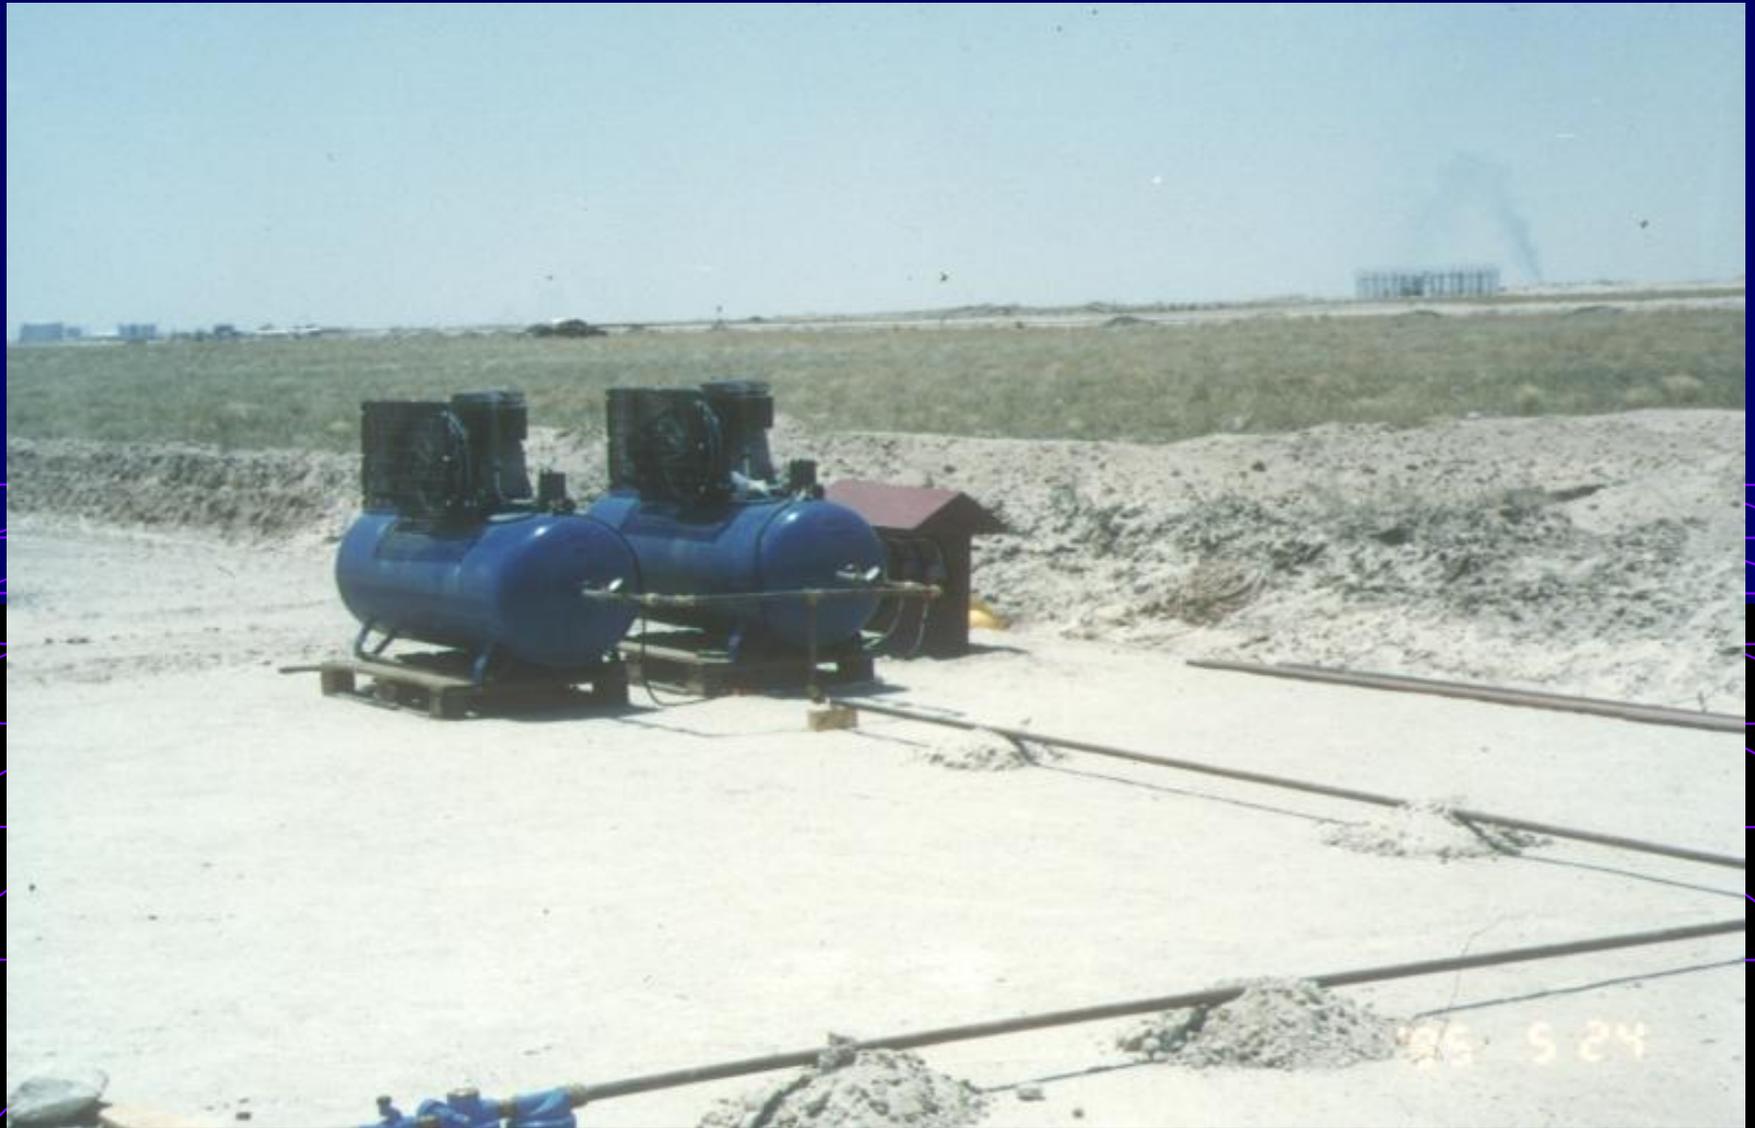
Compressor for the Static Bio-venting Piles

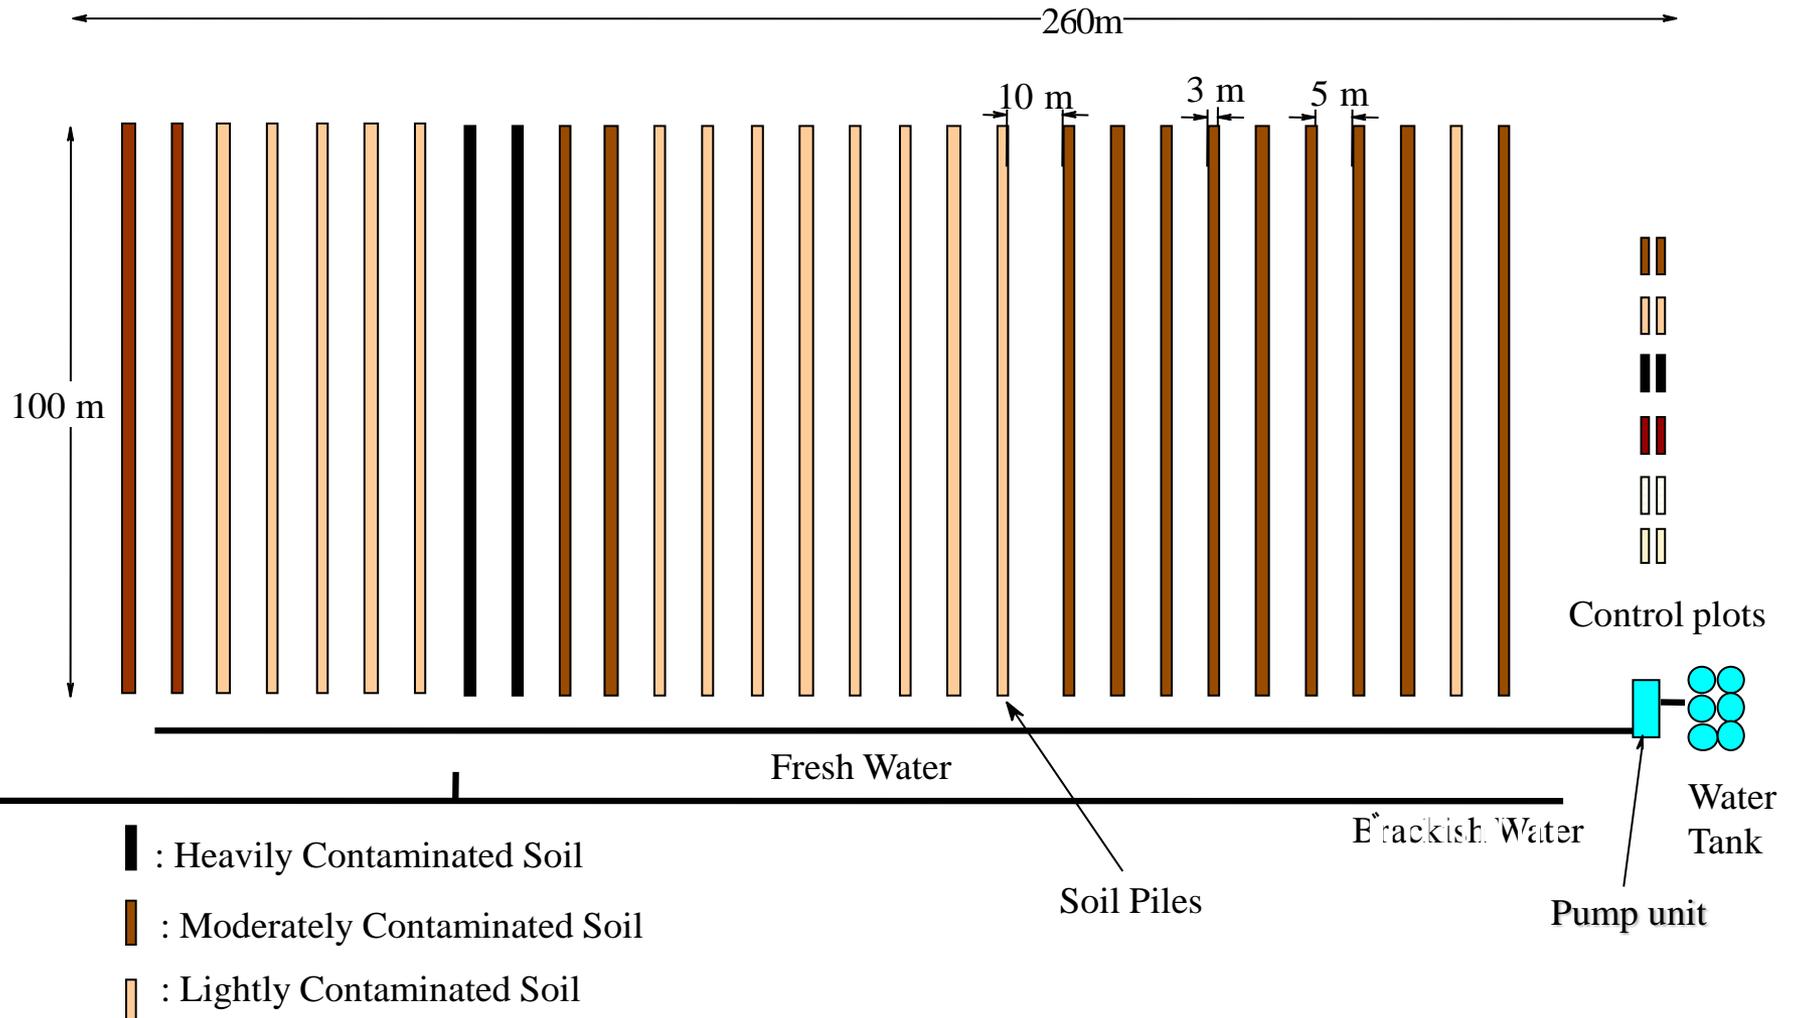
Layout of Pile Turner Experiment

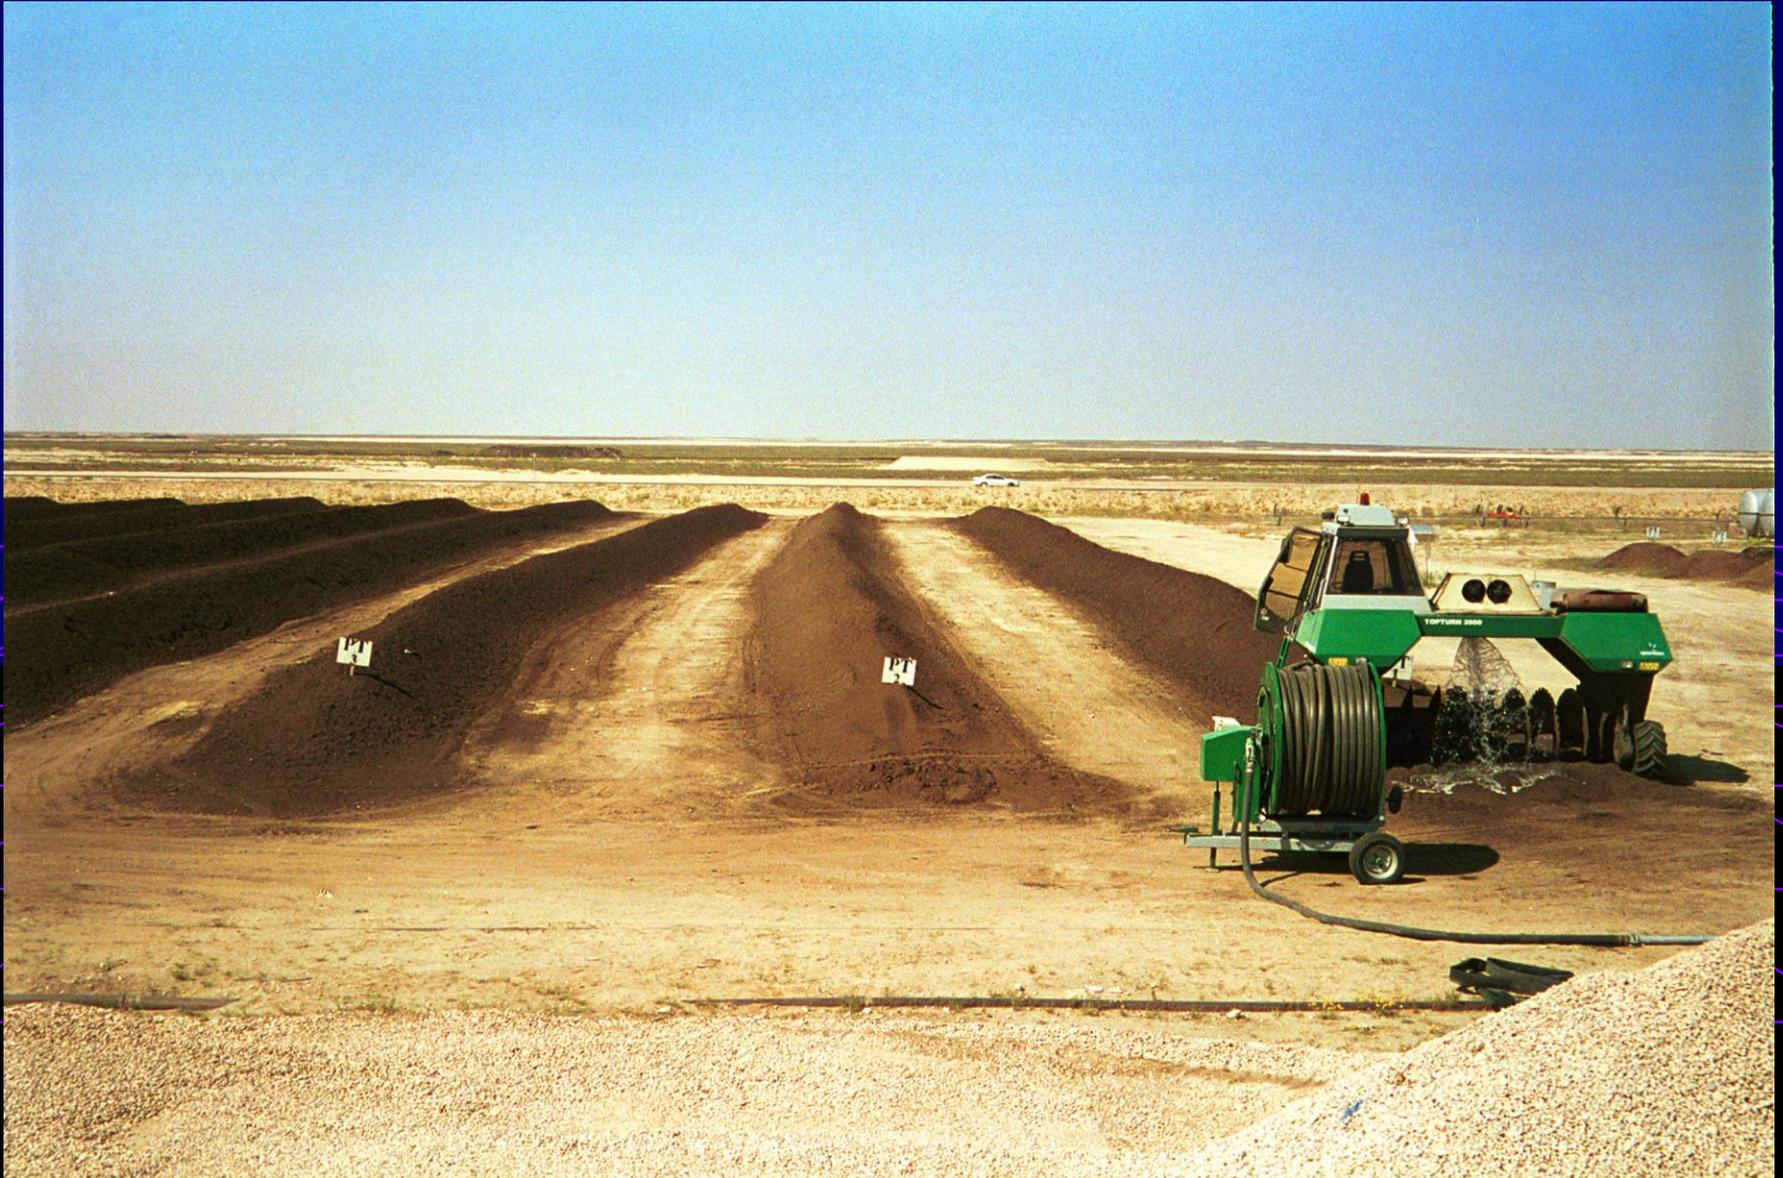
Area for Pile Turner Method

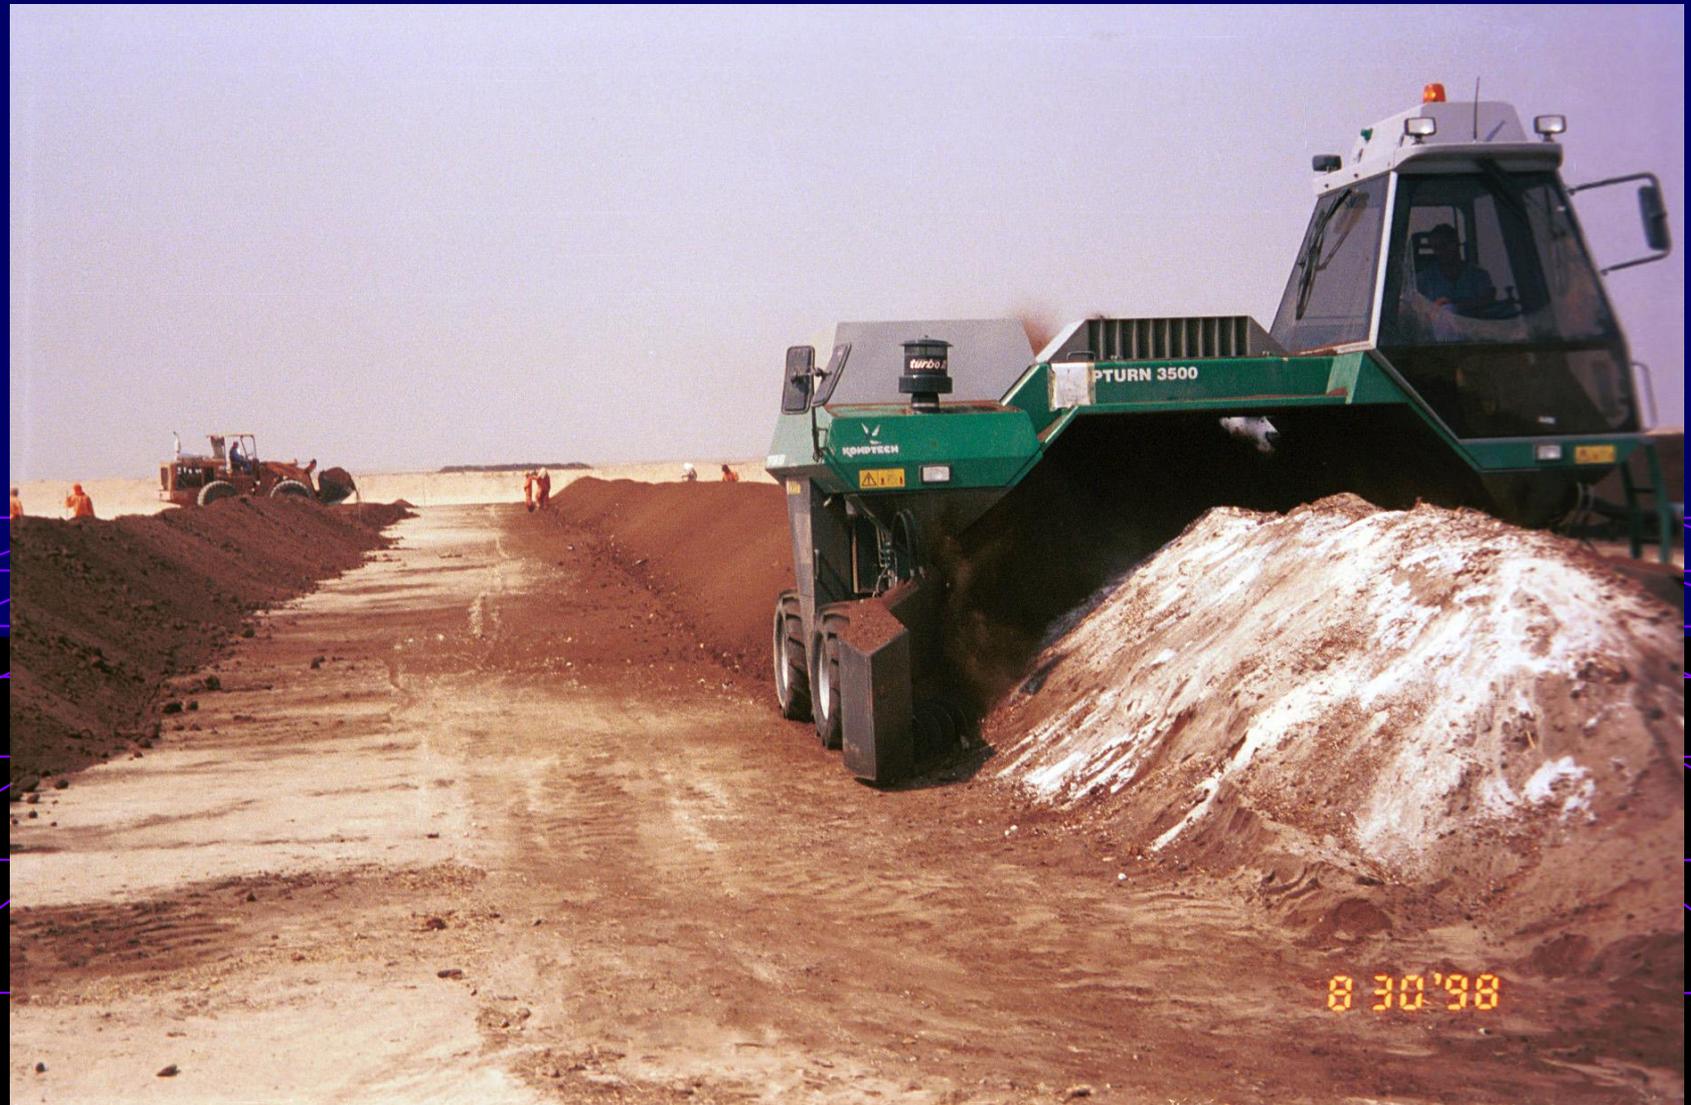
Mixing with Soil and Amendments

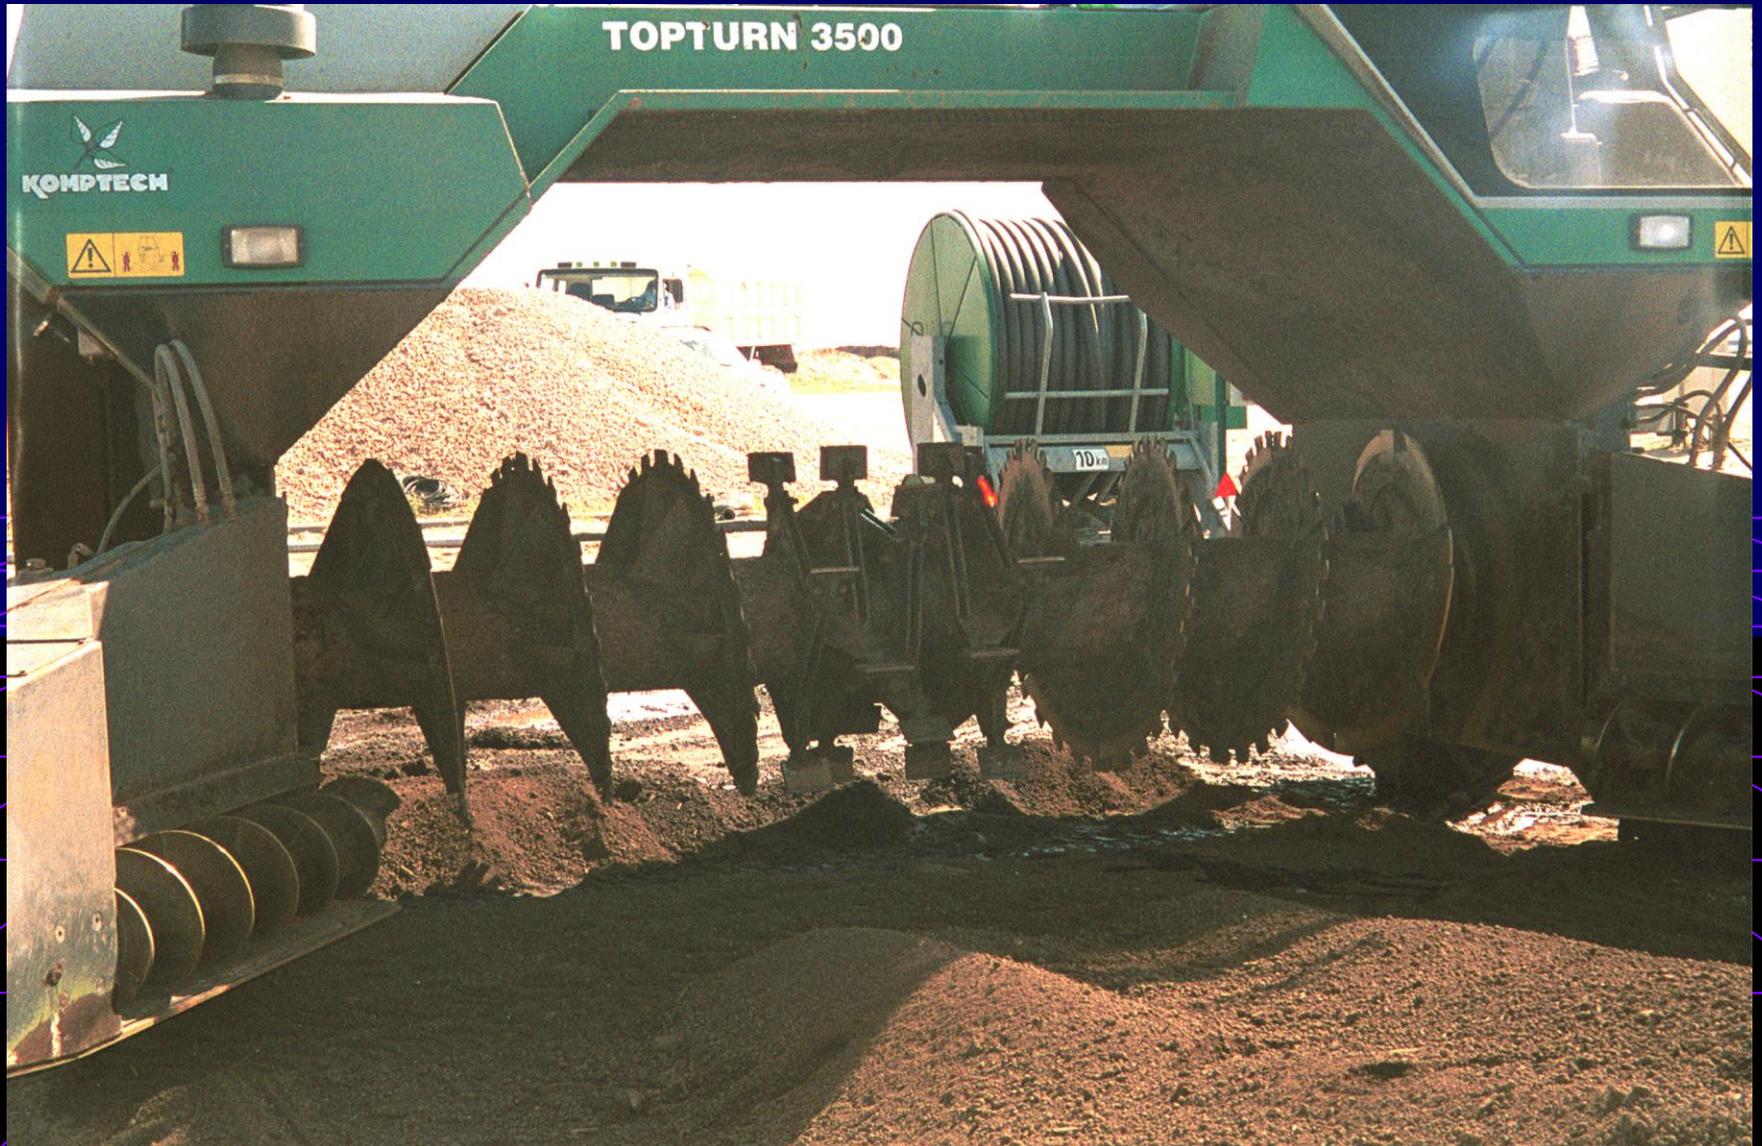
The Blade of Pile Turner

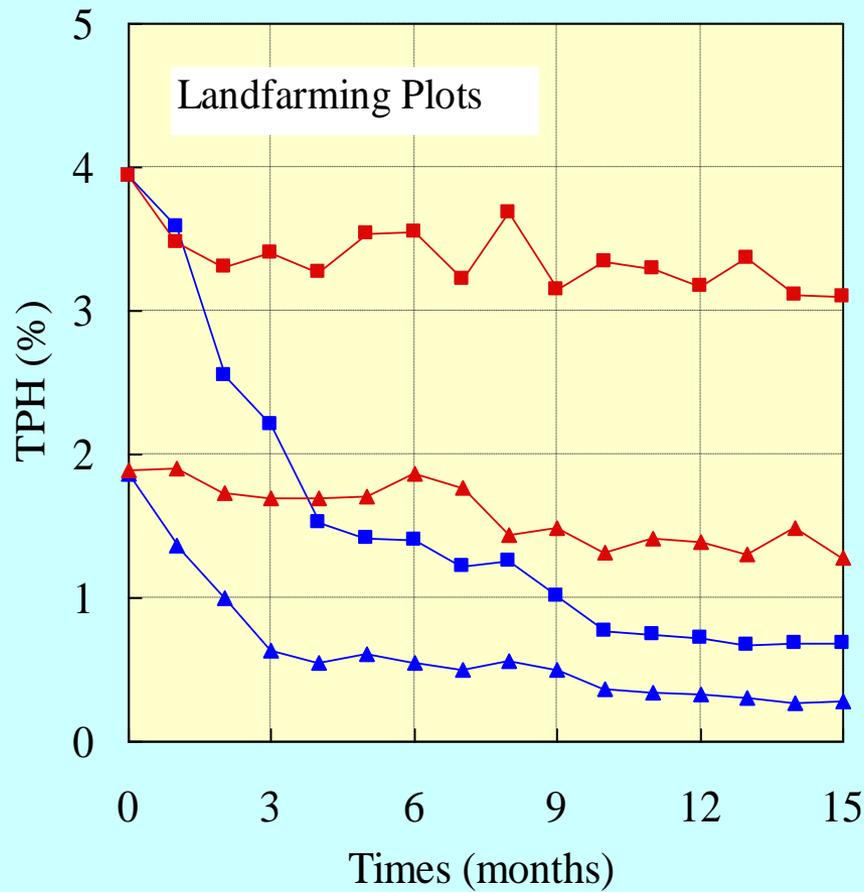
Result of TPH Analysis

- Moderately (Treatment)
- Moderateky (Control)
- ▲ Lightly (Treatment)
- ▲ Lightly (Control)

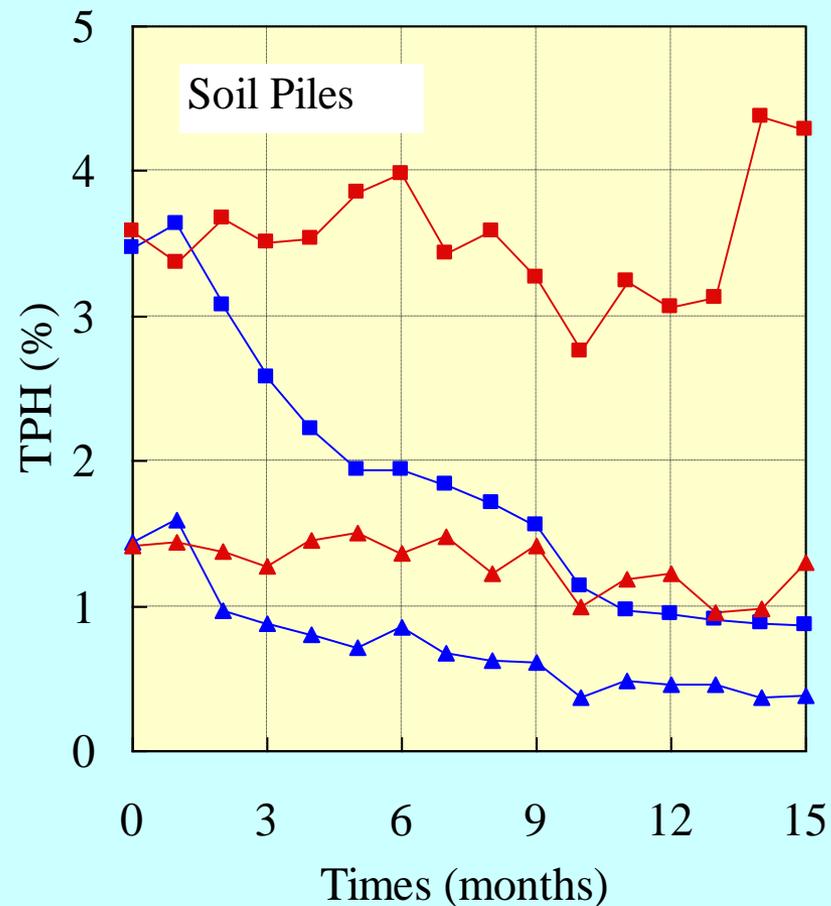
- Windrow (Treatment)
- Windrow (Control)
- ▲ Static (Treatment)
- ▲ Static (Control)

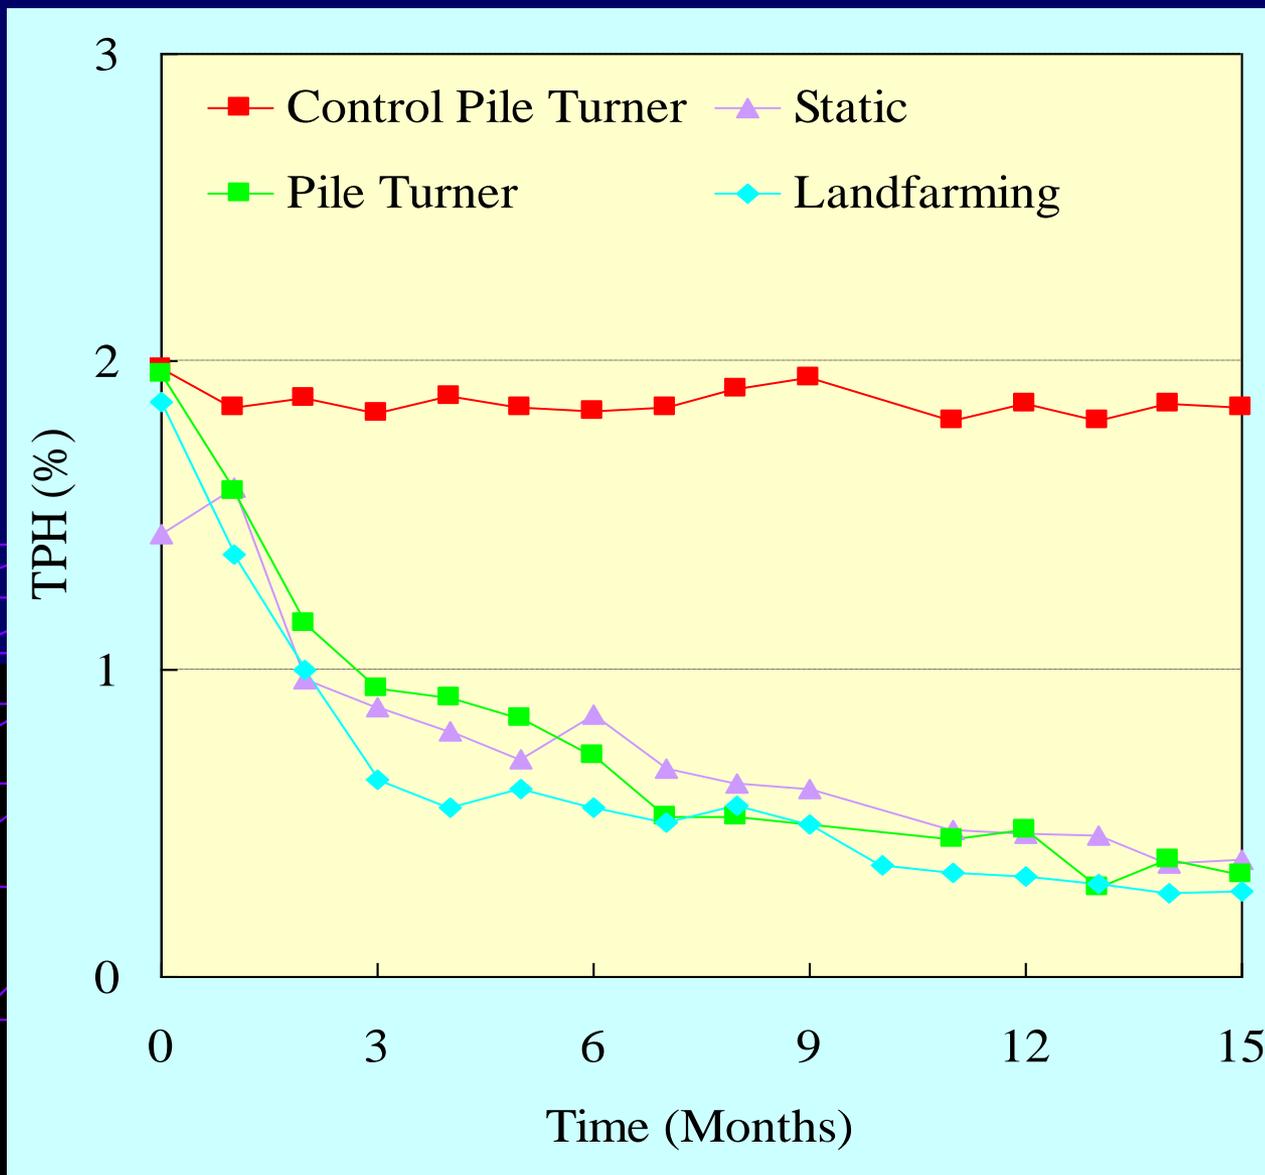
Result of TPH (Part 2)

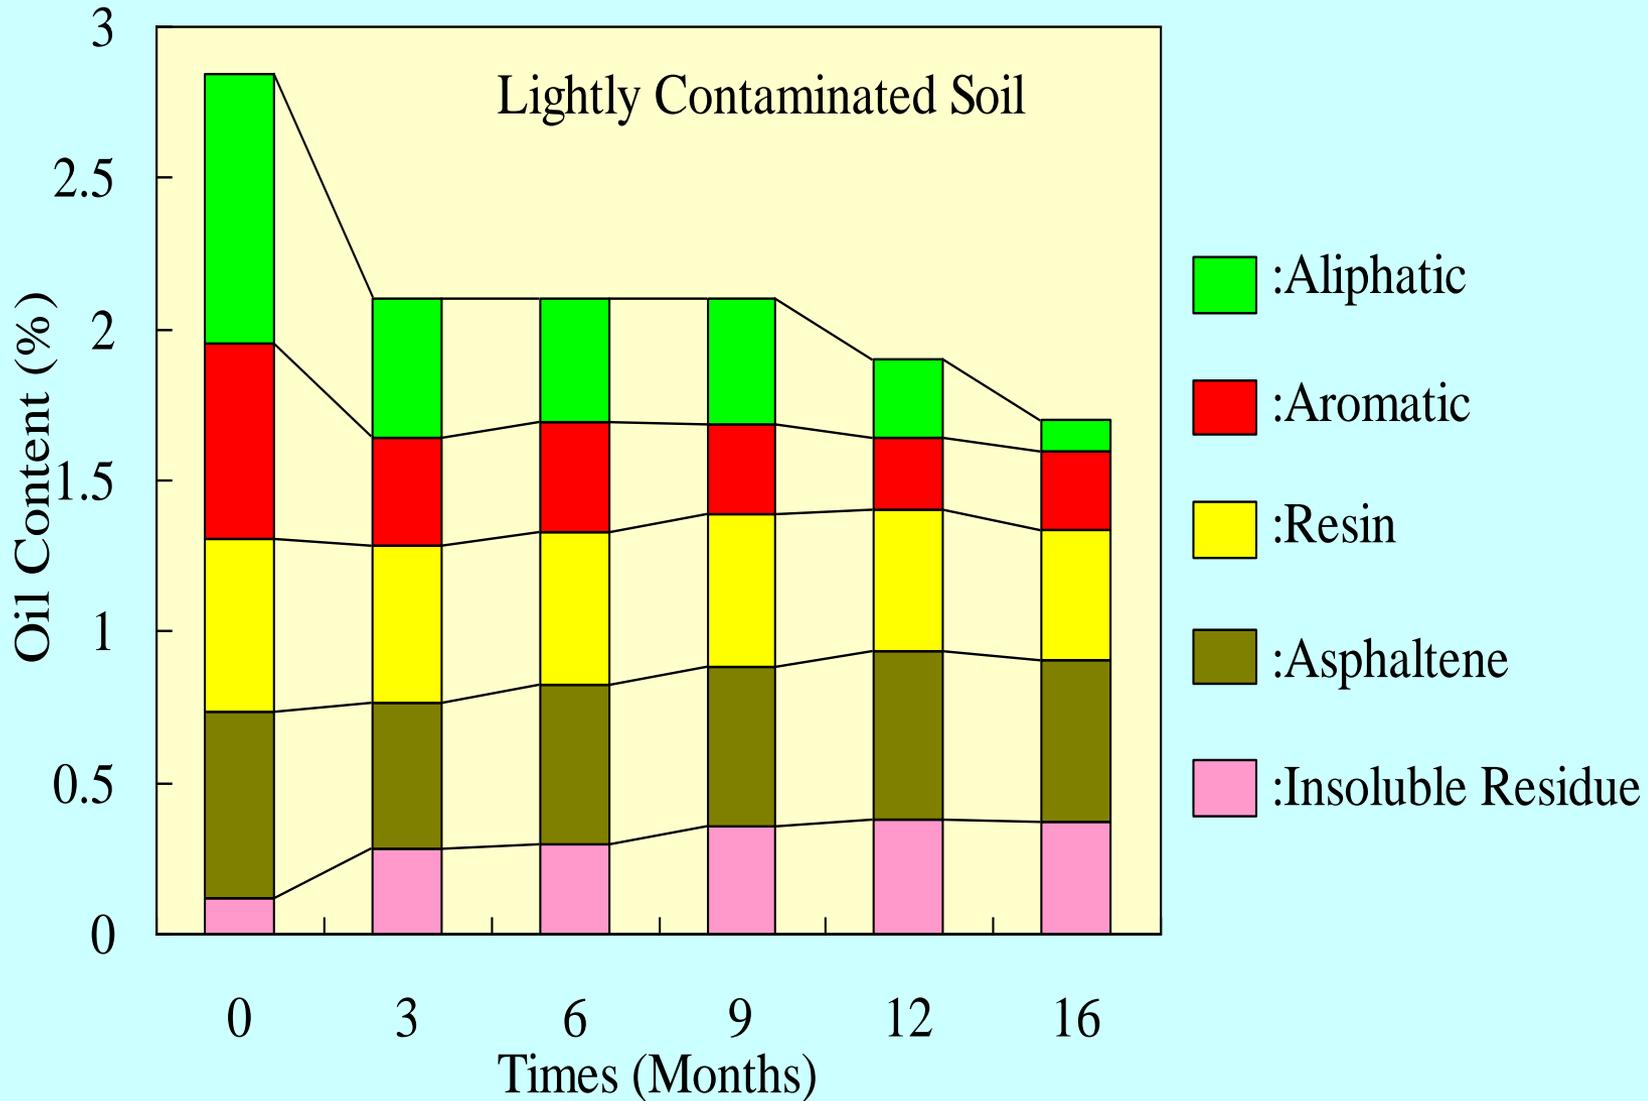
Fraction Analysis (Pile Turner Method)
