Bioremediation of Oil Contaminated Soil in Kuwait

Obayashi Corporation

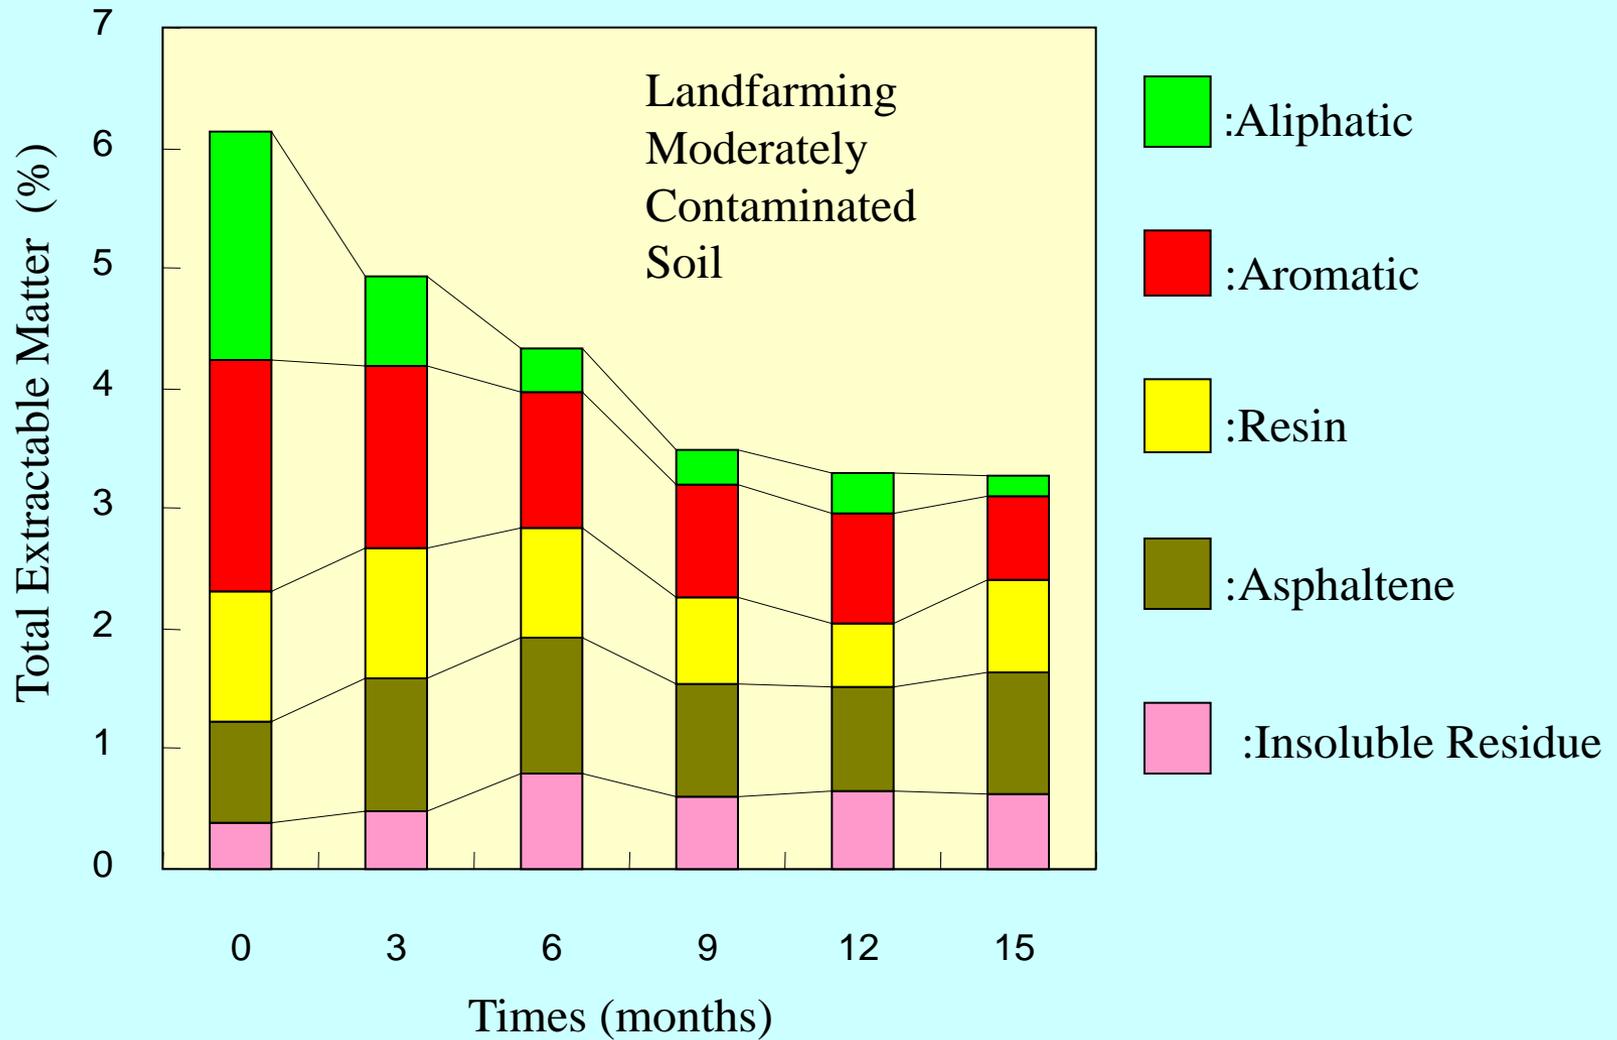
Result of Fraction Analysis (Landfarming)

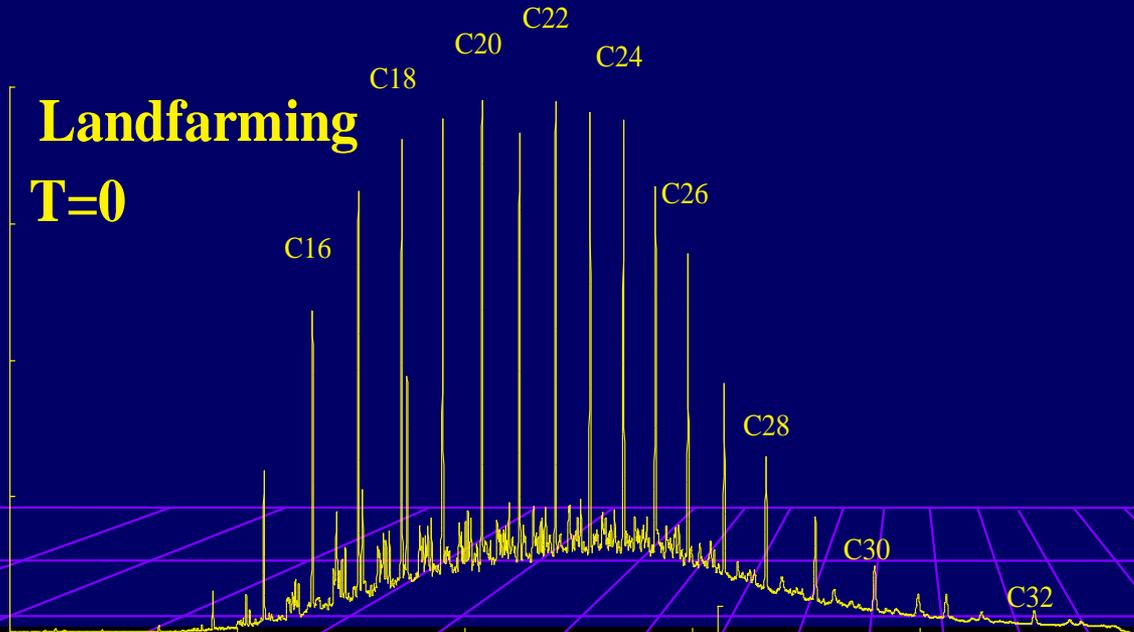
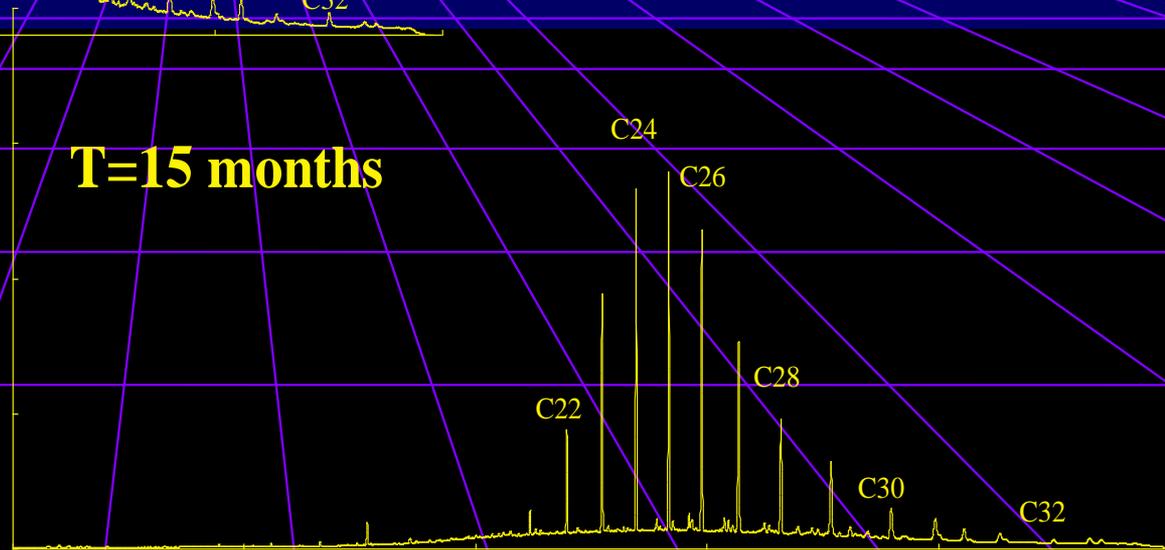
Result of Gas Chromatograph

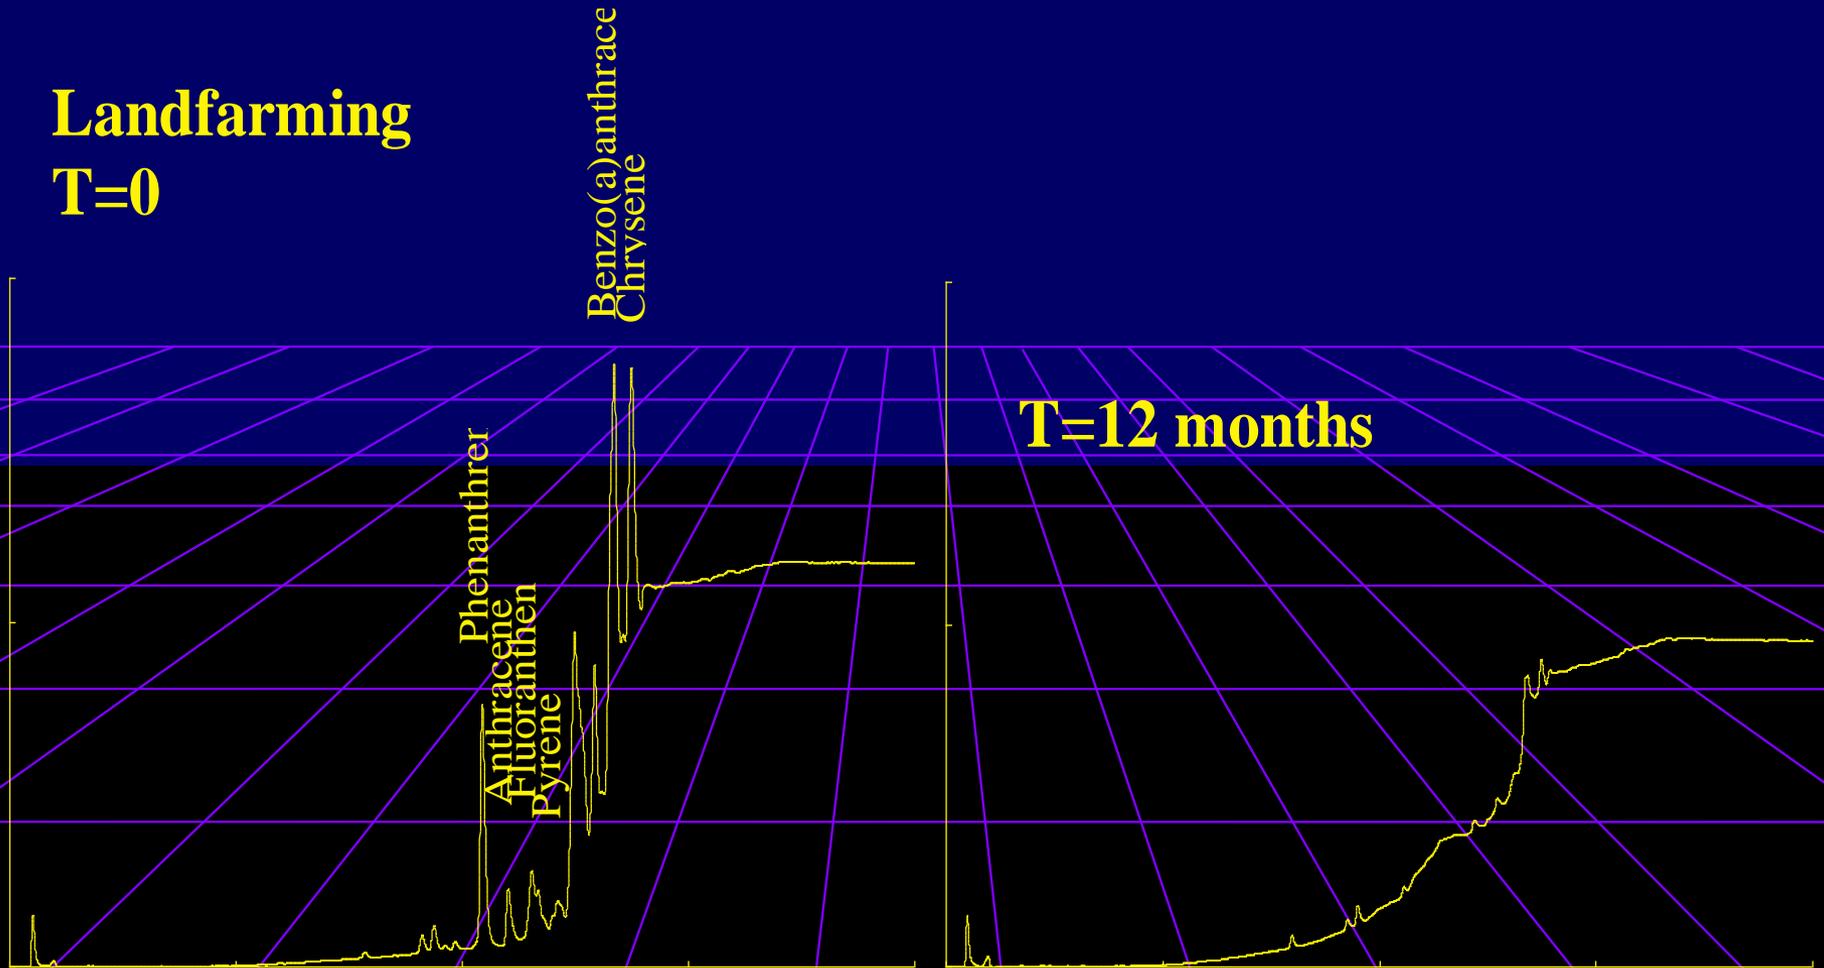
Result of PAH Analysis

Landfarming
T=0

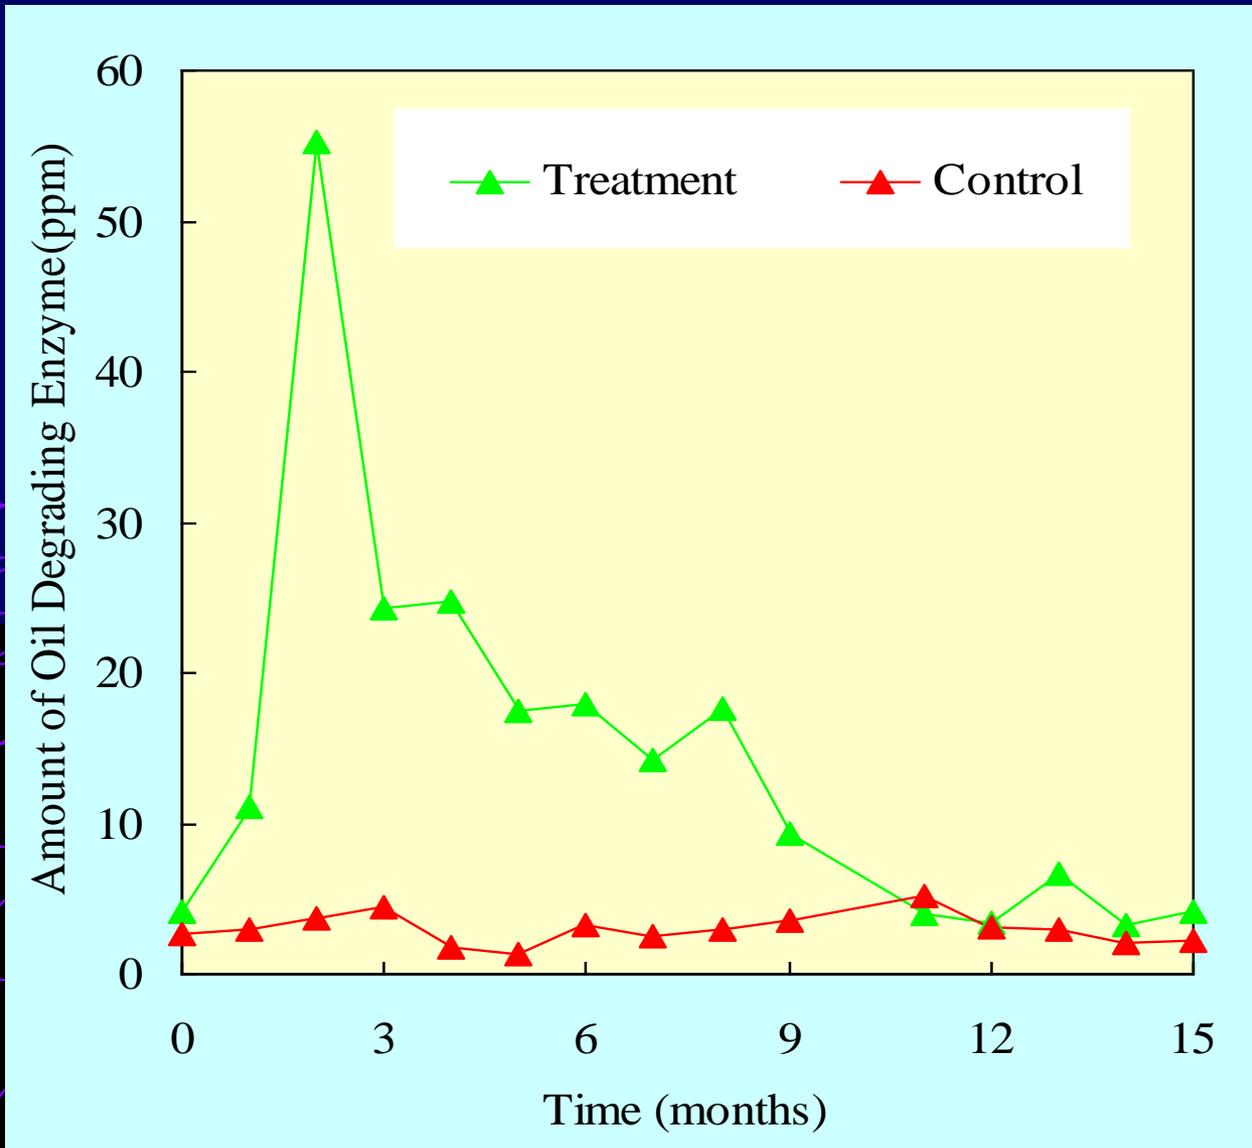
Microbial Activity

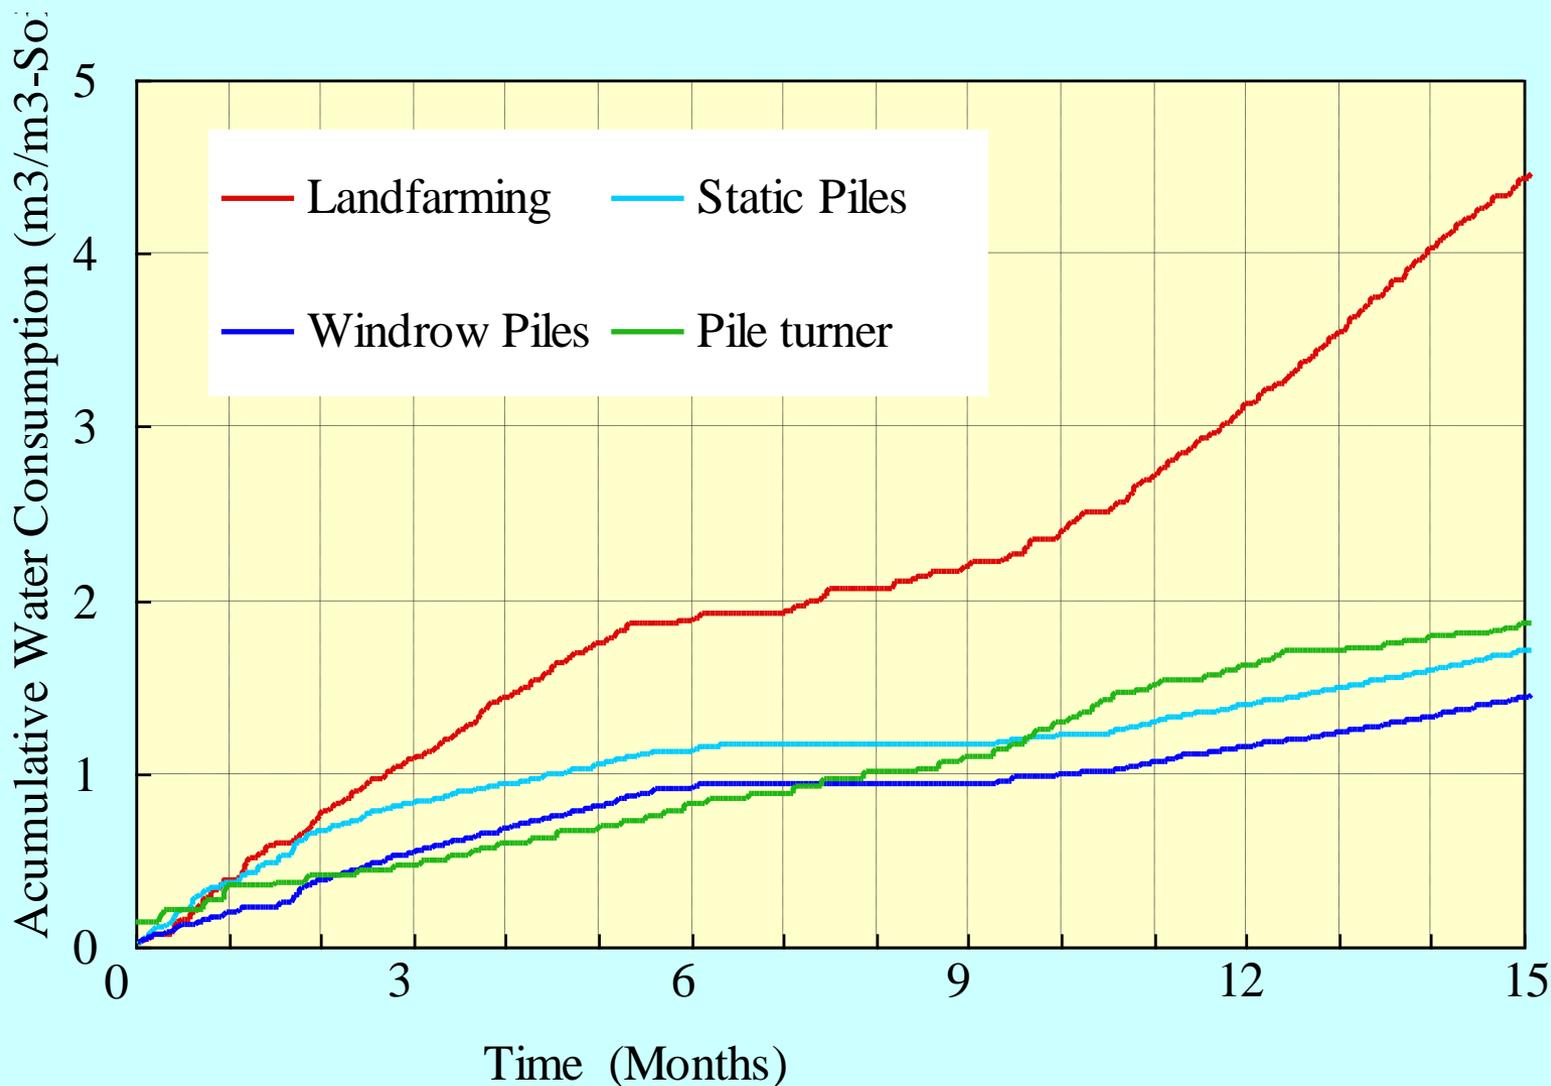
Amount of Water Requirement

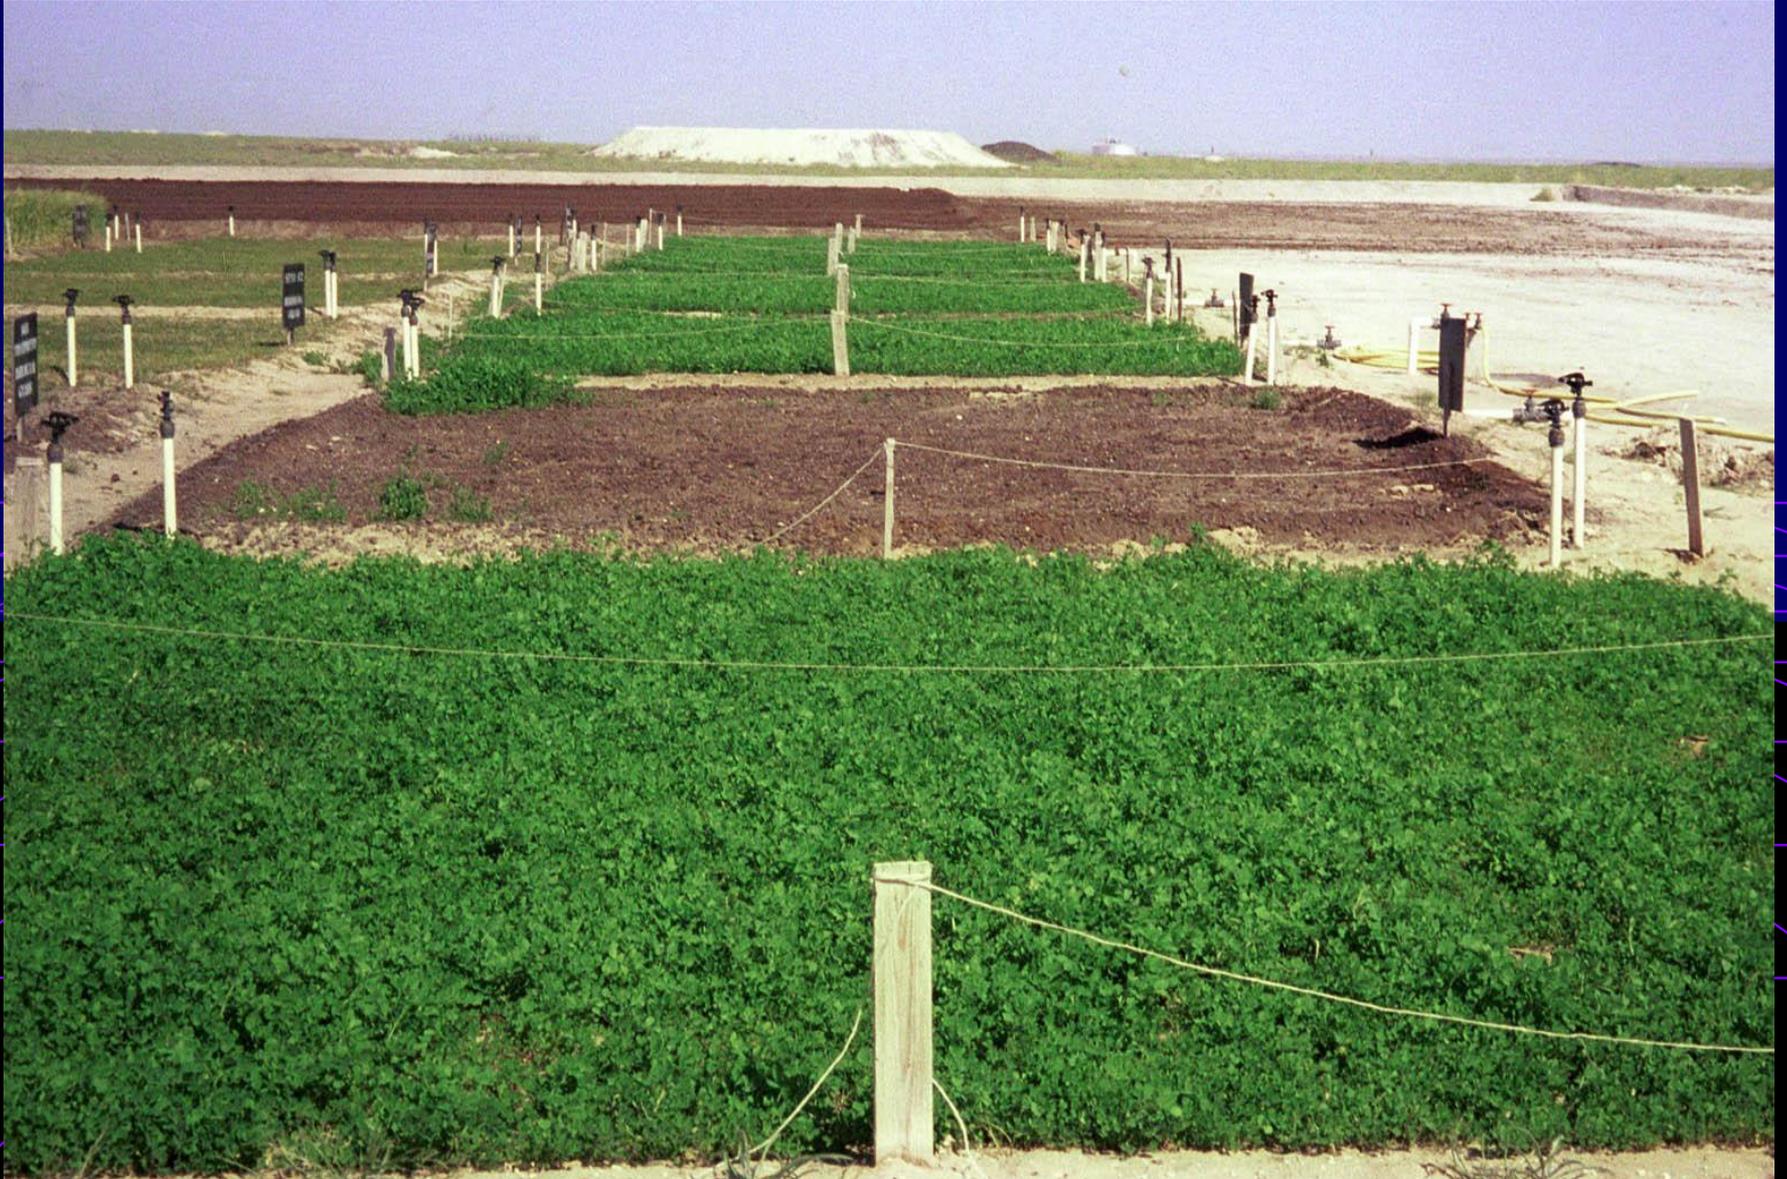
Phyto Toxicity Experiment (Alfalfa)

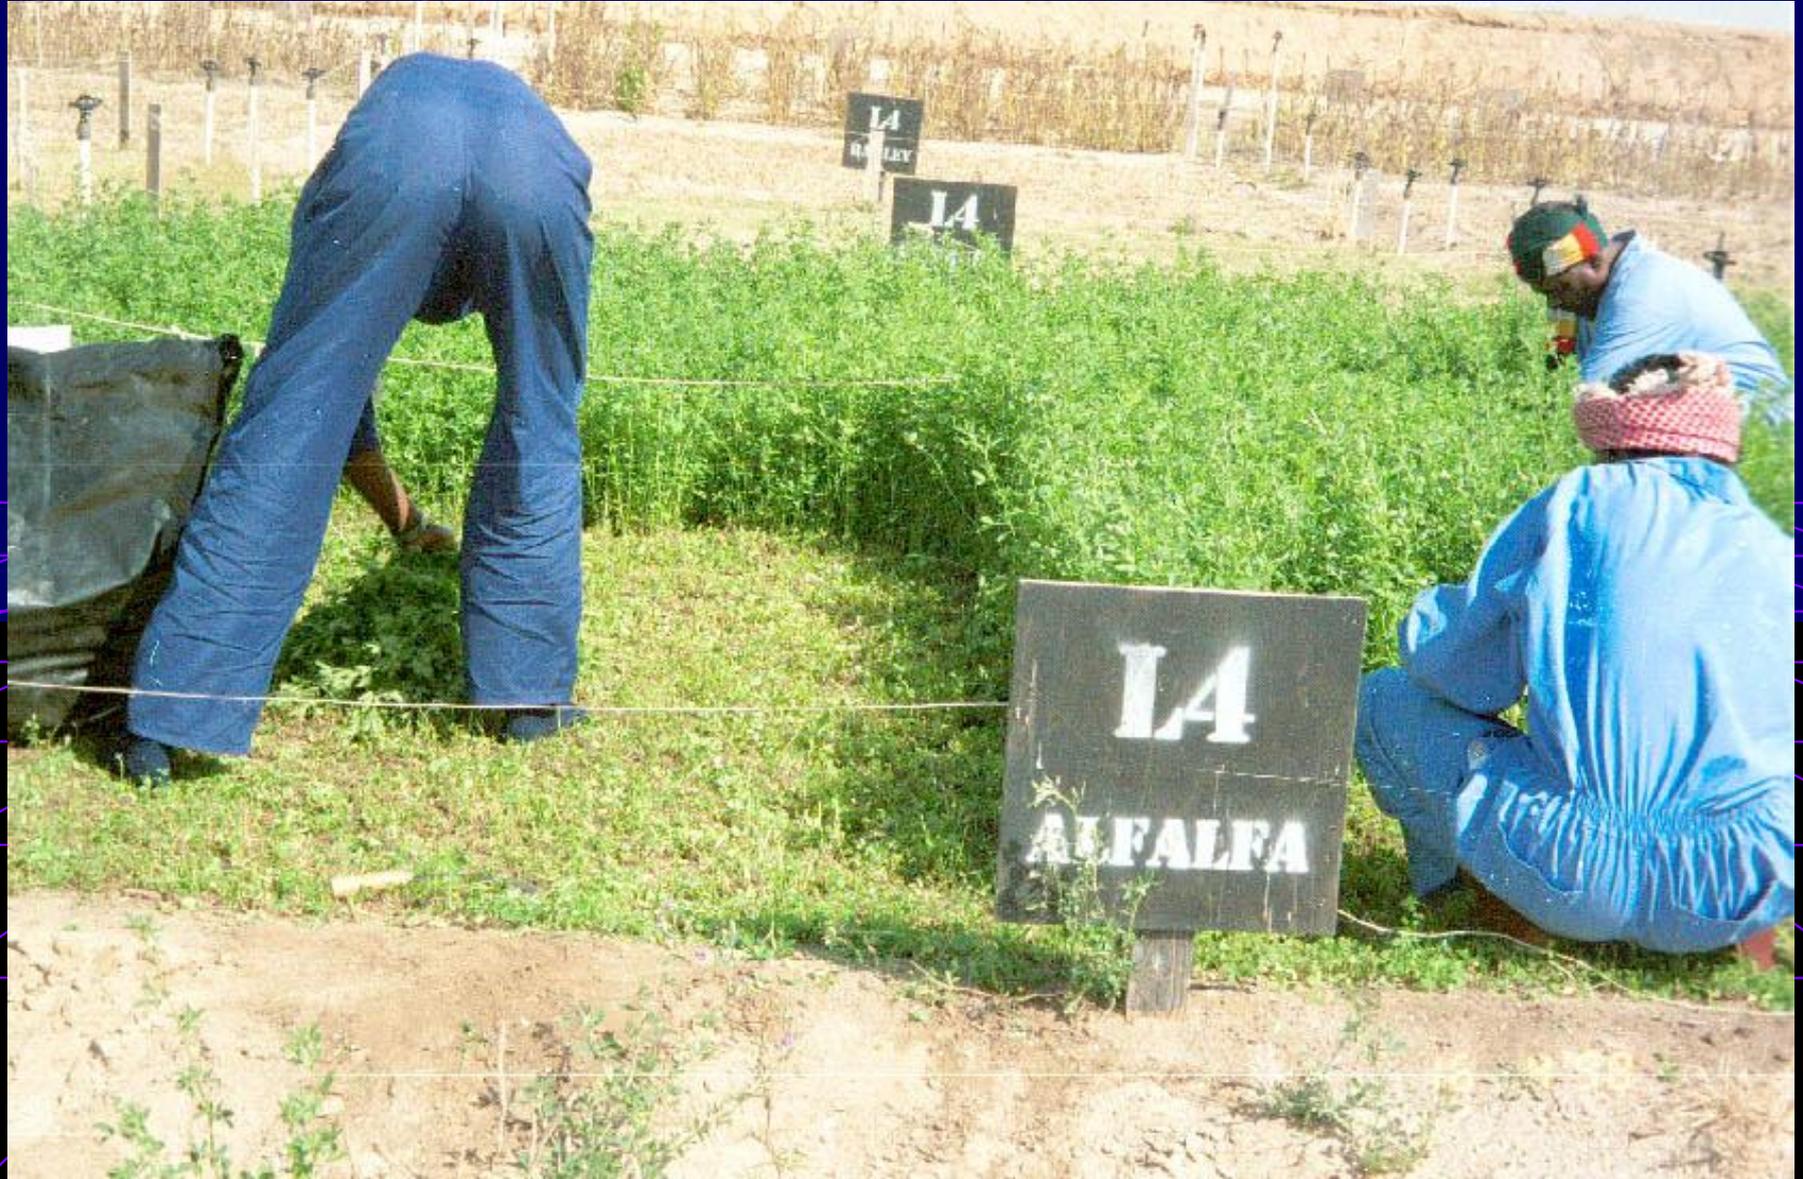
Measurement of the Yield (Alfalfa)

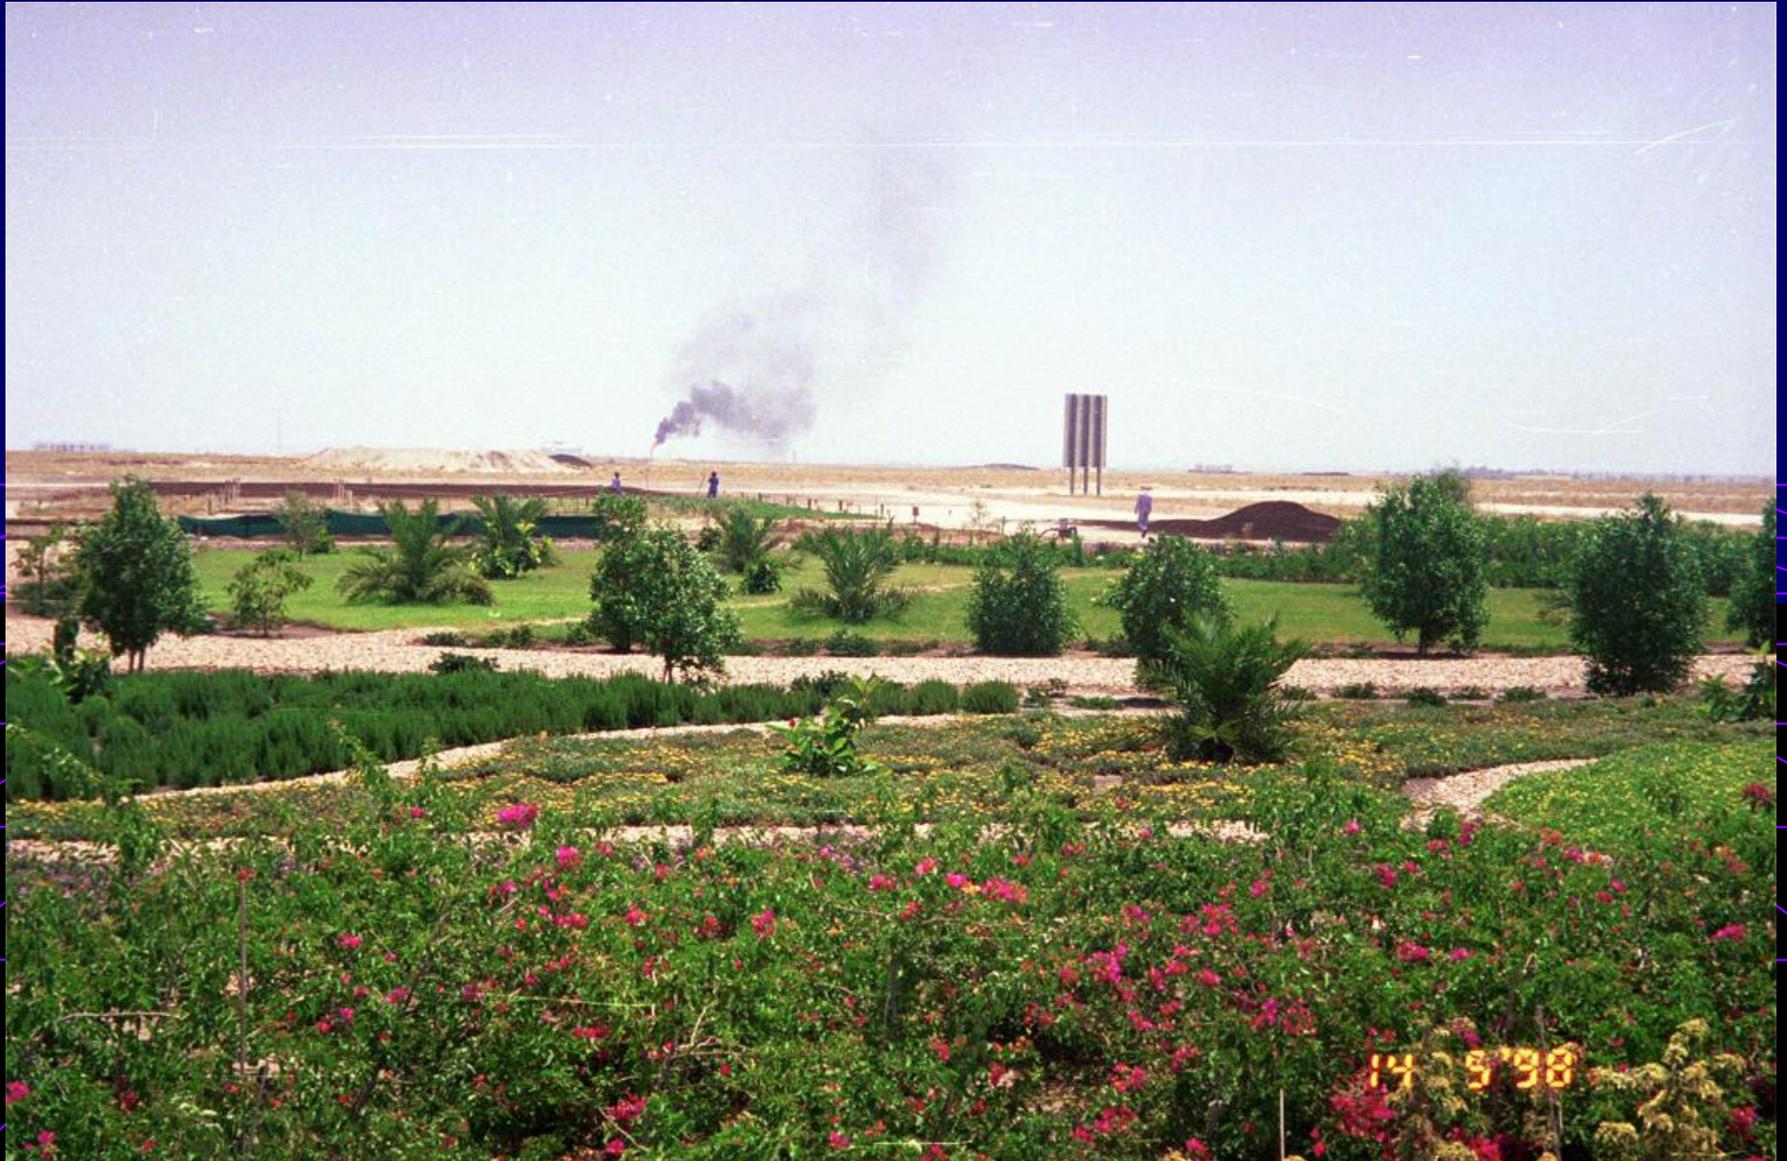
Large Scale Vegetation Field Experiment

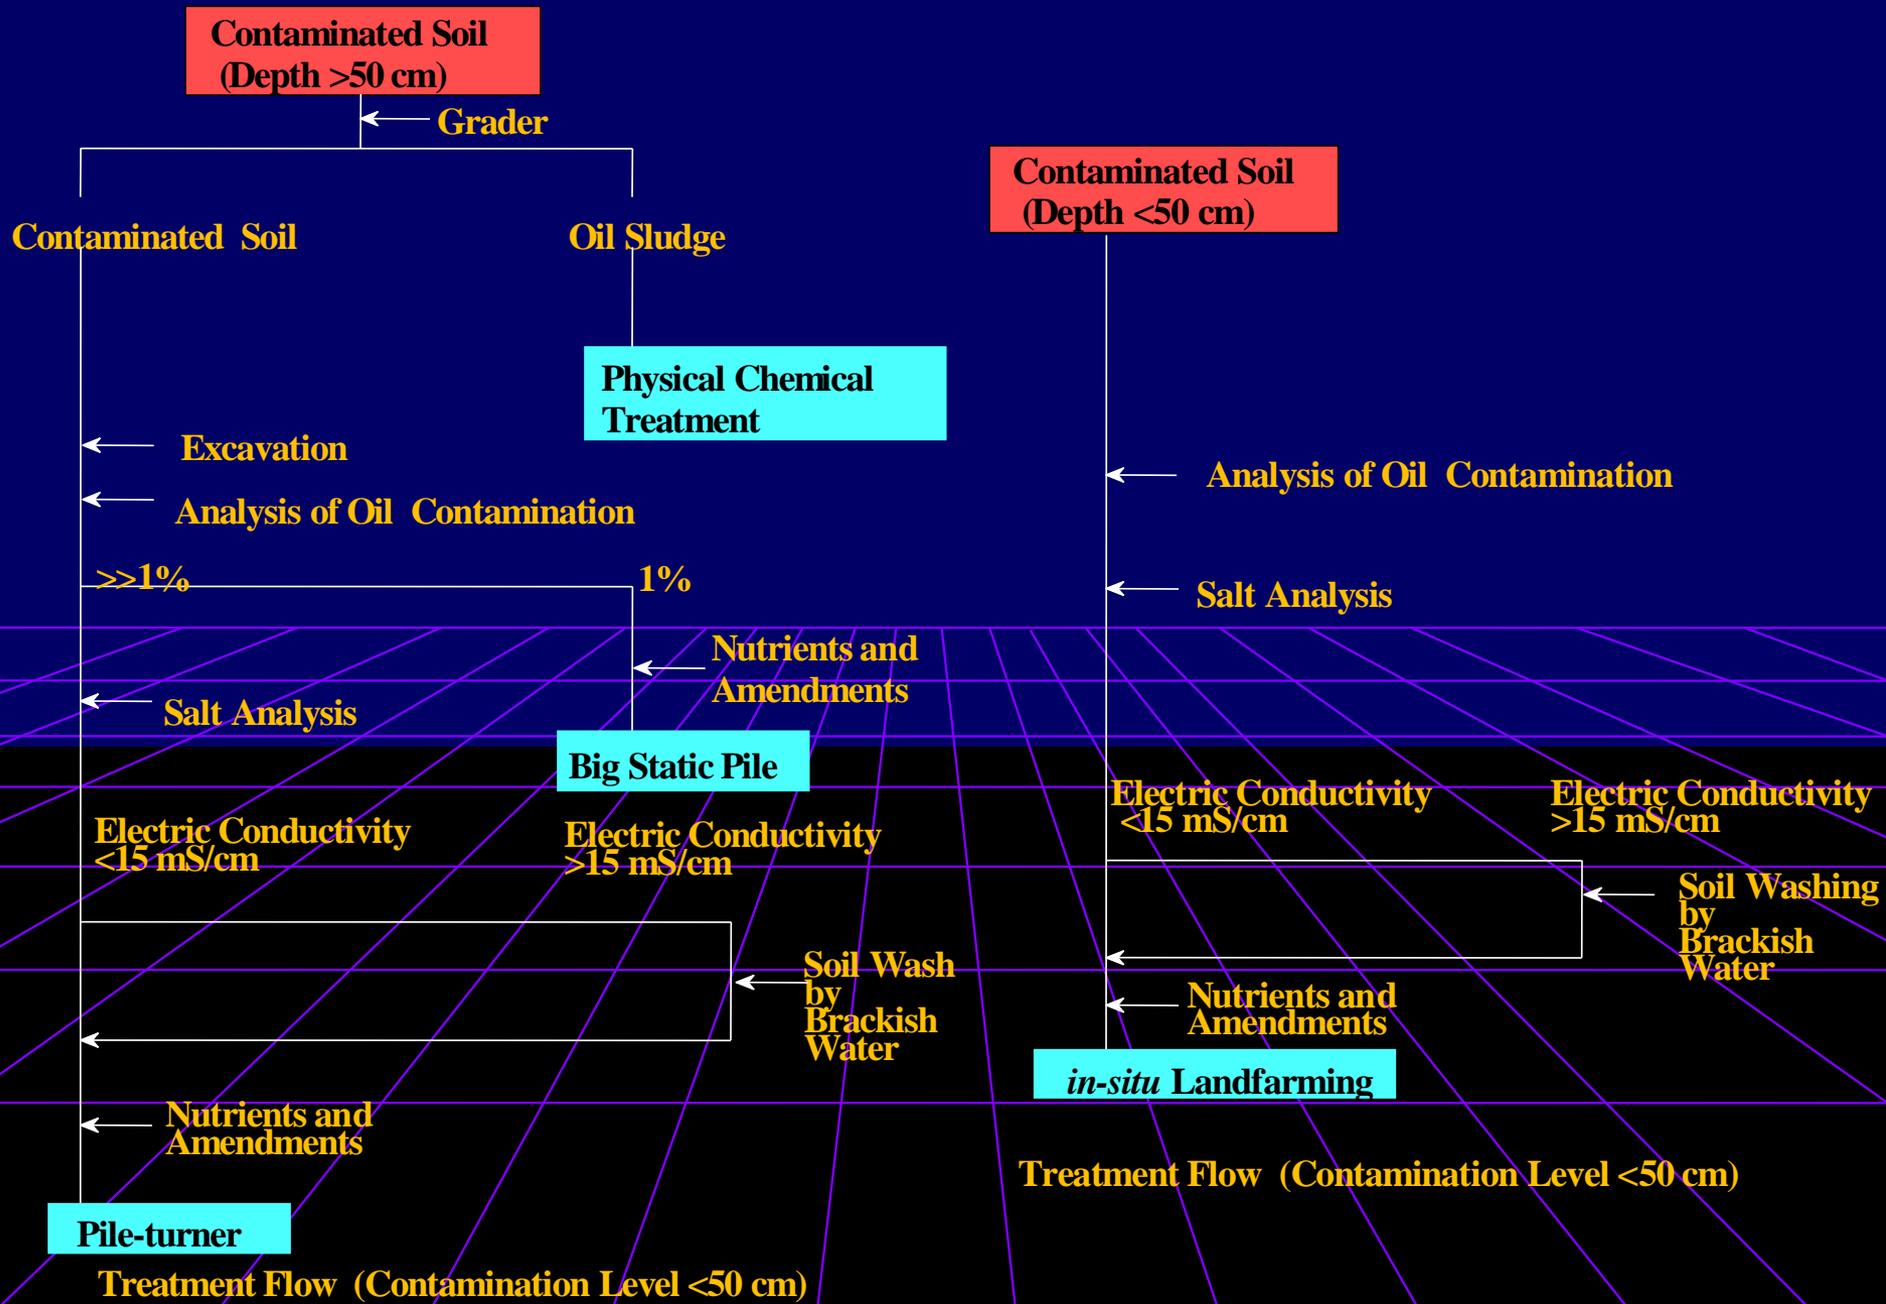
Protocol of the Treatment
